ROOT CAUSE REPORT

3 **TITLE:** Inadequate response to unplanned environmental tritium releases from Braidwood Station due to weak managerial oversight and the lack of integrated procedural guidance.

Unit(s): Braidwood Units 1 and 2

Event Date: 11/30/2005

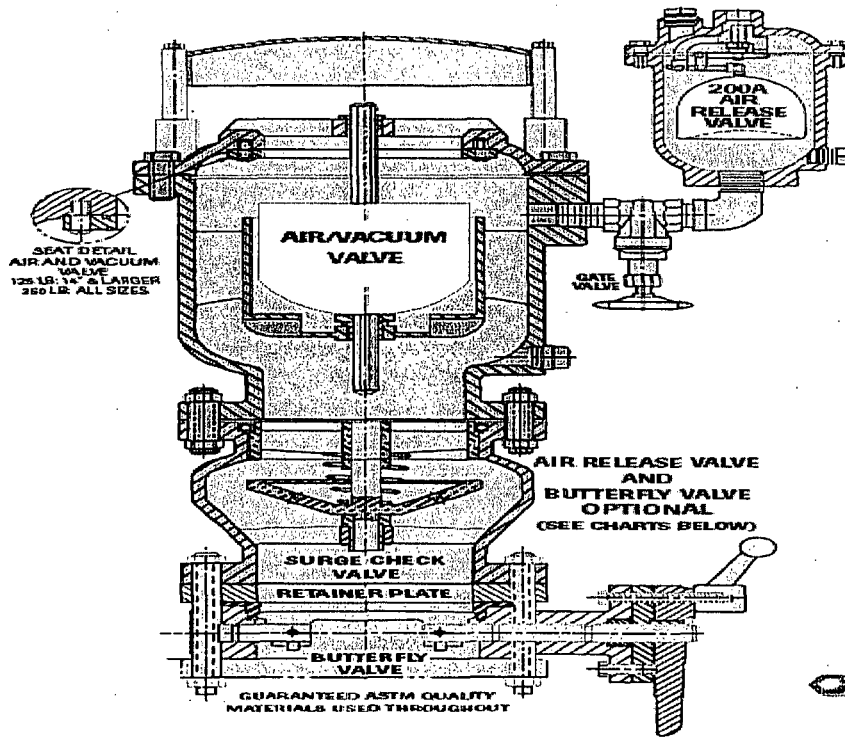
Typical vacuum breaker:

Work history on the Circulating Water Blowdown System vacuum breakers was reviewed. There were no recorded vacuum breaker float assembly failures prior to 2000, however several instances of leaking air release valves were noted from the review. The VB-3 air release valve was discovered leaking in 12/98. PIF # A1998-04324 was generated to address the flooding of site property and the Smiley Road ditch immediately adjacent to site property. The piping to the air release valve on the VB-1 failed in 12/96. The complete vacuum breaker assembly including air release valve was replaced with a new assembly in 1997. It should be noted that the VB-1 vacuum breaker failed again on 11/20/2000. The float assembly broke at the bowl to guide bar weld. No other significant work history was identified.

The failure of the VB-2 float assembly was discussed with the vendor. Based on the failure description, the vendor indicated that it appeared to be consistent with the effects of a pressure surge (i.e. water hammer). The vendor indicated that surge protection check valves should be considered for a vacuum breaker when pipe flows exceed 6 ft/s and are required when flow velocities exceed 10 ft/s. The vendor also recommended a 7-10 year PM frequency to address valve elastomer degradation. The condition was addressed by revising the operating procedure BwOP CW-12 to manually open and close the valves to slowly initiate or terminate blowdown flow.
