# **The MacArthur Maze and Newhall Pass Fires and their Implications for Spent Fuel Transport**

**Christopher S. Bajwa**

**Earl P. Easton**

## **ABSTRACT**

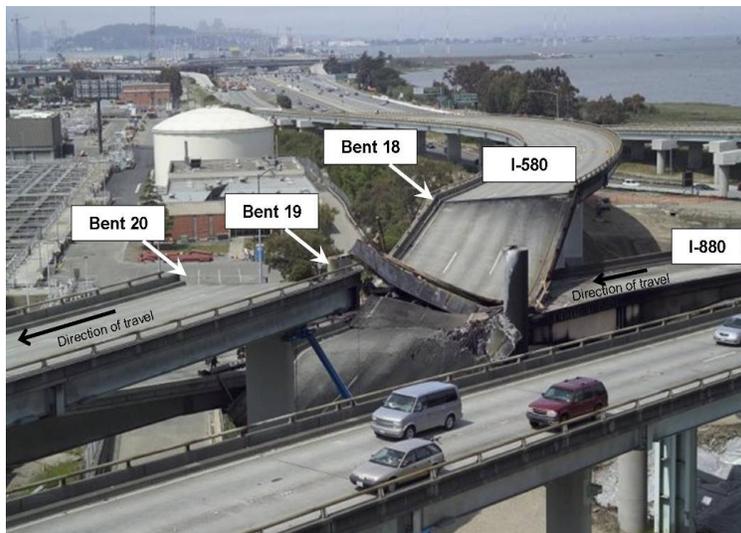
**Fig. 2. Postfire aerial view of the collapsed section of I-580 looking west.**

<sup>1</sup> The transverse support locations for the elevated roadway are referred to as “Bents” in Figure 2.

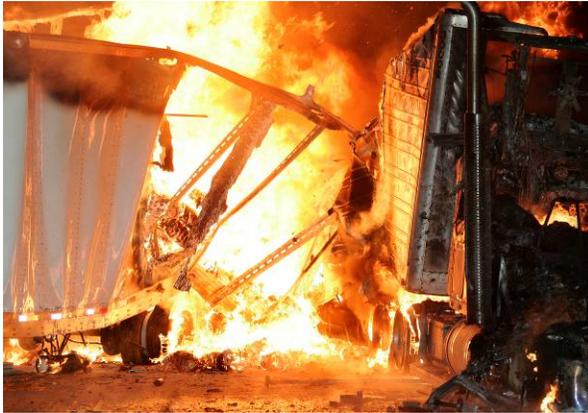
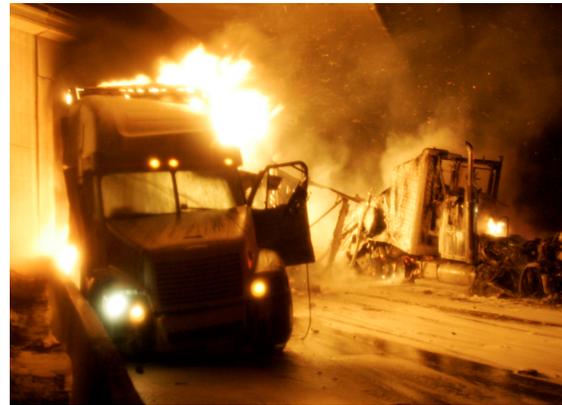
**Fig.3. Images of Commercial Vehicles Outside Tunnel Exit. Photos by Gene Blevins/LACOFD/Photo.**

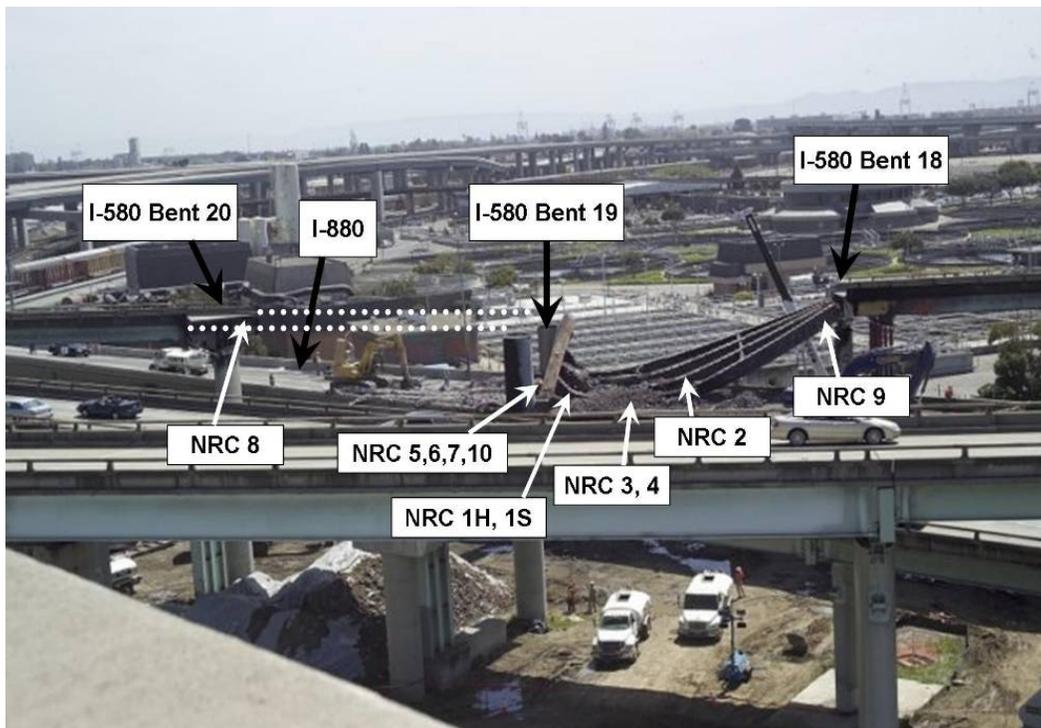
**Fig. 6. View of damage during demolition looking southwest<sup>2</sup>.**

<sup>2</sup> Bent 18, 19, and 20 and approximate locations of collected specimens are indicated. Dotted lines represent pre-accident overpass structure that was demolished and removed prior to this photograph. Original picture from Caltrans website <http://www.dot.ca.gov/dist4/photography/images/070430/index2.html>

A summary of the analysis results for selected samples is shown in Table 2. Efforts were focused on the analysis of girder sections that were believed to be located close to the fire (i.e., near Bent 19) as well as samples that were known to be in much cooler locations such as near Bent 18. For example, Samples NRC 3 and NRC 4 were collected from Plate Girder 5, which was buckled during the fire. Sample NRC 3 was likely located closer to Bent 19 compared to Sample NRC 4.

Based on the samples collected and the results of thermal exposures, the temperature of the I-580 overpass is estimated to range from 850°C [1,562°F] to approximately 1,000°C [1,832°F]. Near the truck, the maximum exposure temperature is estimated to be at least 720°C [1,328°F] and less than 930°C [1,706°F]. Results obtained from the analysis of the overpass and truck samples indicate that the hottest gas temperatures during the fire were located above the I-880 roadway near the steel girders of the I-580 overpass. An extensive discussion of the materials analyses completed for the samples collected are provided in previous papers [4], as well as a NRC NUREG/CR series report [5].

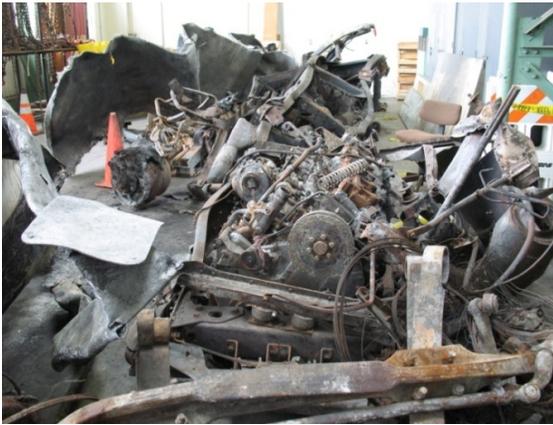
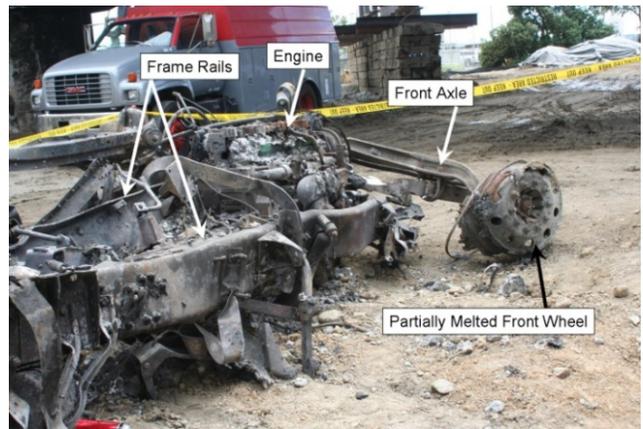
In March, 2008, staff from SwRI® and NRC inspected the tanker truck involved in the accident and collected selected samples for analysis. A variety of materials were collected including glass, aluminum alloys, steel, copper, brass, and stainless steel. Descriptions of the samples are shown in Table 4. Photographs of the truck remains are shown in Figure 7.

**Fig. 7. Photographs of the tanker truck remains at the accident site and at the Caltrans storage facility.**

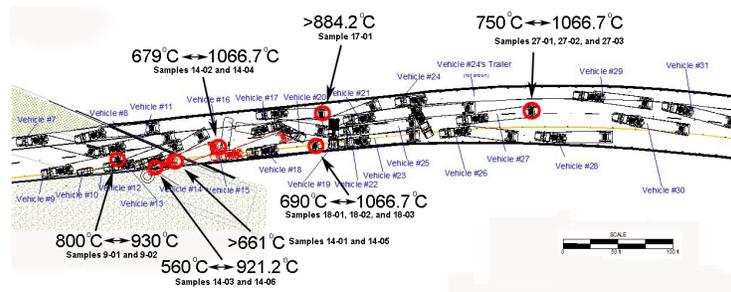
Figure 8 shows a schematic view of a tunnel section that includes the vehicles accessed for this study. Samples were recovered from Trucks 9, 14, 17, 18, and 27. The red circles indicate those specific vehicles and the approximate locations from which samples were acquired. The temperatures assigned to the encircled locations in Figure 8 were obtained from the calorimetry analyses, visual inspections, and mechanical hardness measurements. Exposure temperatures were bracketed through the analysis of multiple substances obtained from adjacent locations. The temperature range provides bounds for the maximum temperature that was believed to have occurred in that location based on the materials analyses. The bounding temperature values were obtained by examining specimens that presented signs of incipient melting (only nonferrous metals) or changes in hardness values (only steel fasteners) due to the fire exposure.

Figure 8 shows that for the location of Truck 9, the results from the sample analysis indicated that the temperature ranged somewhere between 880 and 930 °C [1,472 and 1,706 °F]. The material analysis determined the lower

bound by examining the hardness of graded bolts and melted aluminum. The upper-bound temperature for this vehicle was determined by an unmelted brass Schrader valve, which was located a few feet off the ground.

The temperature range predicted by the materials analysis for Truck 14's tractor was between 560 and 920 °C [1,040 and 1,690 °F]. The lower bound determined from the material analysis was based on melted aluminum from the grill of the tractor. This would be expected to be slightly above the 1.5 m [4.9 ft] level. The upper bound temperature was determined from a brass clamp recovered from the engine compartment. This would have been at an elevation of between 1.5 and 3.5 m [4.9 and 11.5 ft].

For the front end of Truck 14's trailer the materials analysis indicated that the temperature was greater than 660 °C [1,220 °F]. There was only a lower bound because melted aluminum was the only material recovered from that location. The temperature was determined in the materials analysis by examining a section of melted aluminum flooring.

**Figure 8. Newhall Pass Tunnel.  
(Image of Vehicle Location in the Tunnel Provided by CHP.)**

For the backend of Truck 14's trailer the materials analysis indicated that the temperature was between 680 and 1,070 °C [1,256 and 1,958 °F]. The lower bound temperature was determined by melted aluminum wheels, which would have been at the 1.5-m [4.9-ft] level. The upper bound temperature determined from the materials analysis came from examination of unmelted copper wiring.

The materials analysis indicated that the temperature for Truck 17 was greater than 880 °C [1,616 °F]. The lower bound temperature from the materials analysis data was determined by a melted brass compression fitting ferrule.

The materials analysis of Truck 18 indicated that the temperature was between 690 and 1,070 °C [1,274 and 1,958 °F]. The lower bound temperature from the materials analysis was determined by melted aluminum around the wheel level. The upper bound temperature was determined from examination of an unmelted brass wire clip.

The last vehicle where the materials analyses results are reported was Truck 27. The materials analyses indicated that the temperature was at least 750 °C [1,382 °F] but did not reach 1,070 °C [1,958 °F]. The lower temperature point on the materials analyses came from the hardness of a graded bolt. The bolt microstructure indicated it had been converted to pearlite; however, the upper-bound temperature from the materials analyses came from an unmelted plate on the axle.
