Attached is the draft presentation that Garry gave me last night. He cautioned me that there may be changes before the public meeting on Friday. Note that they have already identified that there has been a change in the repair they are considering. The PNSC met yesterday and recommended that the repair consist of the delamination removal and replacement.

# Crystal River Unit #3 Containment Delamination Evaluate

November 17, 2009

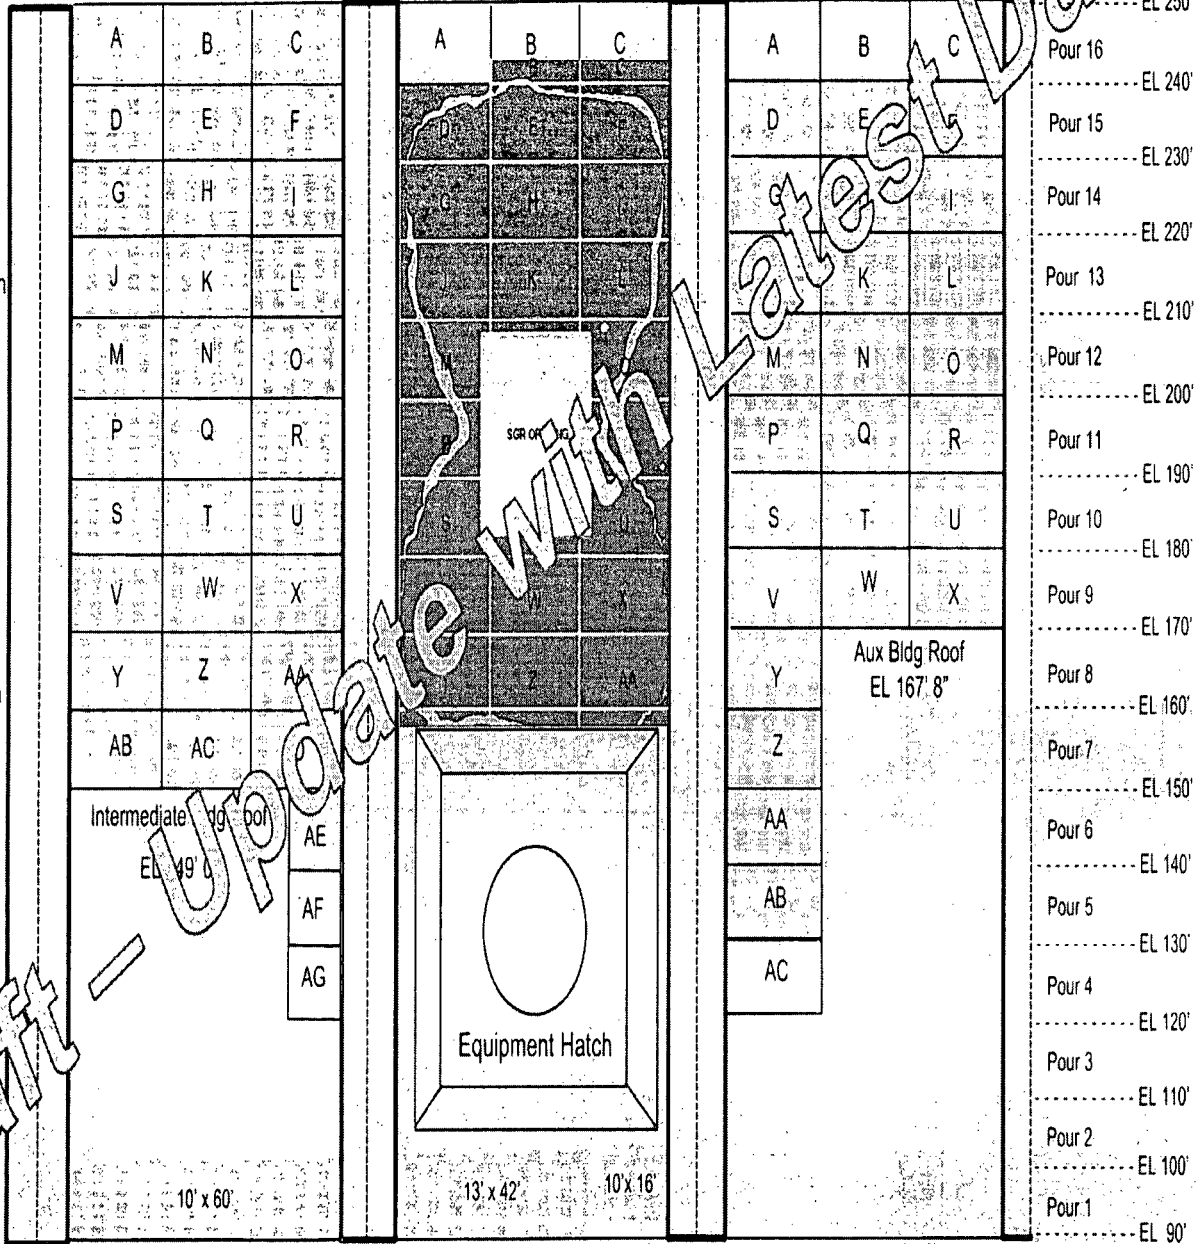
# Containment "Unfolded" - Buttress 2 to 5

Actual IR scan output data:  
Blue = no delamination  
Yellow = transition  
Red = delaminated

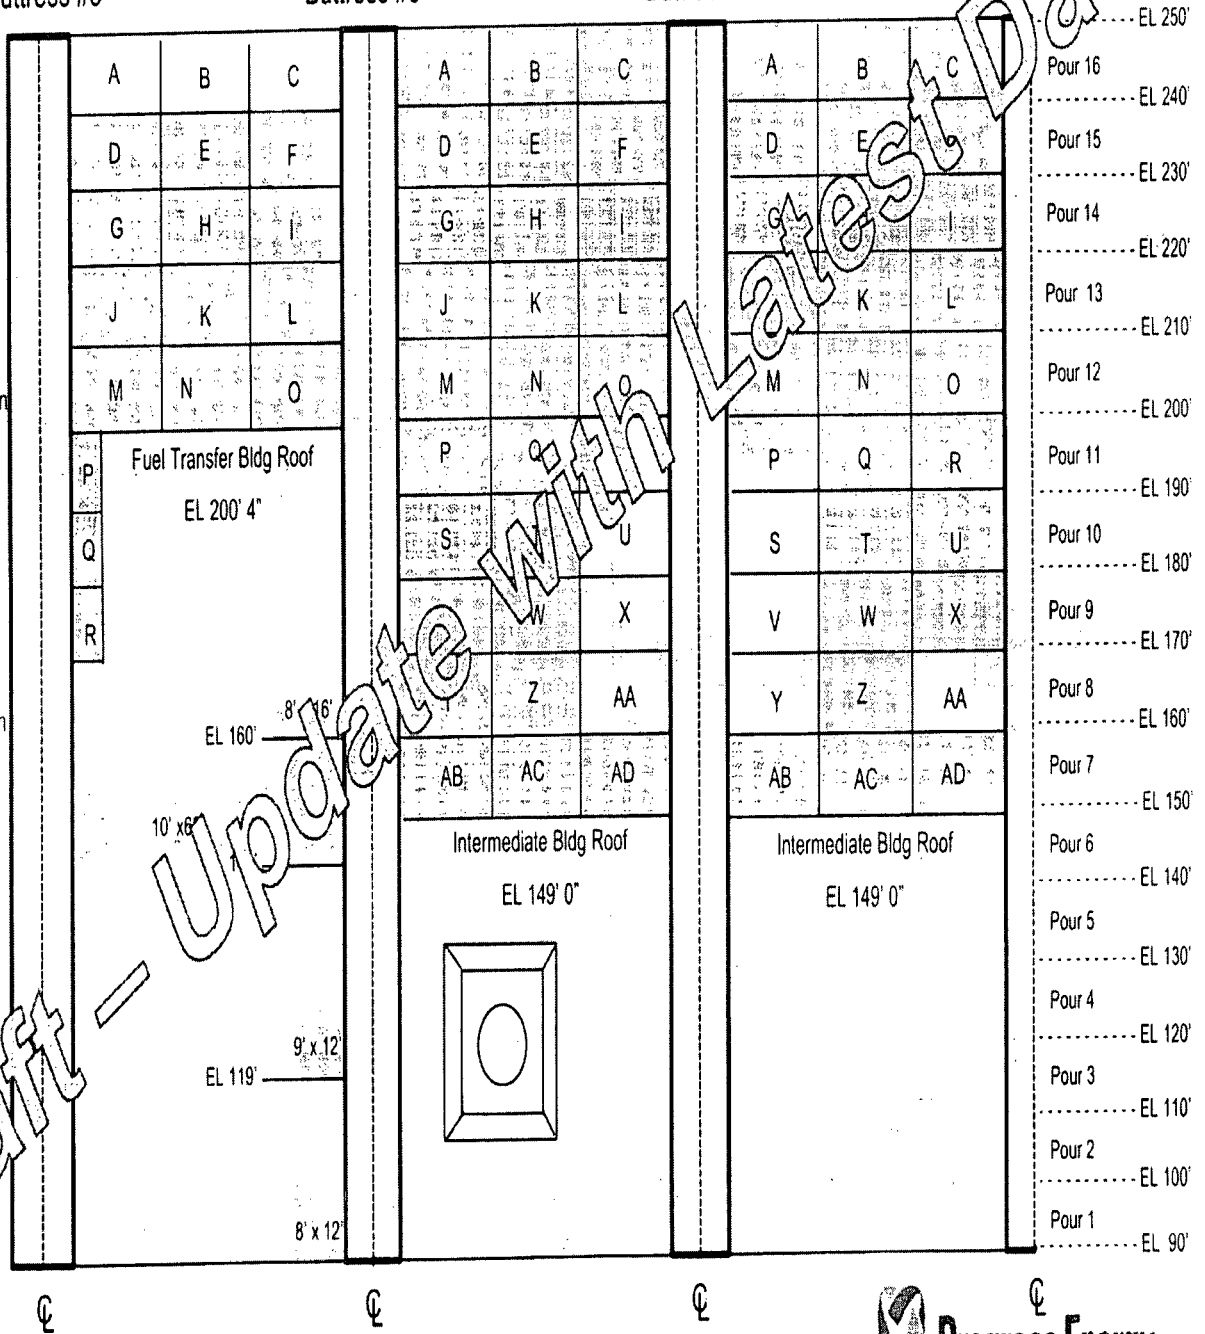
# Containment "Unfolded" - Buttress 5 to 2

Actual IR scan output data:  
Blue = no delamination  
Yellow = transition  
Red = delaminated

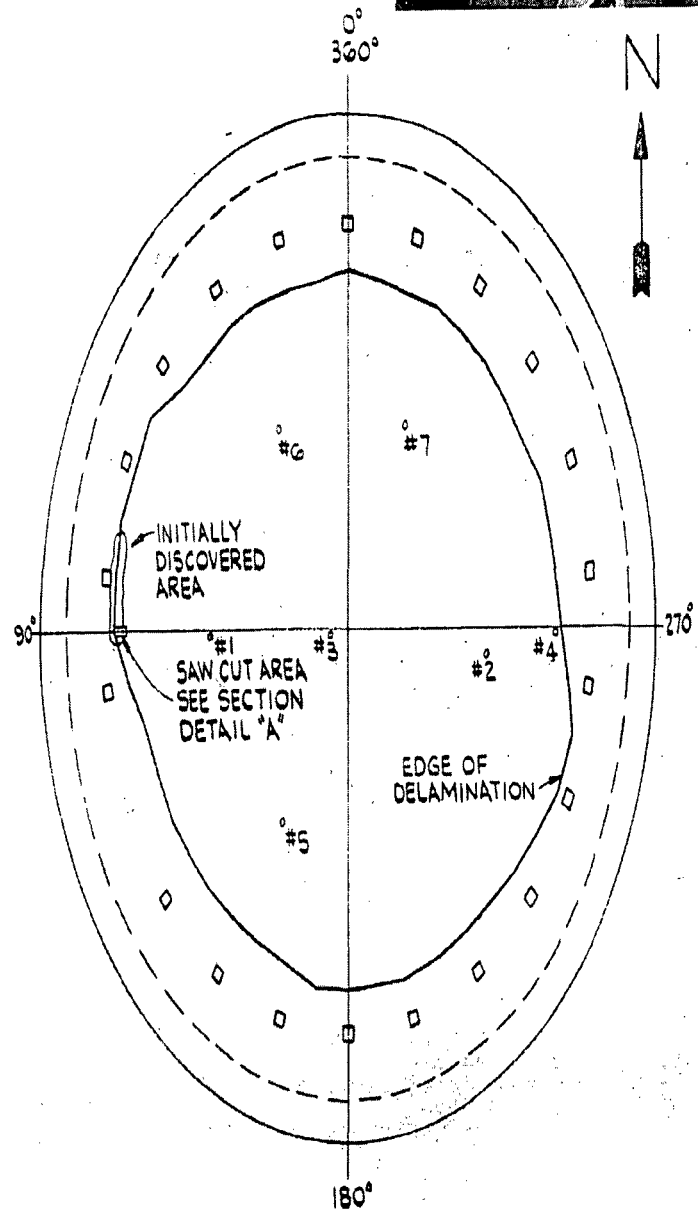
# 1976 Dome Delamination Cause

- Compression - tension interaction failure occurred
- Contributing Effects
  - Radial tension due to prestressing
  - Thermal effects
  - Tendon alignment
  - Stress concentrations
  - Shrinkage
- Combined with biaxial compressive stresses and lower than normal direct tensile strength of concrete
