Containment Exterior Surface Survey Data

**SPECIFIC PURPOSE SURVEY FOR
 PROGRESS ENERGY**

Citrus County, Florida
 Project No. 09017A04 Field Book 48 Page 88 Date November 24, 2009
 Scale: N.T.S. Field Date 11/21/2009 Sheet 1 of 1

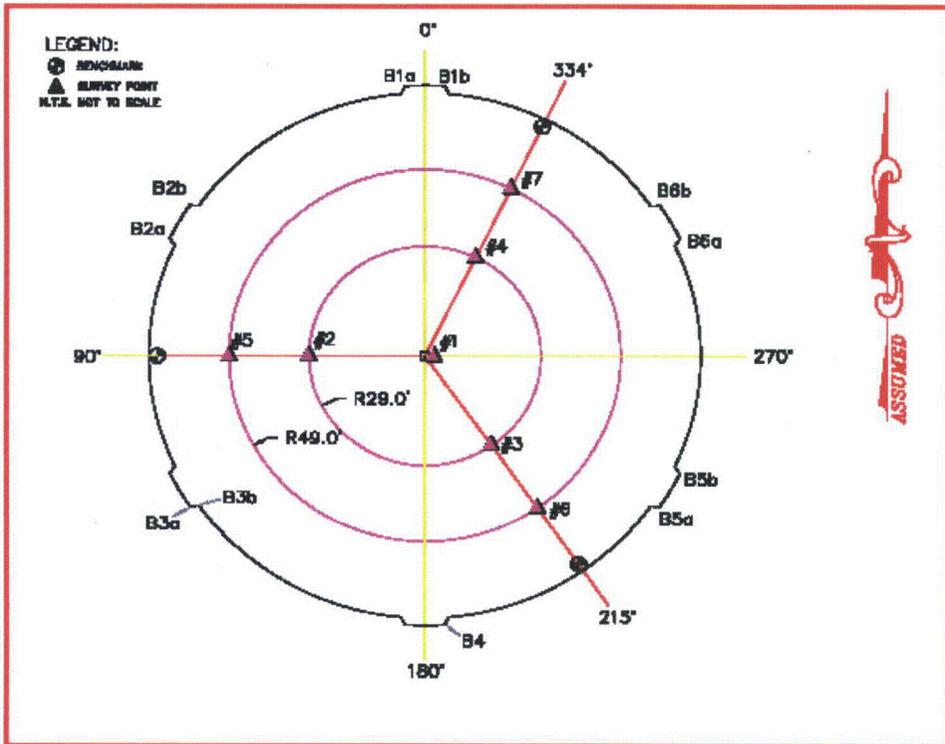
Surveys were performed of the containment dome and buttresses (field date 11/21/09). Attachment 1 includes a map of the dome and buttresses. The dome survey was performed to identify if there are significant changes on the surface of the dome by comparing the current survey data to the final dome survey performed in 1981. The dome was surveyed between 1977 and 1982 as technical specification surveillance required based on the dome delamination event. Procedure SP-180, Reactor Building Structural Integrity Dome Surveillance Program, was initiated to perform a survey of the dome to identify changes in dome elevation and an inspection of the dome surface identifying crack width and crack pattern. The final surveillance was performed in 1981 with an additional survey performed 3 months later due to exceeding acceptance criteria. The buttress survey was performed to determine the relative position of the buttress corners.
