Containment Exterior Surface Survey Data

Surveys were performed of the containment dome and buttresses (field date 11/21/09). Attachment 1 includes a map of the dome and buttresses. The dome survey was performed to identify if there are significant changes on the surface of the dome by comparing the current survey data to the final dome survey performed in 1981. The dome was surveyed between 1977 and 1982 as technical specification surveillance required based on the dome delamination event. Procedure SP-180, Reactor Building Structural Integrity Dome Surveillance Program, was initiated to perform a survey of the dome to identify changes in dome elevation and an inspection of the dome surface identifying crack width and crack pattern. The final surveillance was performed in 1981 with an additional survey performed 3 months later due to exceeding acceptance criteria. The buttress survey was performed to determine the relative position of the buttress corners.

**SPECIFIC PURPOSE SURVEY FOR
 PROGRESS ENERGY**

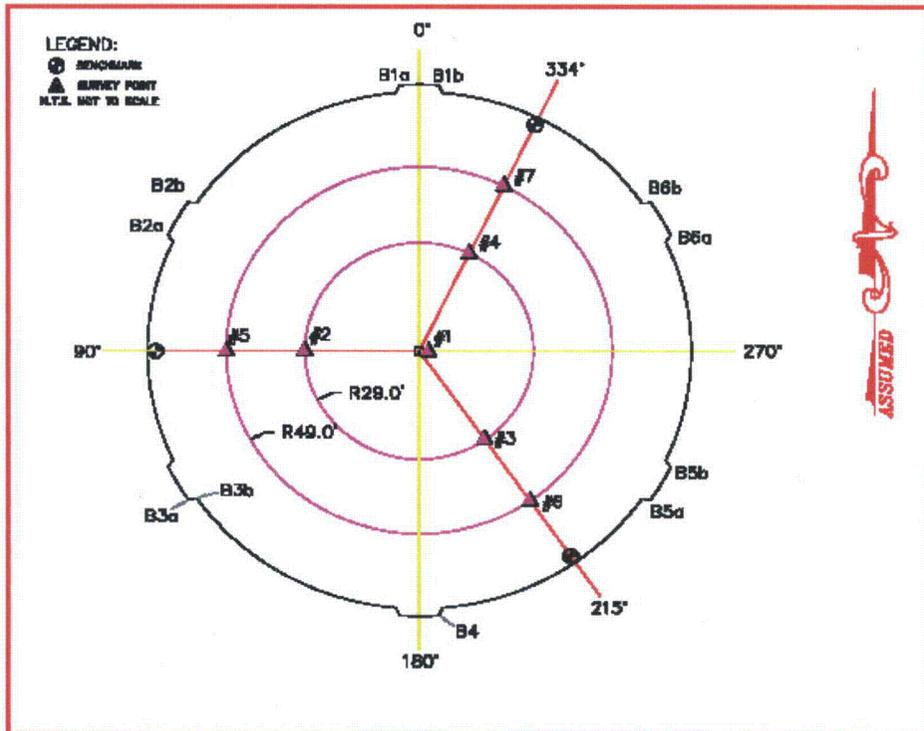
Attachment 1

ELEVATION BENCHMARK	ELEVATION BENCHMARK	ELEVATION BENCHMARK	#1	#2	#3	#4	#5	#6	#7
90°	215°	334°	285.106	281.245	281.227	281.106	274.244	274.308	274.311
