Report for
Progress Energy

CTLGroup Project No. 059169

**Petrographic Examination of Concrete Half
Core from Delaminated Containment Wall,
Crystal River, Florida**

November 2, 2009

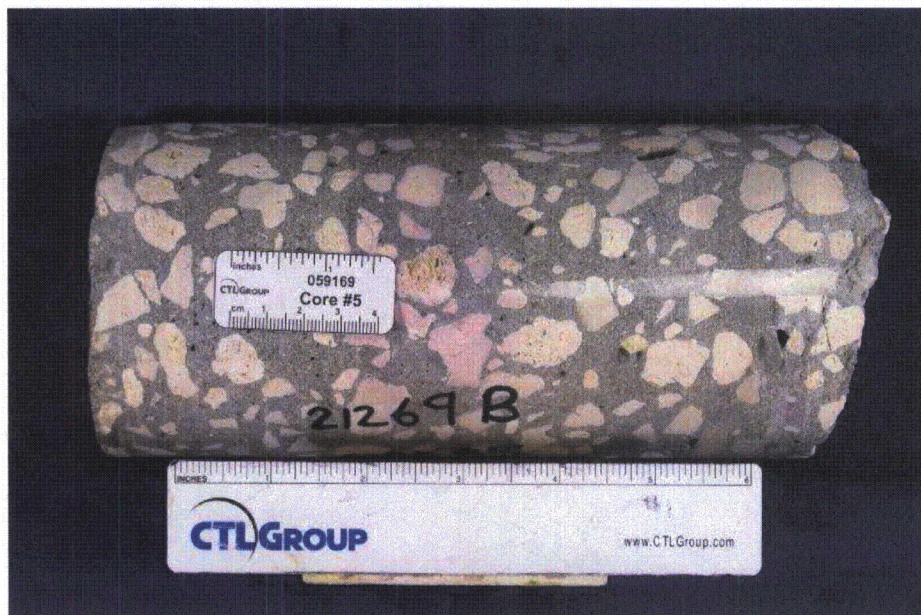
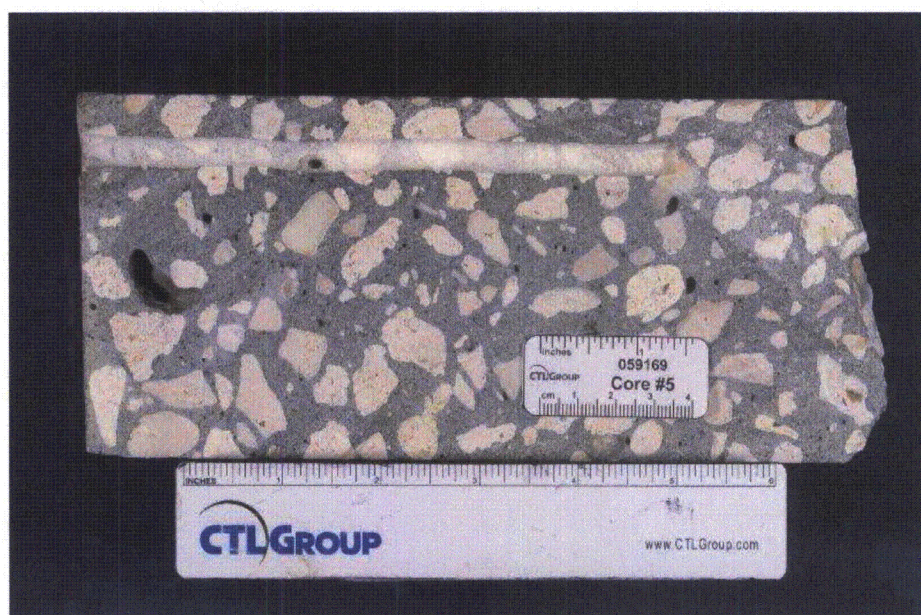
Fig. 1 Side views of Core #5, as received for examination.

One saw cut half concrete core labeled Core #5 (Figs. 1 and 2) was received on October 27, 2009 from Mr. Jerzy Zemajtis, Project Manager, CTLGroup on behalf of Mr. Paul Fagan of Progress Energy, Crystal River, Florida. According to Mr. Zemajtis, the core represents the outer portion of concrete from a containment wall and the core is fractured at its inner surface at a delamination that was found to be present when access was gained to the wall interior. The delamination is approximately at a depth of 200 mm (8.0 in.) where horizontal post tensioning ducts are present.

1a. Curved surface. Outer end is to the left.

1b. Saw cut surface. Outer end is to the left

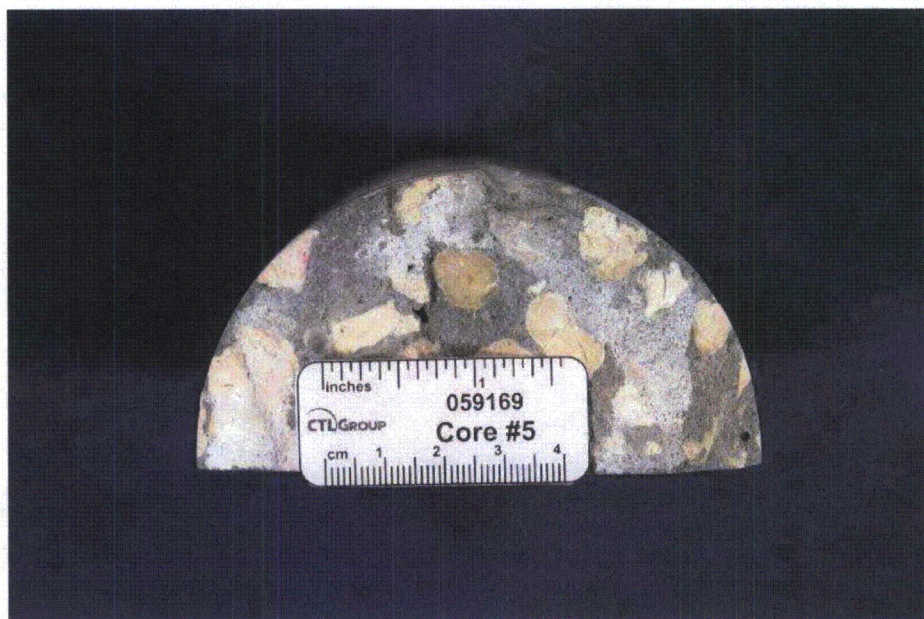
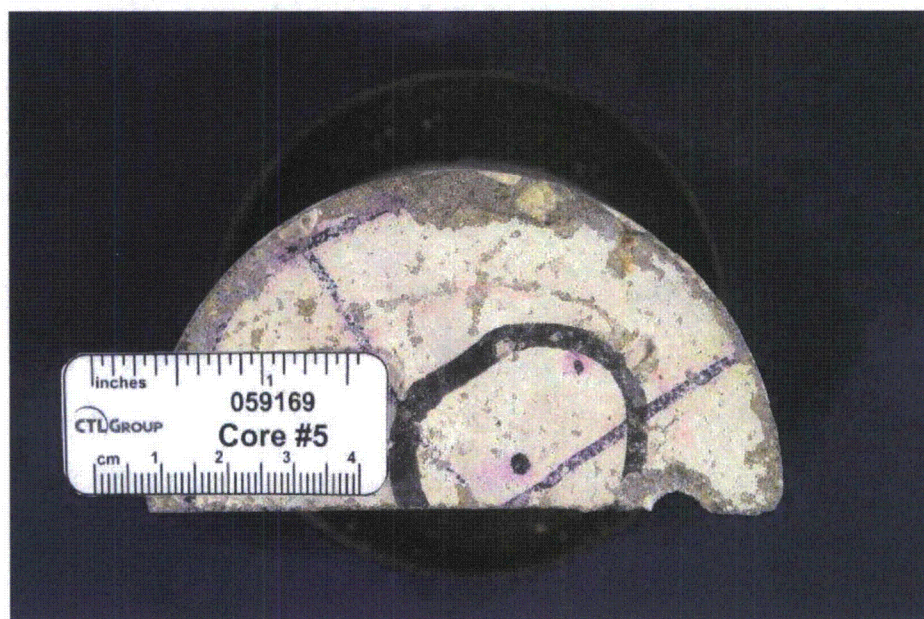
Fig. 2 End views of Core #5, as received for examination.

2a. Inner end.

2b. Outer end.

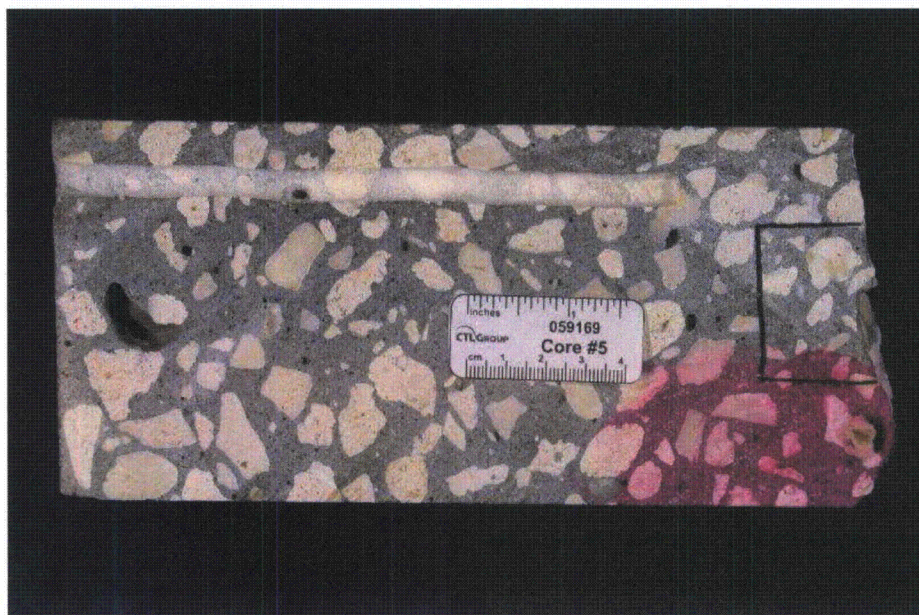
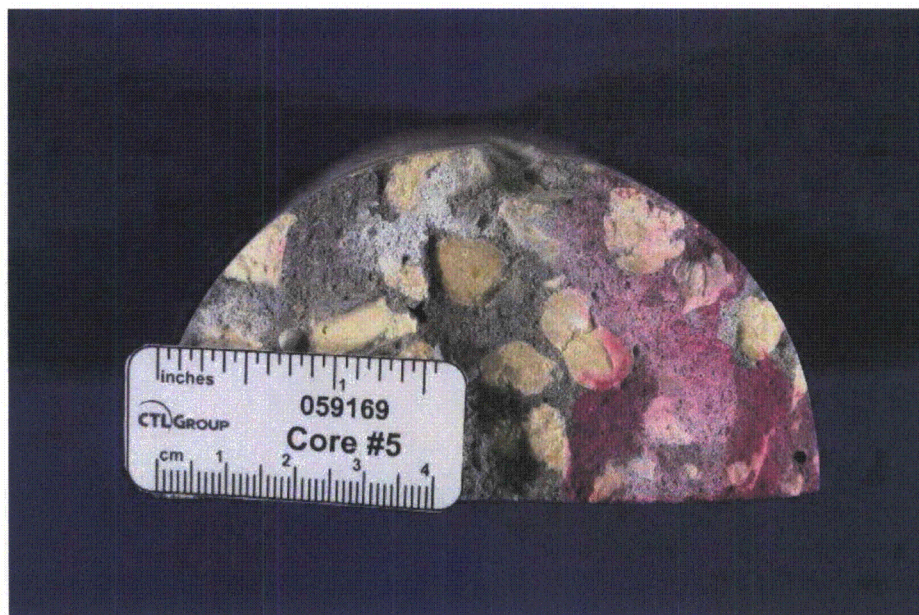
Carbonation to any significant depth from the fracture surface into the outer concrete is not observed (Fig. 3). Incipient carbonation is exhibited in thin section at the immediate fracture surface (Fig. 6a). However, an older delamination surface that was not exposed to air due to the depth of outer concrete, and other possible wall coverings, may also have such an absence of carbonation.

3a. Saw cut side. Outer surface is to the left.

3b. Fractured inner end.

Fig. 3 Views of the portions of Core #5 treated with phenolphthalein, a pH indicator. All the pink regions exhibited denote the limits of where the indicator was applied. No colorless, low pH (carbonated) regions were observed at the fractured end regions.

Depth of Carbonation: 4 to 5 mm (0.16 to 0.20 in.) as measured from the outer surface. Negligible when measured from the inner fractured core surface.

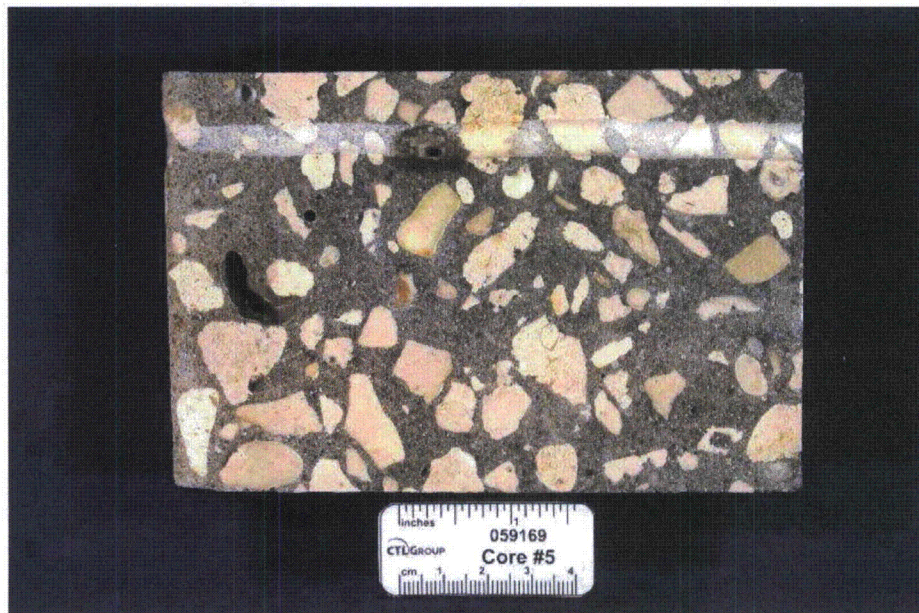
The concrete represented by Core #5 is well consolidated and free of any cracks or excessive microcracks (Fig. 4). The concrete consists of crushed carbonate rock coarse aggregate and natural sand fine aggregate, well distributed in a portland cement paste. No evidence is exhibited of any deleterious chemical reactions involving the cement paste and / or aggregates. The concrete could be considered marginally air entrained based on an approximate volume of 1 to 2% of small, spherical entrained air voids in the hardened cement paste (Fig. 5).

Fig. 4 View of the lapped surface of a portion of Core #5 showing the general appearance of the concrete.

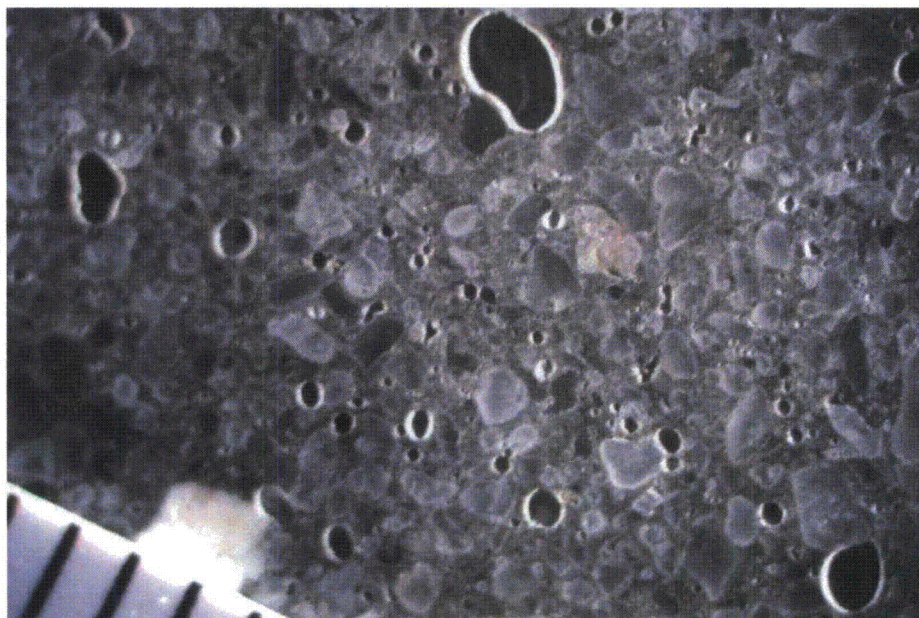
Fig. 5 View of the concrete hardened air-void system of Core #5 illustrating the moderate quantity of both coarse and fine air voids. Scale is millimeter increments.

Air Content: Estimated 2 to 4% total. Approximately 1 to 2% of the total air is larger entrapped air voids of up to 3 mm (0.12 in.) in size, plus a few large voids of 4 to 10 mm (0.16

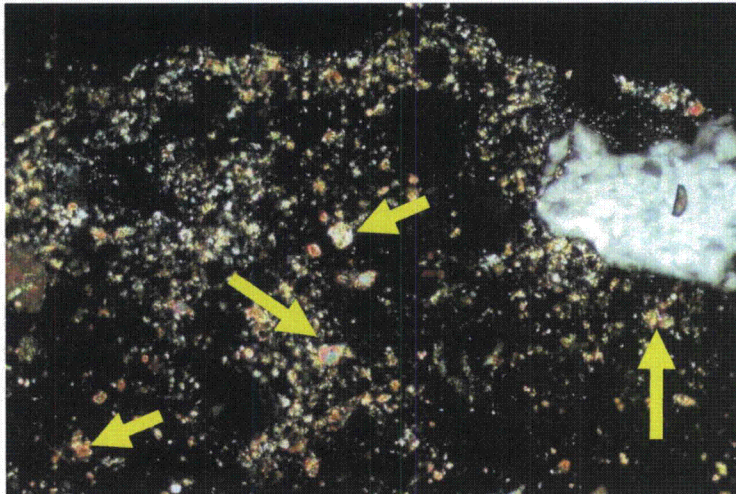
6a. Crossed-polarized light view of the paste adjacent to the inner fractured surface. Only incipient carbonation is indicated by the speckled high birefringence colors in the paste. Carbonate fines are arrowed yellow. Width of view is approximately 0.5 mm.

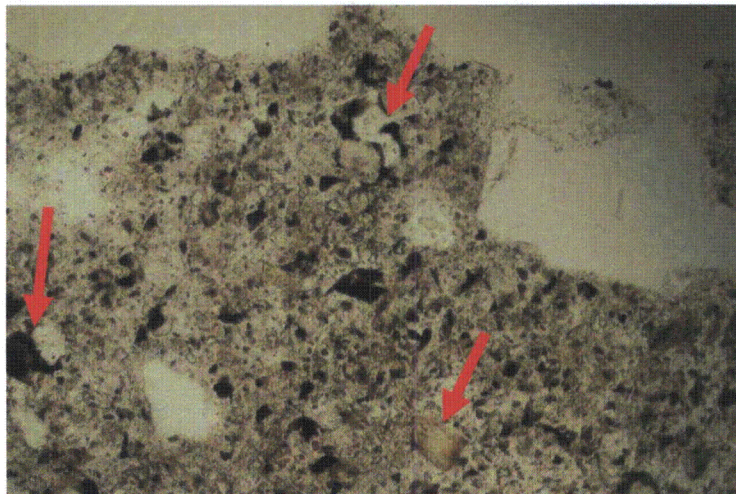
The cement hydration adjacent to the fracture is well advanced and comparable to that of the body of the core (Figs. 6b and 6c). This suggests that there was no moisture ingress to the fracture surface, over a period of time long enough, to change the general degree of hydration. This is supported by an absence of secondary deposits within air voids adjacent to the fracture surface.

6b. Plane-polarized light view of the paste adjacent to the inner fractured surface (same field of view as 6a.). A low to moderate number of unhydrated and partially hydrated cement particles (arrowed red) are exhibited by the paste. The amount is comparable to that in the body of the core in Fig. 6c. below. Width of view is approximately 0.5 mm.

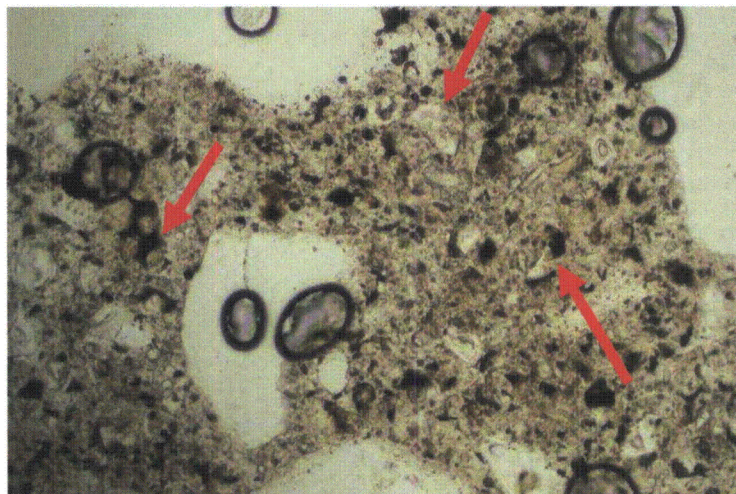
6c. Plane-polarized light view of the paste in the body of the core. A low to moderate number of unhydrated and partially hydrated cement particles (arrowed red) are exhibited by the paste. The amount is comparable to that near the fracture surface in Fig. 6b. above. Width of view is approximately 0.5 mm.
