CR-3 WORK REQUEST FORM

TAG DESC : PRESTRESSING SYSTEM TENDONS

SIXTH TENDON SURVEILLANCE PER SP-182 TO BE PERFORMED BY PRE

The sixth tendon surveillance for the Crystal River Unit 3 (CR-3) Reactor Building post tensioning system was performed between October 20, 1997 and January 16, 1998. The surveillance was performed to demonstrate the integrity of the containment prestressing system, including containment tendons, tendon end anchorage hardware, general and adjacent concrete integrity, and corrosion protection system. The tendon surveillance was performed in accordance with the CR-3 Improved Technical Specifications (ITS). This surveillance occurred during the twenty-second year after the CR-3 structural integrity test, which took place in November, 1976. The tendon surveillance was completed while the plant was shut down.

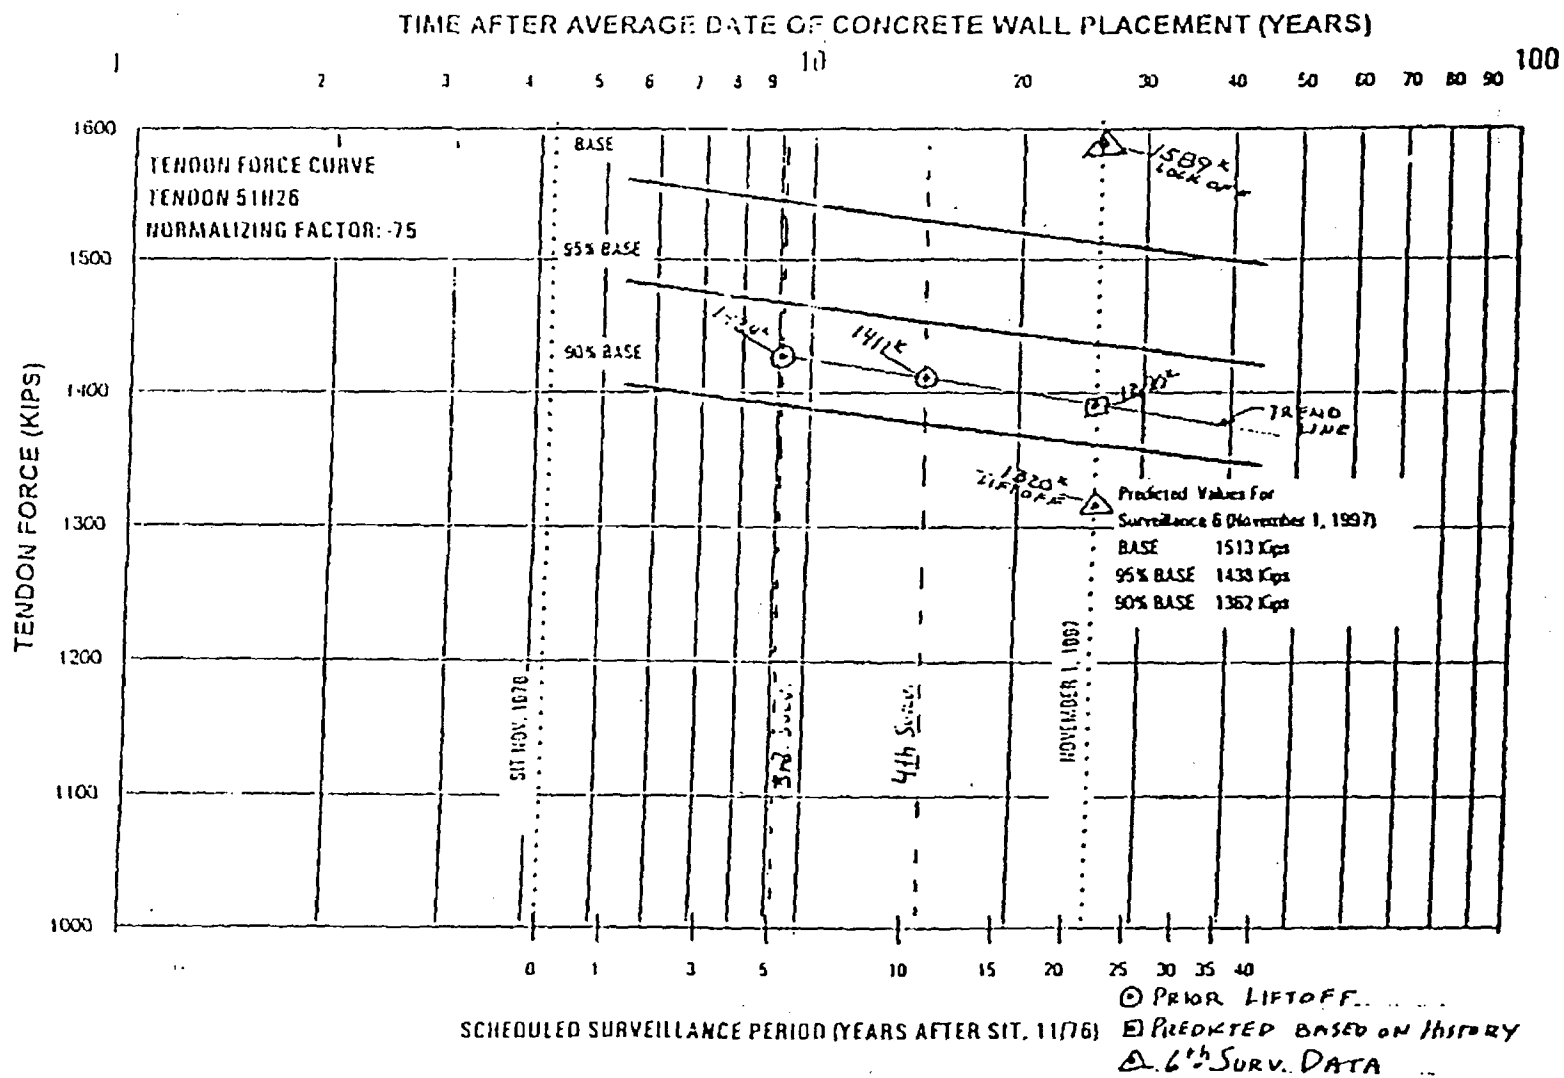
FIGURE 1
TENDON 51H26 LIFT-OFF
18 of 30

Measured elongation values from this surveillance are presented in the PSC report for each tendon. One tendon did not meet the acceptance criteria. Tendon 51H26 had a negative 11.6 % variance in elongation when the surveillance results were compared to the original measured elongation. The negative value indicates that less elongation was measured in the current surveillances than at the original stressing. This condition was observed in prior surveillances for other tendons as well. FPC concluded that the condition was not indicative of wire failure and slippage. The elongation differences

Tendon 51H26 had two wires removed for inspection and testing. Tensile and yield strength tests were performed on the wire samples. These wires were visually inspected and found to be in good condition and the test results demonstrated that all wires met the guaranteed minimum ultimate tensile and yield strengths for the material.

The less than expected tendon elongation is not the result of wire failure or slippage. Therefore, there was no adverse or detrimental effect on the integrity of the post tensioning system.

Horizontal lift-offs revealed two isolated areas 42H30 to 42H36 inclusive and 51H26 and 51H27 where average tendon lift-offs were between 90% and 95% of Base Value. Two tendons 51H26 and 42H35 were found to be below 90% of base and were detensioned for continuity tests. These continuity tests revealed that all of the wires were continuous, one wire was removed for testing and the tendons restored to base value -0%, +6%. All other tendons found between 90% and 95% of Base Value were subsequently restored per SP-182 to the Base Value.
