Event # 46289

POTENTIAL ISSUES WITH CERTAIN REGULATOR MODEL 77N-40 AIR REGULATORS

Subject: 10 CFR Part 21 report of potential issues with certain Regulator Model 77N-40

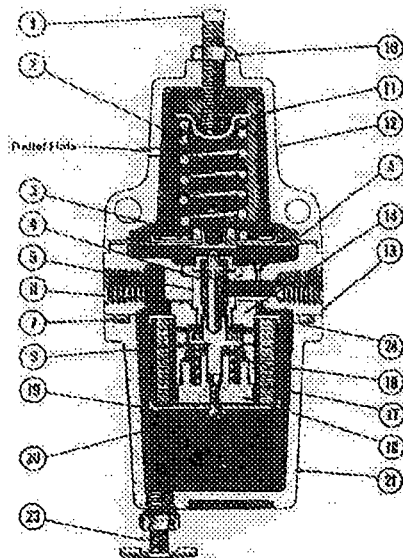
Figure 1

It was discovered during the evaluation process that the O-ring (#8 Figure 1) which isolates the pressure chambers can become damaged during the assembly process. A review of internal procedures found that the O-ring in question was assembled in the inverted position not visible to the technician during the process. Therefore the O-Ring had the potential to be damaged by the threads of the mating part.

It was also found that the supplier of the component referred to as the "Body" (#13 Figure 1) had not properly de-burred the bore that contained the sealing surface of the O-Ring on some components. The resulting sharp edge can be another source of potential damage to the O-ring.

- Inspection was added to the Body bore edge in our dedication plan.
- Inspection was added to the Relief Valve seat in our dedication plan.
- Procedures and instructions were updated to ensure that the O-Ring was assembled such that the technician can visibly see the components and ensure the O-Ring is not damaged during the assembly process.
- We reviewed the use of the "coining" technique and eliminated the practice from the current process. The technician is now instructed to assemble and test the Regulator without coining. If the Regulator does not pass the required testing the Regulator will be disassembled and the relief valve components replaced until an acceptable combination passes test.
- The existing inventory was reworked to the corrective actions above.

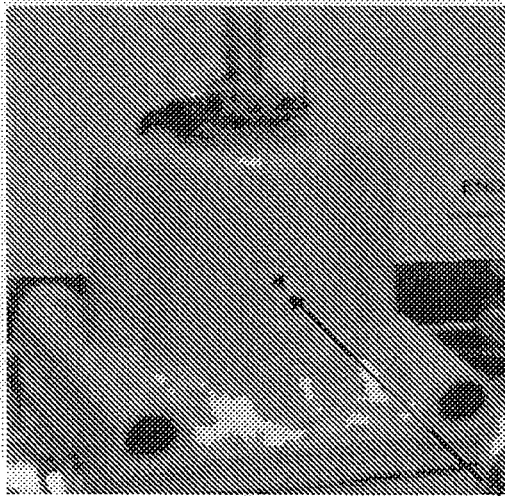
Figure 3
Acceptable

Apply leak detection fluid to the Relief hole as shown. Acceptable bubble size is shown in Figure 4. The acceptable leak rate of the bubbles is 1 to 3 per second. Unacceptable bubble size is shown in Figure 5 or bubbles that form at a rate of more than 5 or more per second.
