F6m
DPSPU 81-11-4

HISTORY OF WASTE TANK 6 1954 THROUGH 1974

C. J. THOMAS
Waste Management Technology

March 1981

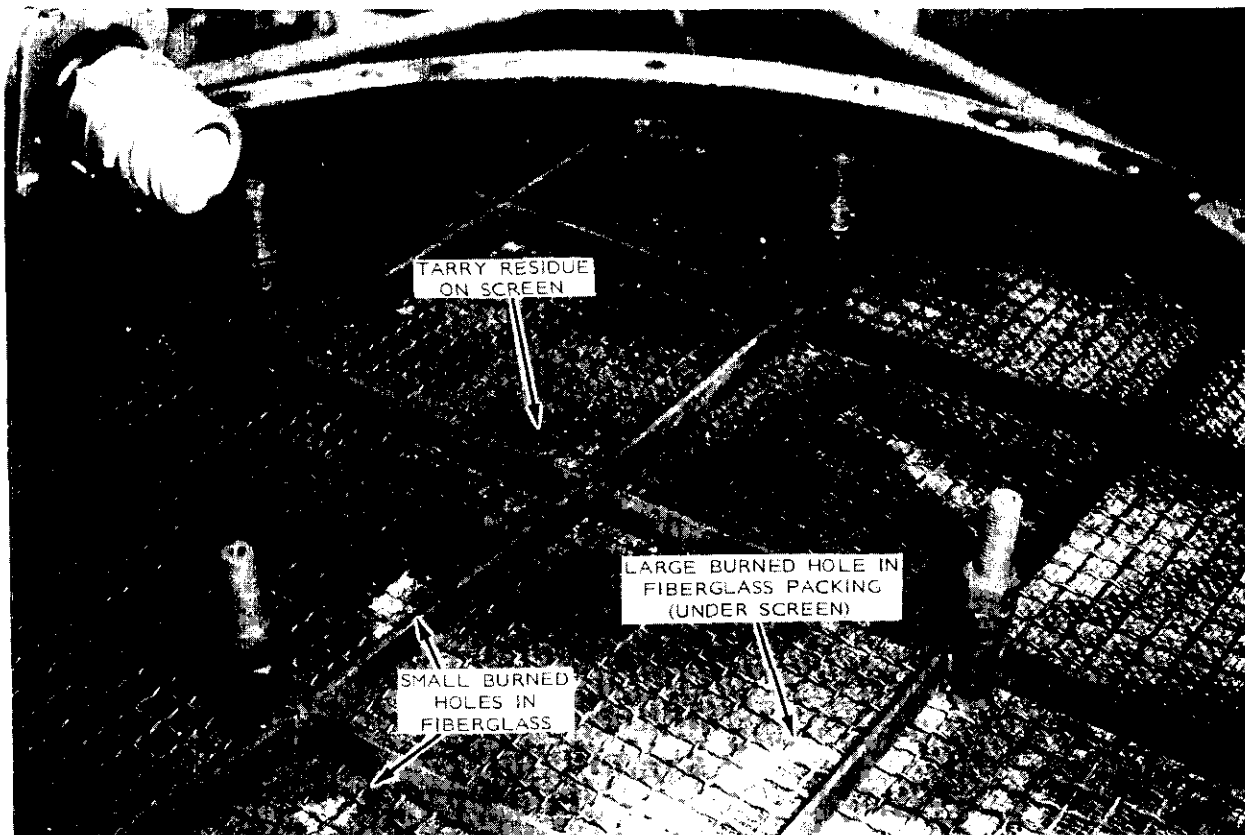
In 1963, tank 6 was placed in service as an emergency spare tank. Fresh HW from the Purex process in Building 221-F was routed to tank 6 when tank 4 became filled in October 1964. The tank's vent filter (figure 3) ignited on March 31, 1965. The fire started when forced ventilation was restored after being off for about 10 hours. The fire was caused by the combination of high temperature, stagnant air in the steam jacketed filter, and an organic rust inhibitor, VPI-220, which accumulated in the fiberglass filter packing. There was no release of contamination to the environment. In December 1965, a bluish fog was seen coming from the ventilation filter. Investigation indicated the fog was derived from degraded solvent, tributylphosphate (TBP), in the waste tank. Fog analysis is shown in table 2.

- Apr 1965 A fire started in the vent filter when the VPI-220 inhibitor in the vent piping and filter ignited spontaneously.
- May 1965 A temperature profile was taken. Cooling water was increased 20% to overcome the flow resistance in the line. A reel tape was installed.

- Oct 1965 The filter involved in the fire was disassembled and inspected. The old packing was removed and burned in a steel container. The filter housing was recharged with fiberglass and installed in tank 2.

FIGURE 3. TANK 6 FILTER FOLLOWING FIRE. View of 5-in.-diameter top (exit) surface of tank 6 vent filter. Object at upper left is an HP air sampler. DPSPF 10267-3.

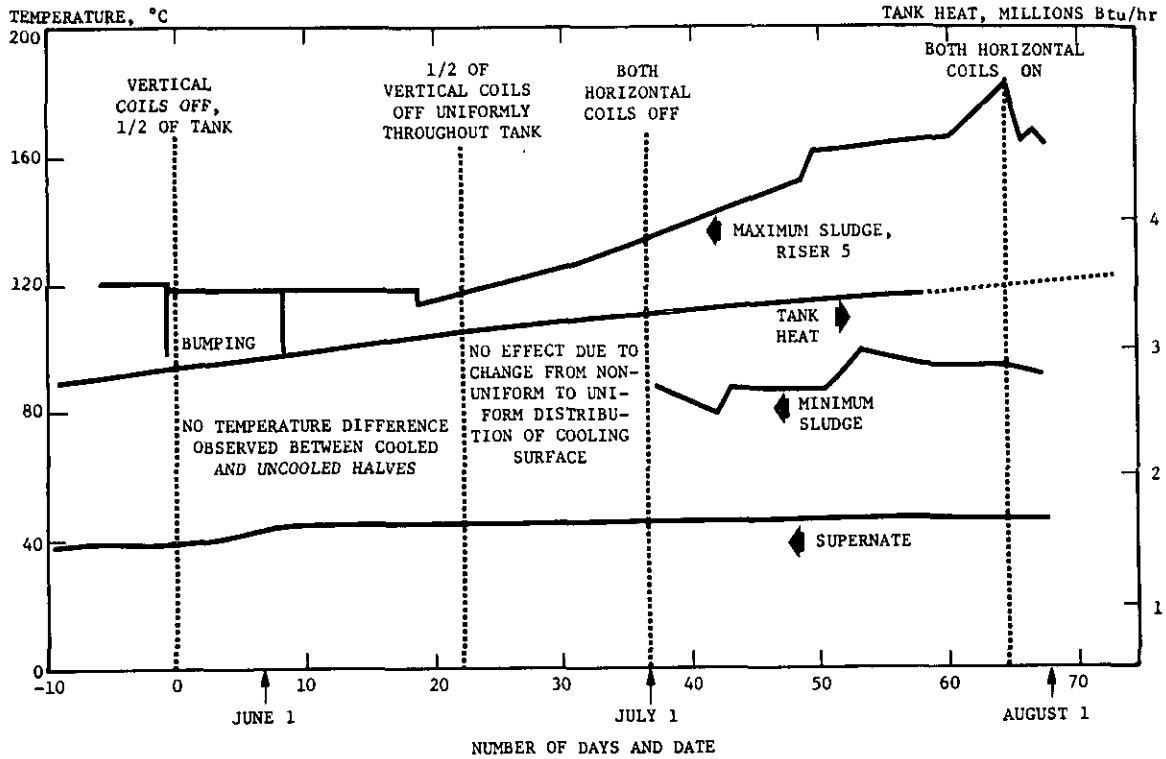
FIGURE 4. EFFECT OF COOLING SURFACE DISTRIBUTION - TANK 6, 1966

The vertical and horizontal cooling coils in tank 6 were hydrostatically tested in May 1964. In June 1966, the cooling coils were tested to determine the effect of isolating cooling water from different coil groups on the temperature distribution in the tank. The effect of cooling surface is shown in figure 4. The test concluded that the coil arrangement was adequate to maintain a uniform temperature in the tank.

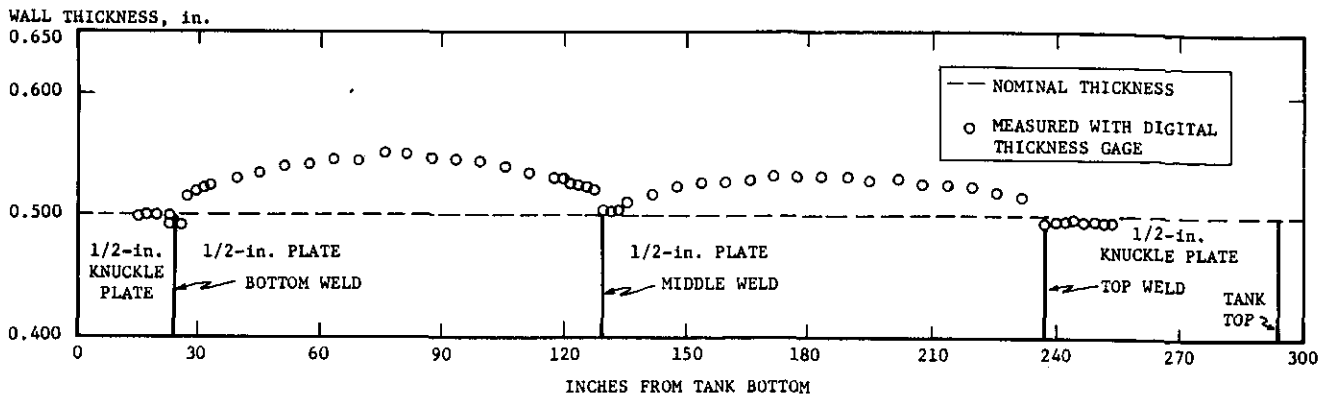
FIGURE 6. TANK 6 WALL THICKNESS MEASUREMENTS AT THE EAST RISER

Jan 1974 Primary wall thicknesses under east riser were checked and found to be within specifications.

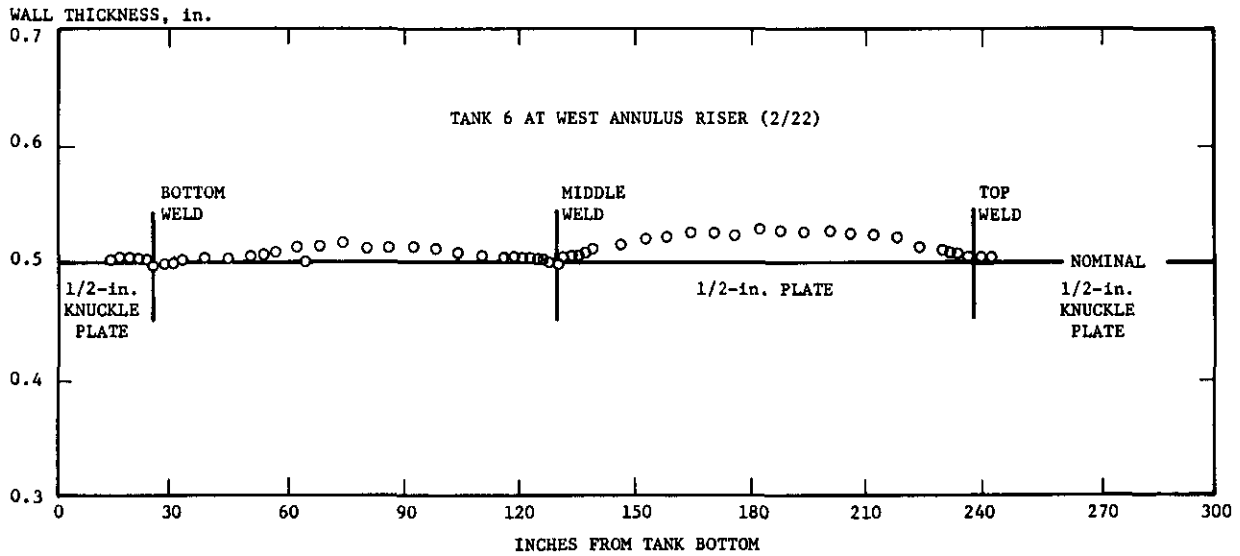
FIGURE 7. PRIMARY WALL THICKNESS MEASUREMENTS

Mar 1974 Primary wall thicknesses under west riser were checked and found to be within specifications.
