**SUBJECT: CRYSTAL RIVER NUCLEAR PLANT - SPECIAL INSPECTION REPORT
05000302/2009007**

The purpose of this inspection was to examine activities associated with the delamination identified in the Unit 3 containment. The inspection was conducted in accordance with the Special Inspection charter issued by the Region II Administrator on October 13, 2009. As part of the inspection, the NRC examined your evaluation of extent of condition, your evaluation of root cause, and your planned corrective action for continued operability. The inspectors interviewed personnel and conducted plant walk downs, including visual examination of accessible portions of the outside and inside surfaces of the containment.

ROOT CAUSE ASSESSMENT CRYSTAL RIVER UNIT 3 CONTAINMENT CONCRETE DELAMINATION

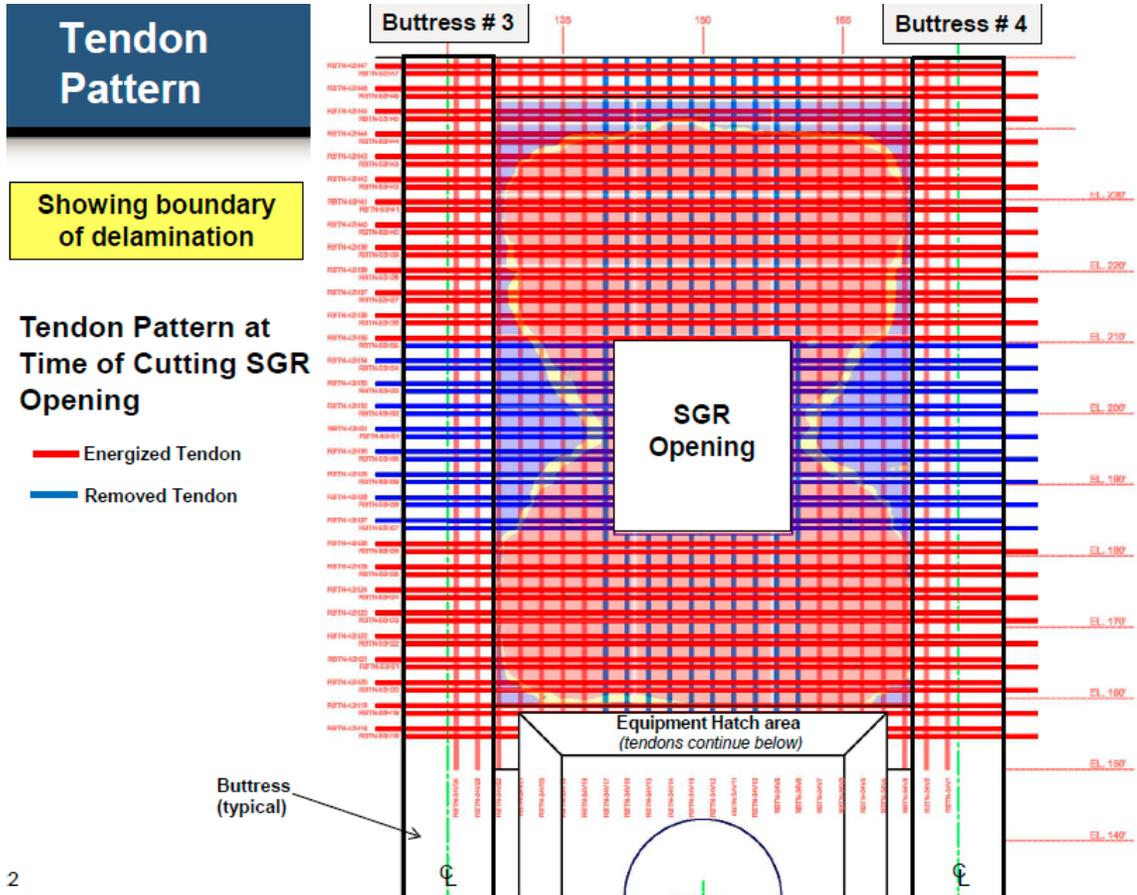
Figure 5.2.1 Tendon Pattern at SGR Opening and Delamination Profile

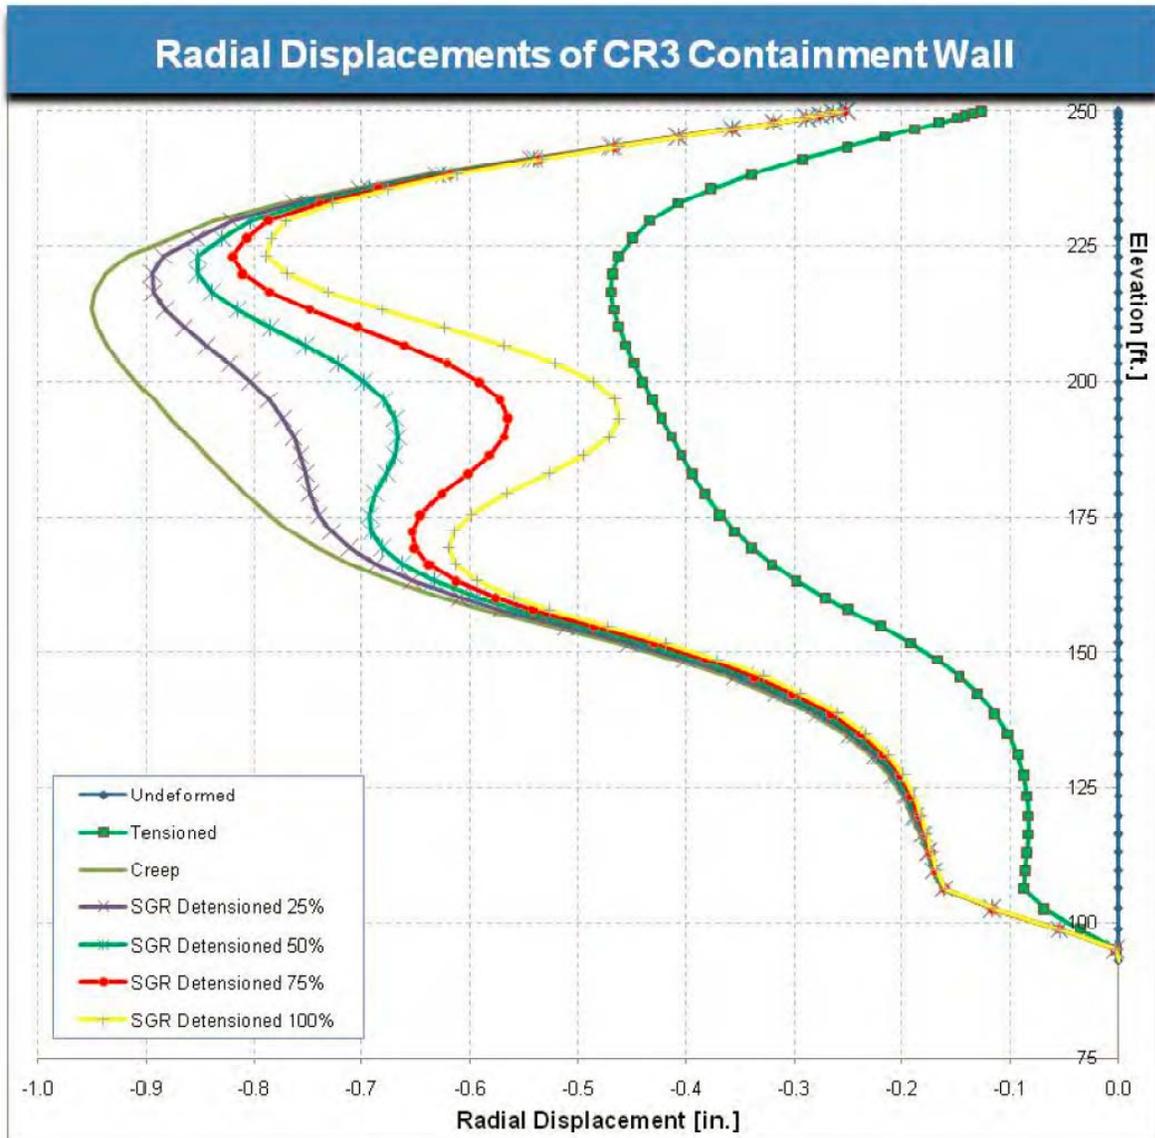
Figure 5.2.2 Bay 3-4 midline vertical profile of radial displacements during progressive SGR detensioning (Note that displacements are plotted to an exaggerated scale)

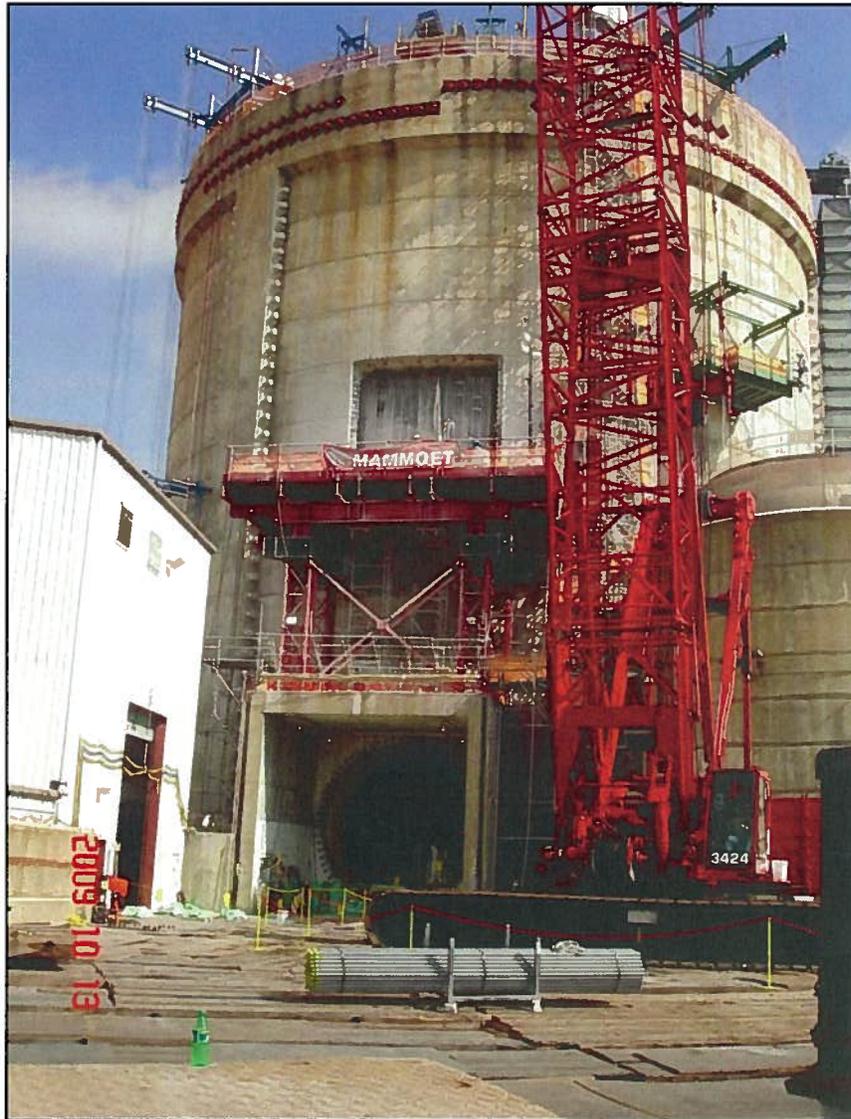
Figure 1.1 Photograph of the steam generator opening worksite.
Note the newly constructed rectangular opening above the existing circular equipment hatch.

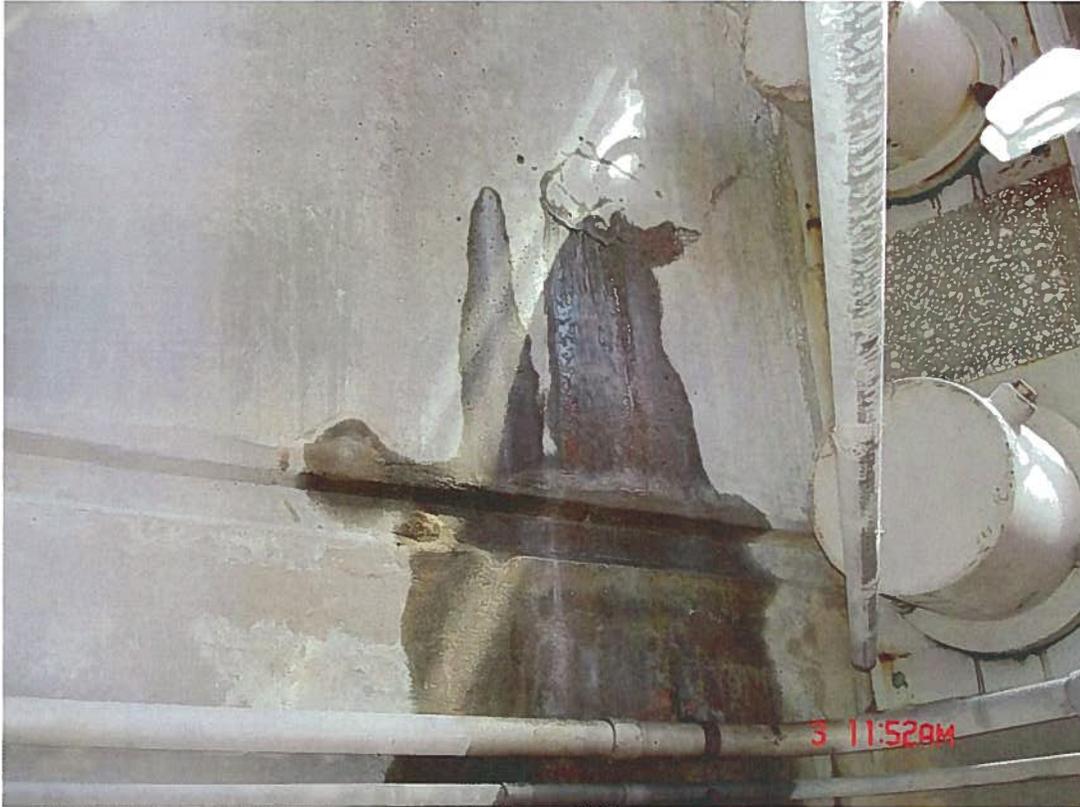
Figure 1.2 Photograph of water leakage from the containment wall (10/3/2009).

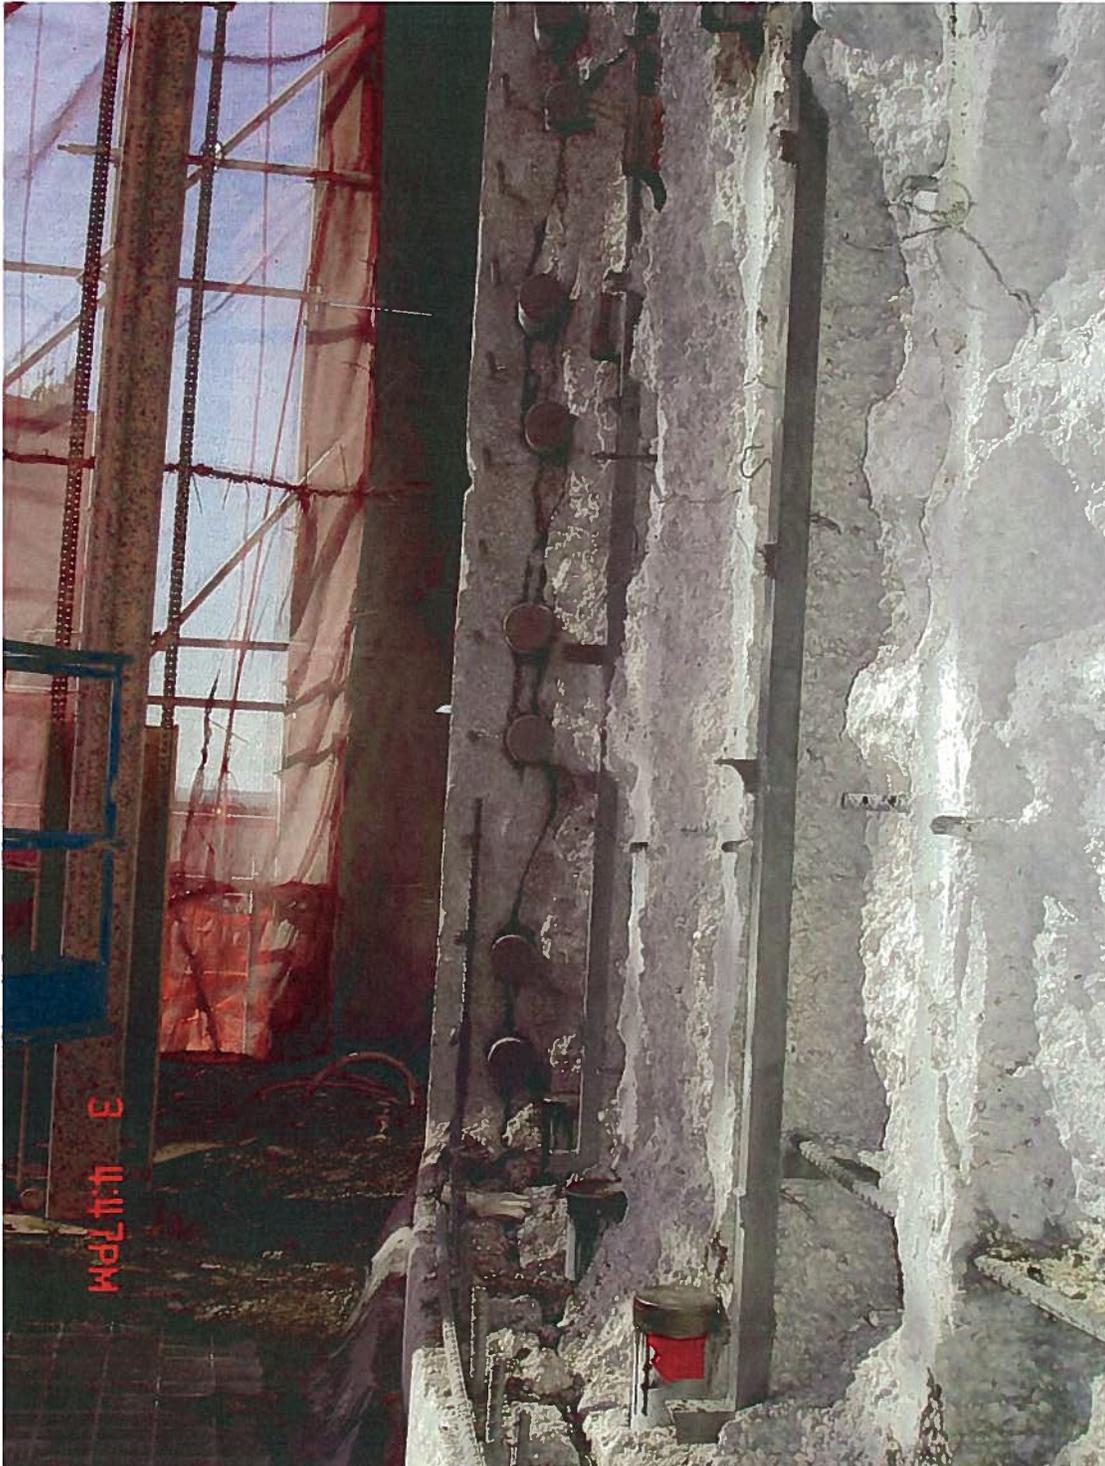
Figure 1.3 shows the extent of delamination visible on the edge surfaces of the SGR construction opening. Figure 1.4 is a sketch identifying the most important features of the containment wall construction.

Figure 1.3 Photograph of delamination crack running from horizontal tendon to horizontal tendon, parallel to the wall surface, approximately 10 inches deep. (Photo taken after partial concrete demolition)

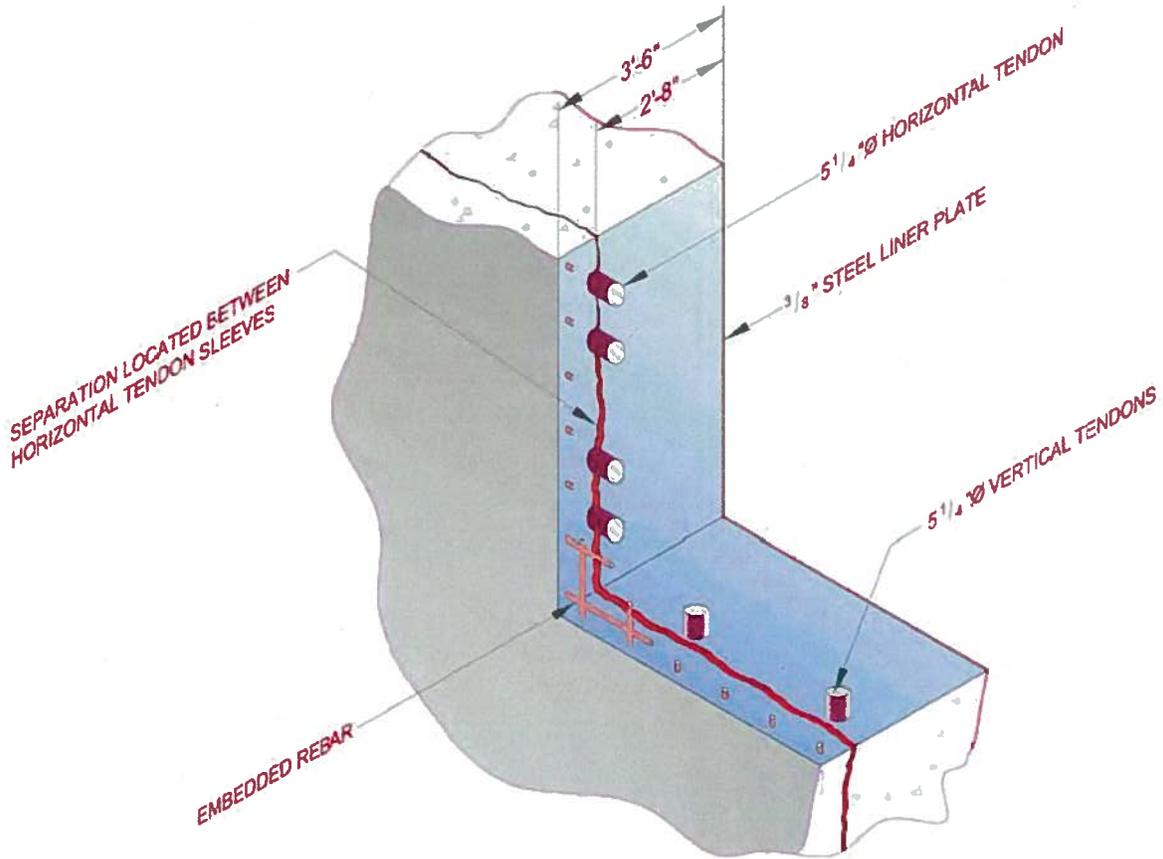
Figure 1.4 Sketch of the delamination cracking in the bay 34 wall.

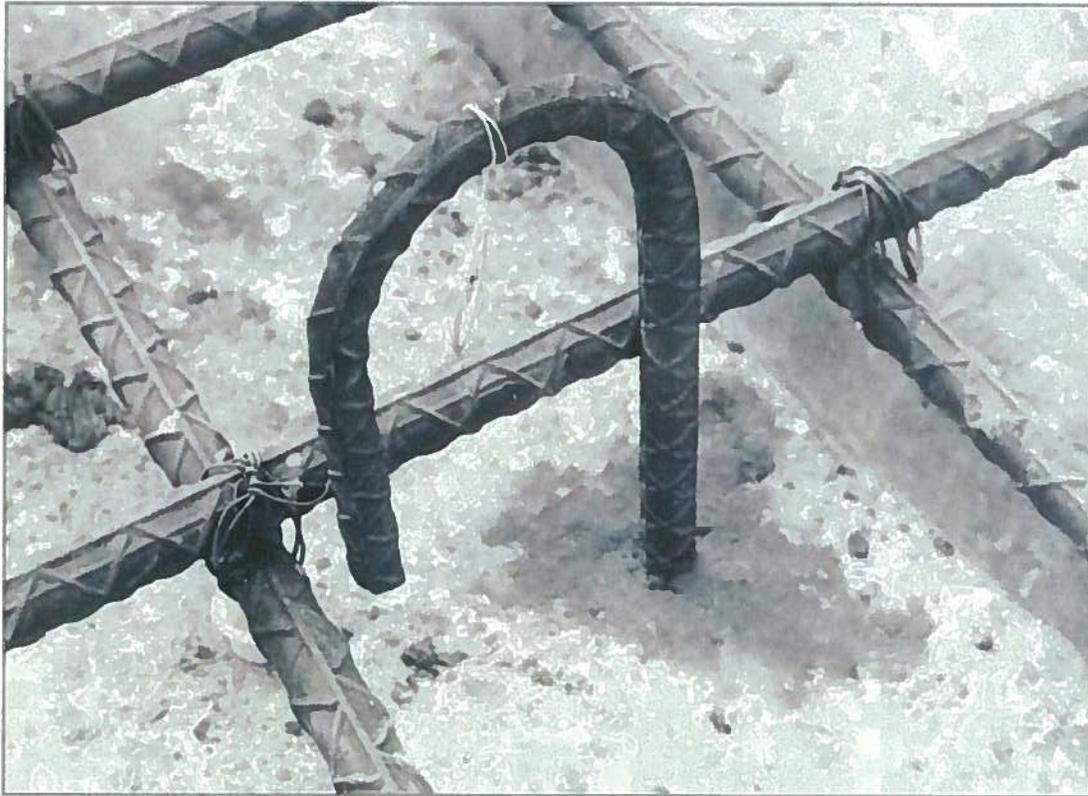
Figure 3.7 Photograph of a radial reinforcement installed as a corrective action to the CR3 Dome delamination

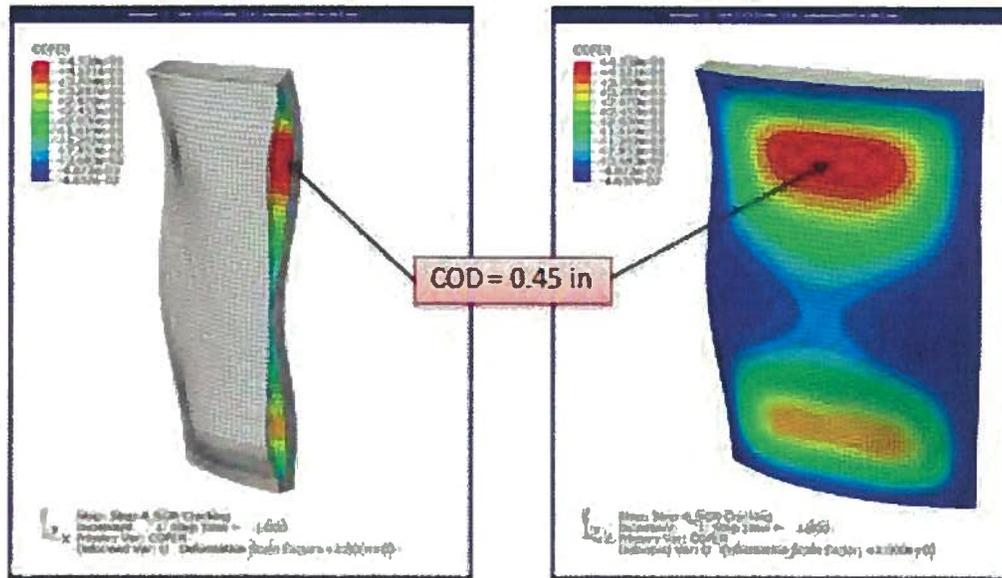
Figure 7.12 The Dimensional response to delamination – Step 4 SGR Cracking
Crack Opening Distance (COD) is the width of the crack that develops. Note the similarity of the pattern in this Figure to that in Figure 7.14.

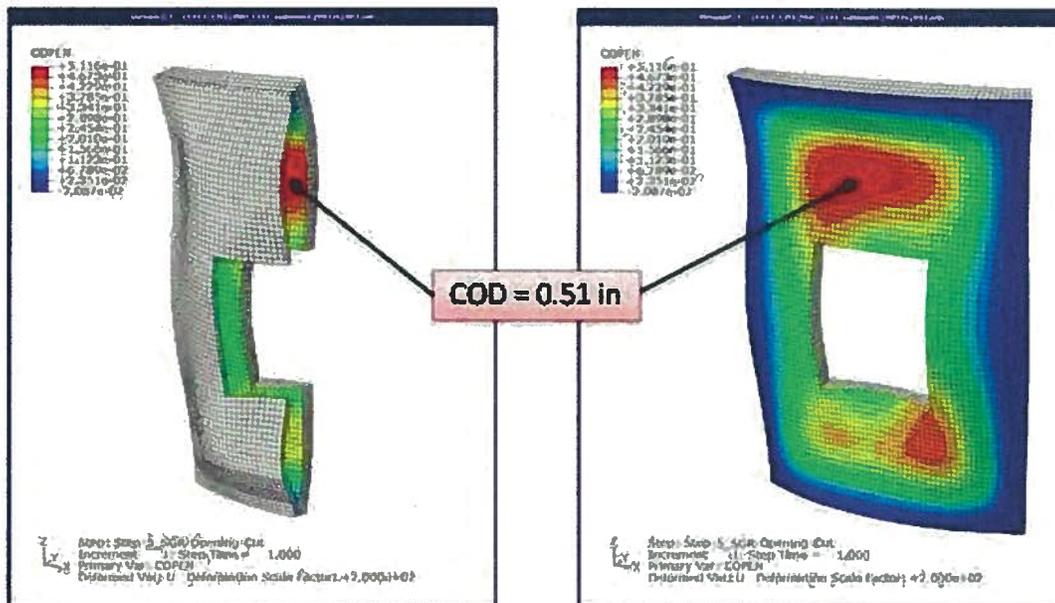
Figure 7.13 Crack Opening Distance (COD) after Concrete Removal – Step 5.
Note the width of the crack increased by about 10% due to concrete removal. Concrete removal does cause an increase but not a significant one.

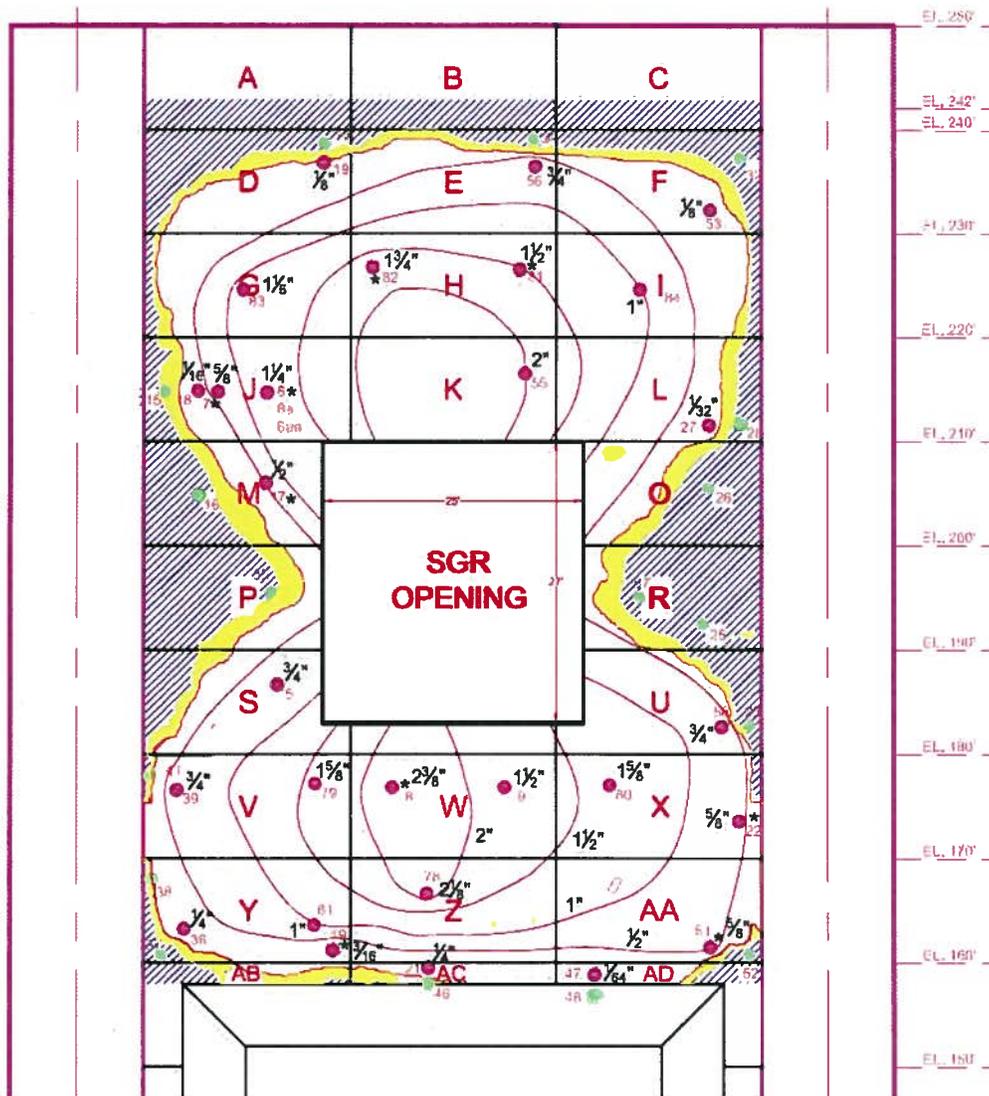
Figure 7.14 Plot of delamination damage in Bay 34. Shown are the measurements of the delamination gap both by impulse response test and by core bores.

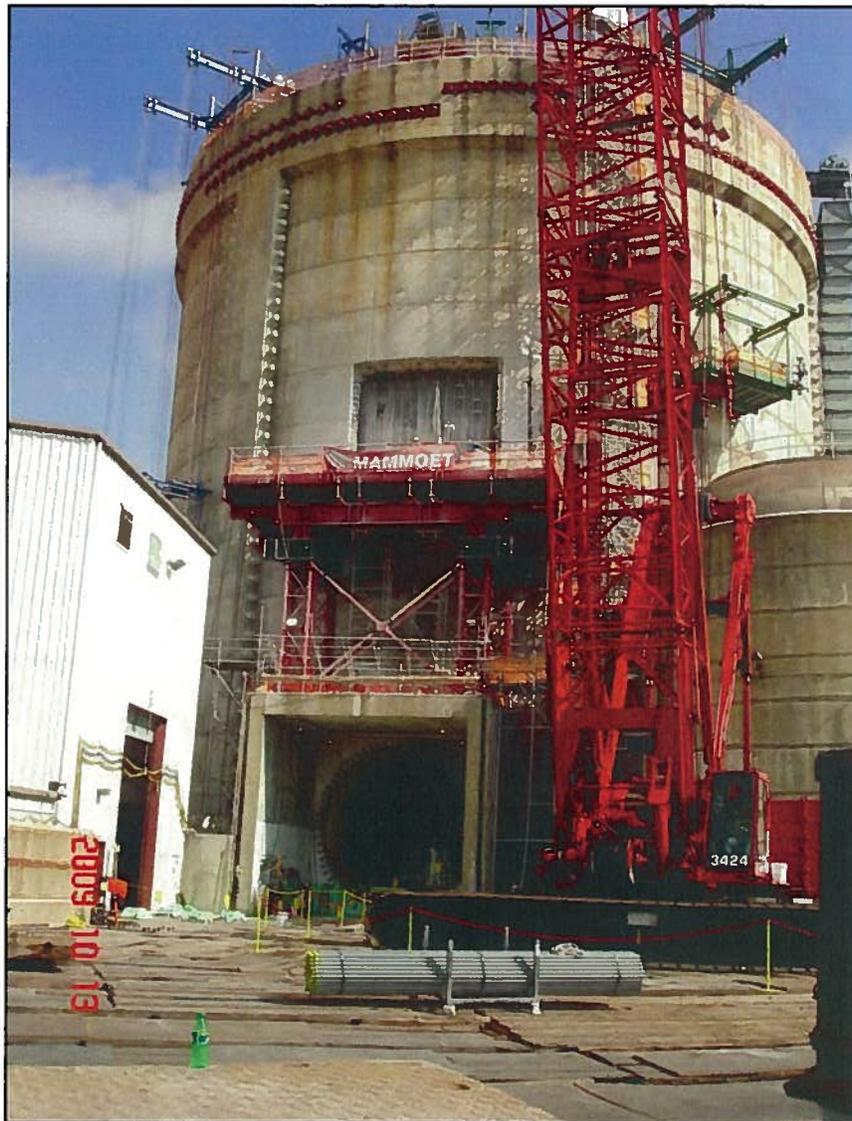
Figure 1.1 Photograph of the steam generator opening worksite.
Note the newly constructed rectangular opening above the existing circular equipment hatch.

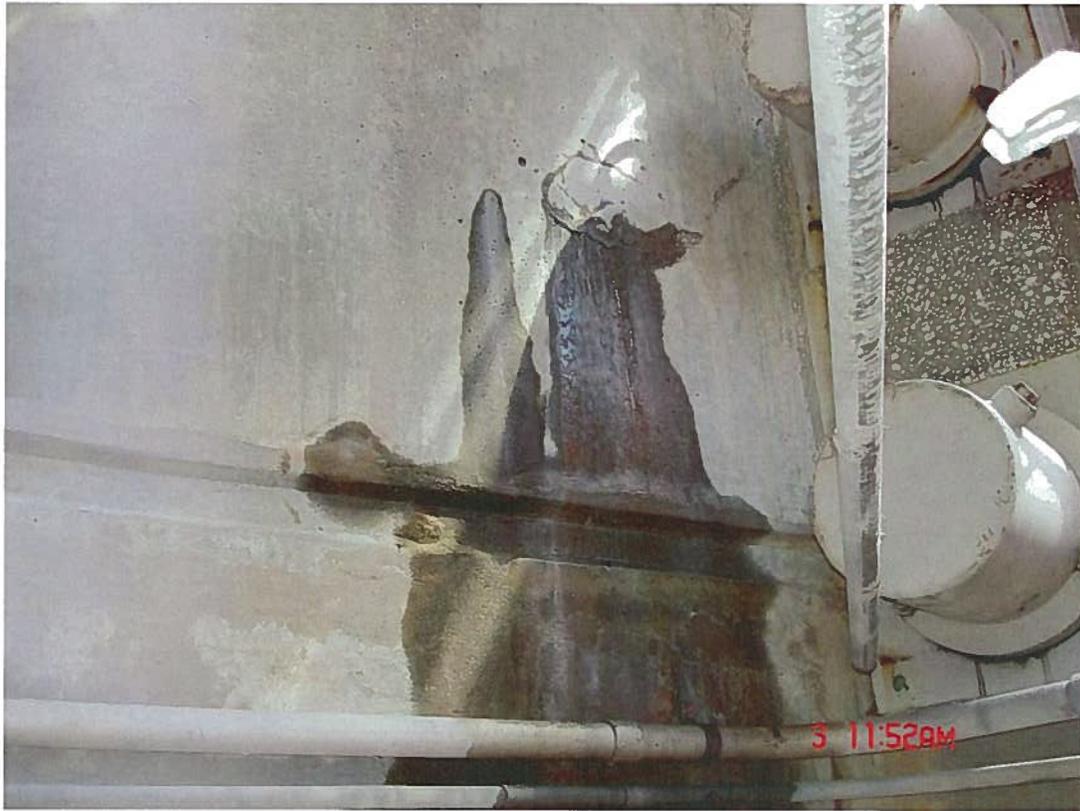
Figure 1.2 Photograph of water leakage from the containment wall (10/3/2009).

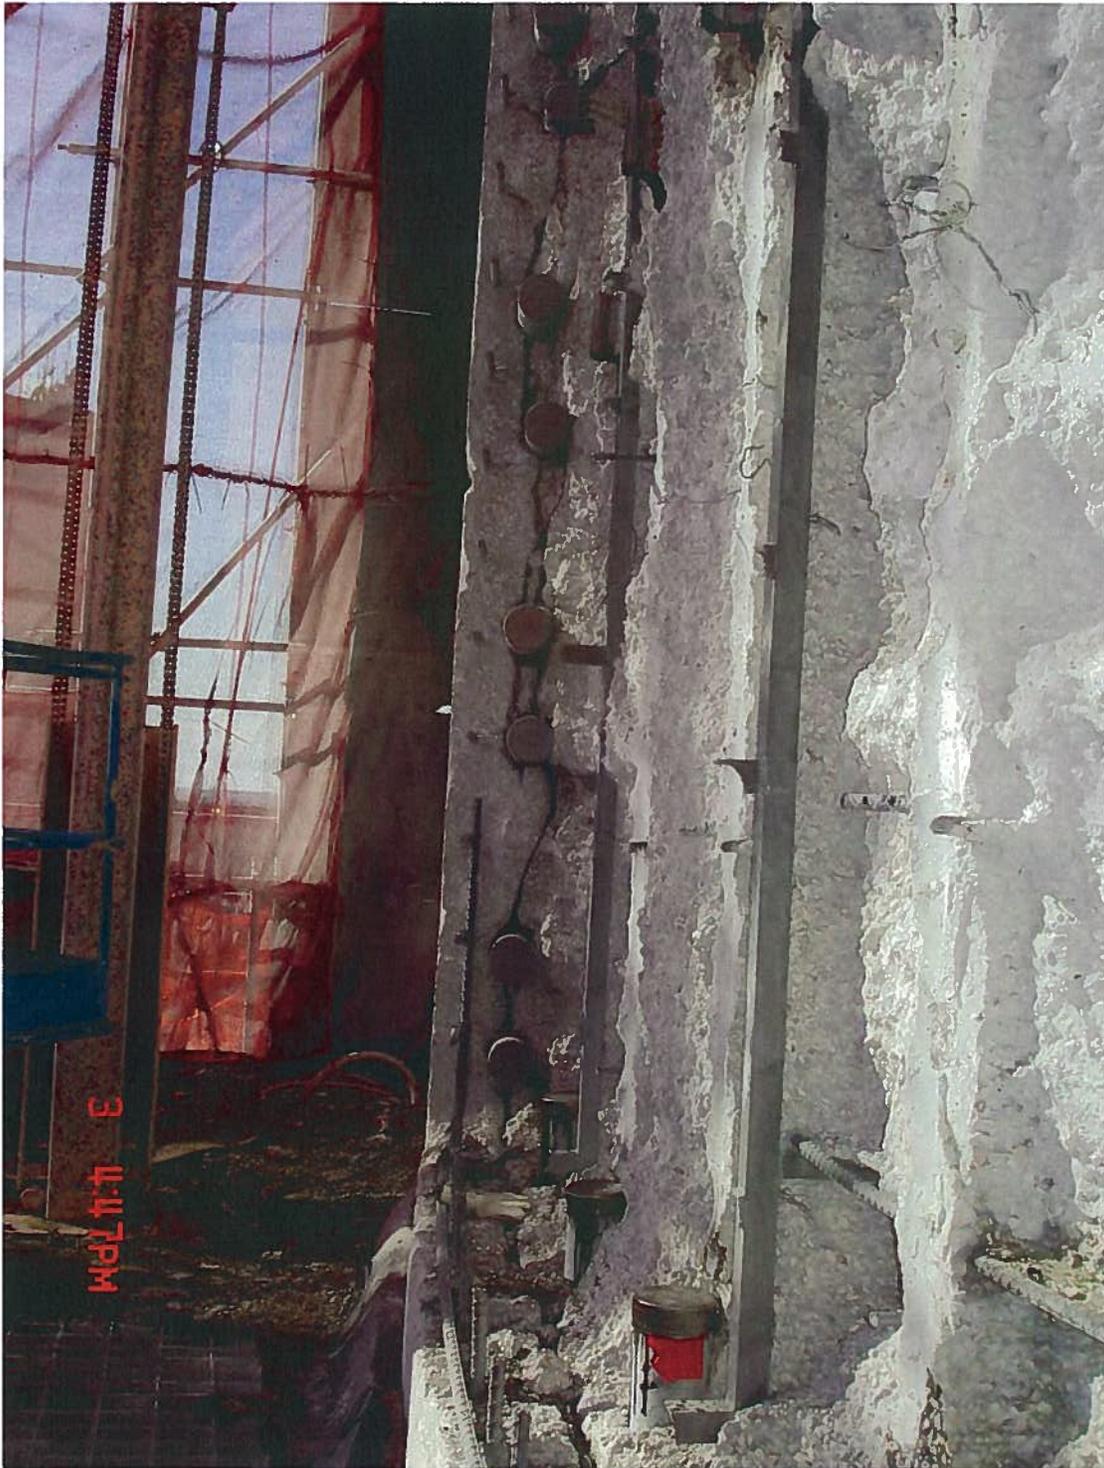
Figure 1.3 Photograph of delamination crack running from horizontal tendon to horizontal tendon, parallel to the wall surface, approximately 10 inches deep. (Photo taken after partial concrete demolition)

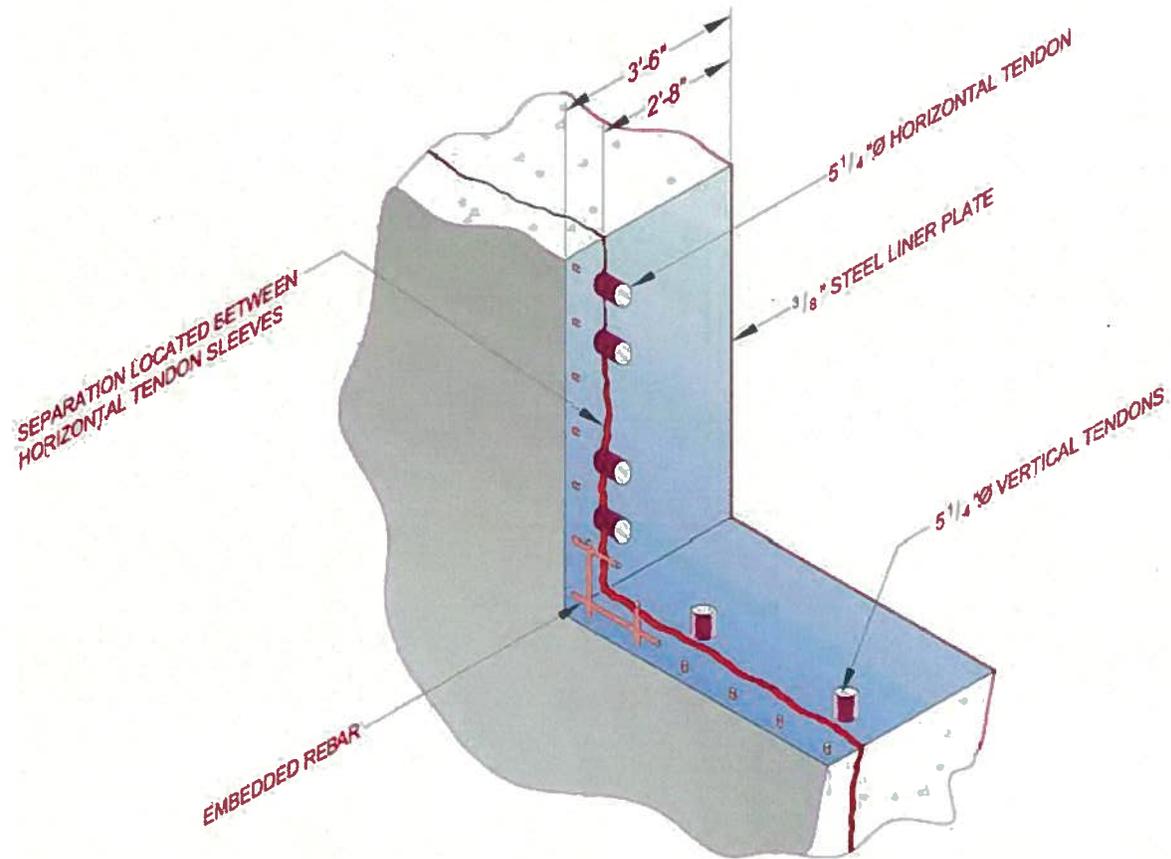
Figure 1.4 Sketch of the delamination cracking in the bay 34 wall.

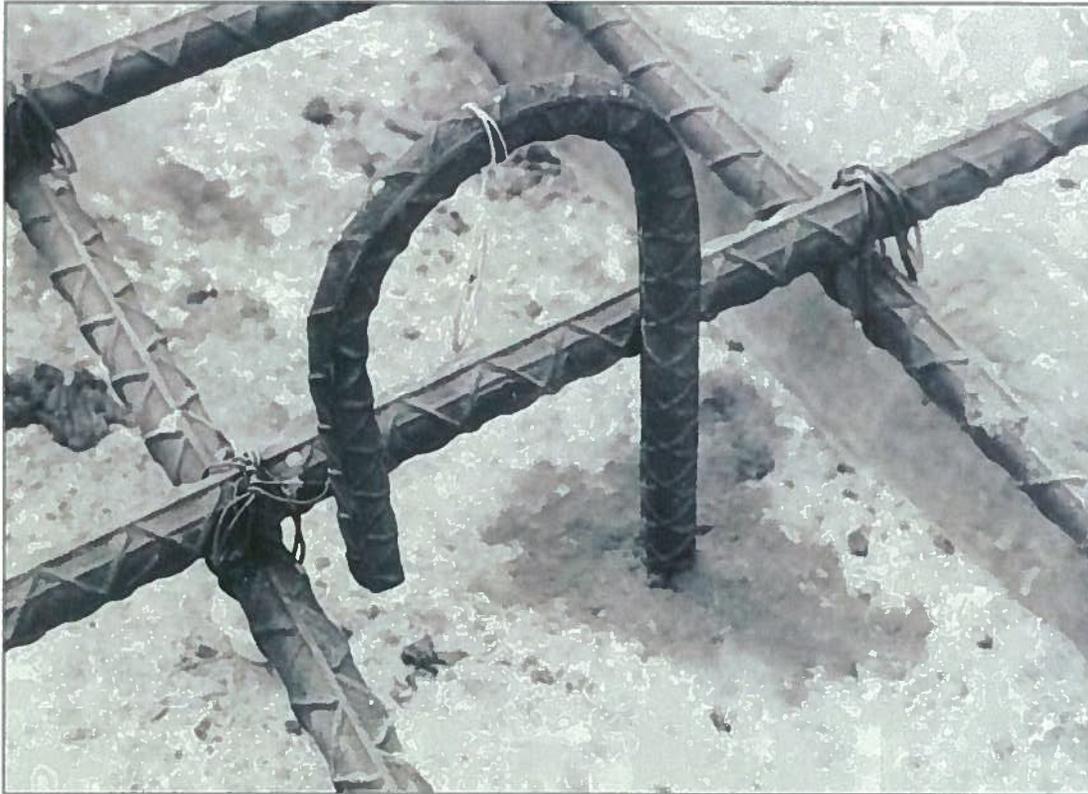
Figure 3.7 Photograph of a radial reinforcement installed as a corrective action to the CR3 Dome delamination

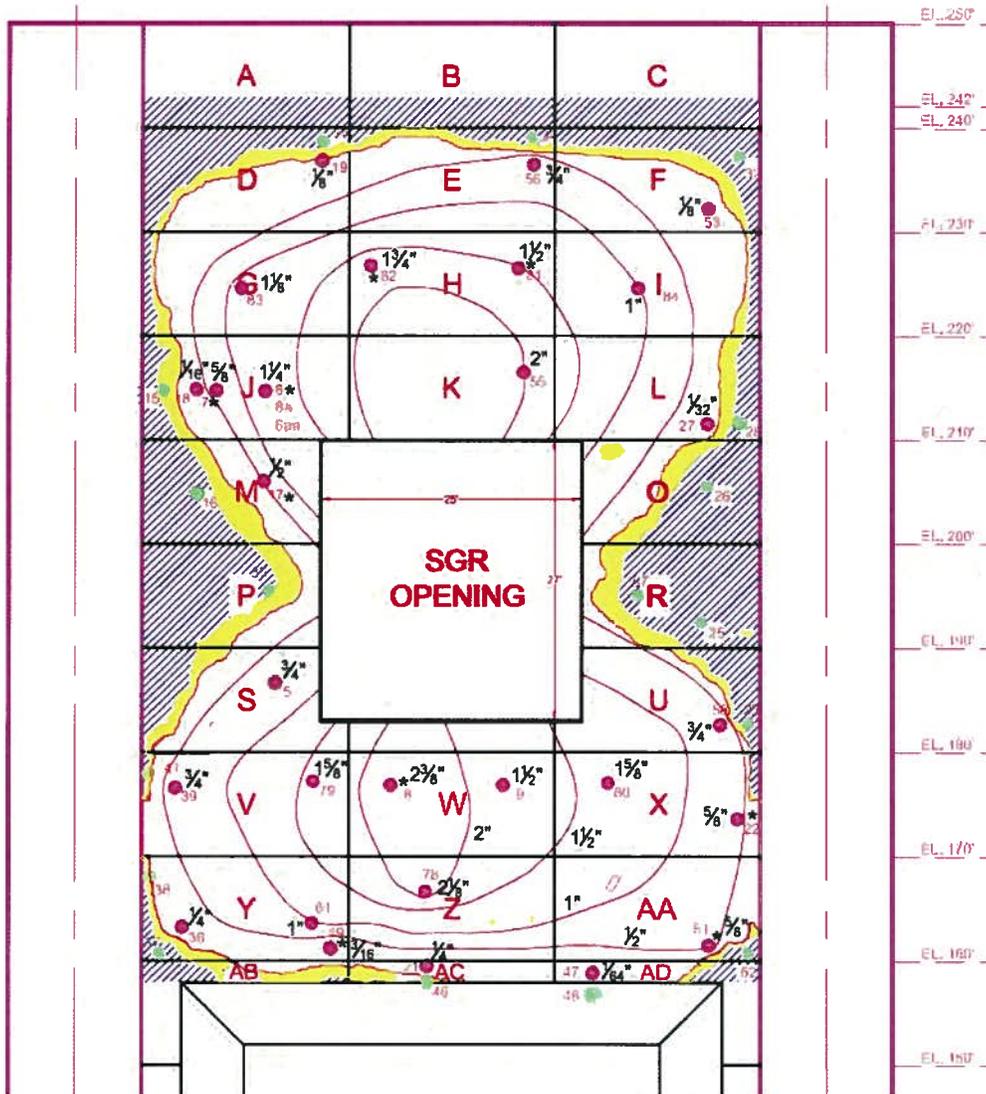
Figure 7.14 Plot of delamination damage in Bay 34. Shown are the measurements of the delamination gap both by impulse response test and by core bores.

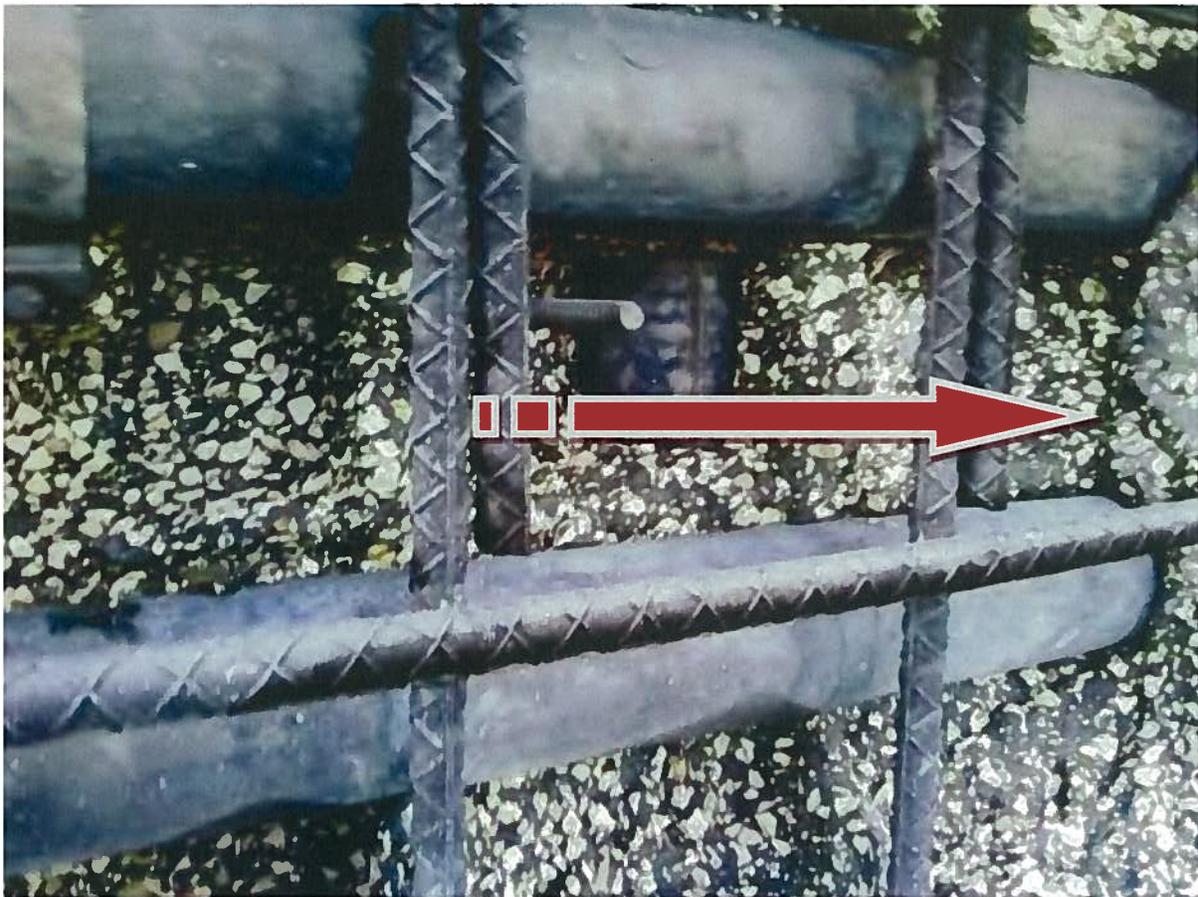
Figure A4.1 The first indication of cracking between horizontal tendons taken on 9/30.

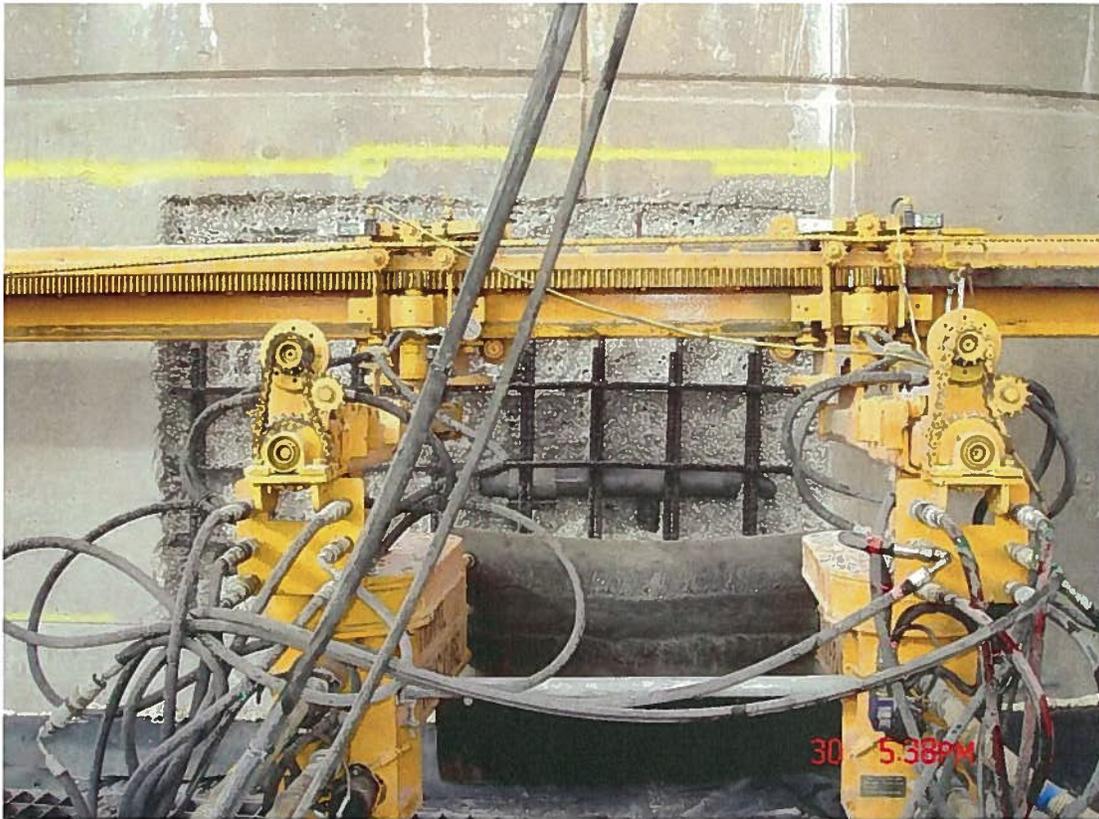
Figure A4.2 Photograph of overall status of demolition taken on 9/30/09.at 17:38

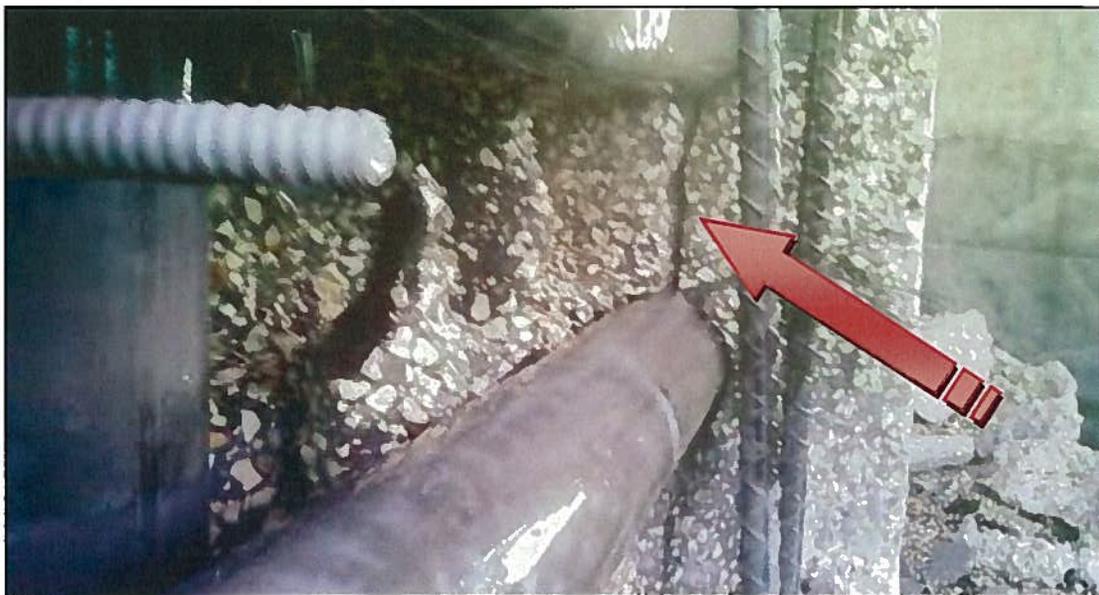
Figure A4.3 Another crack photograph taken on 10/01/09

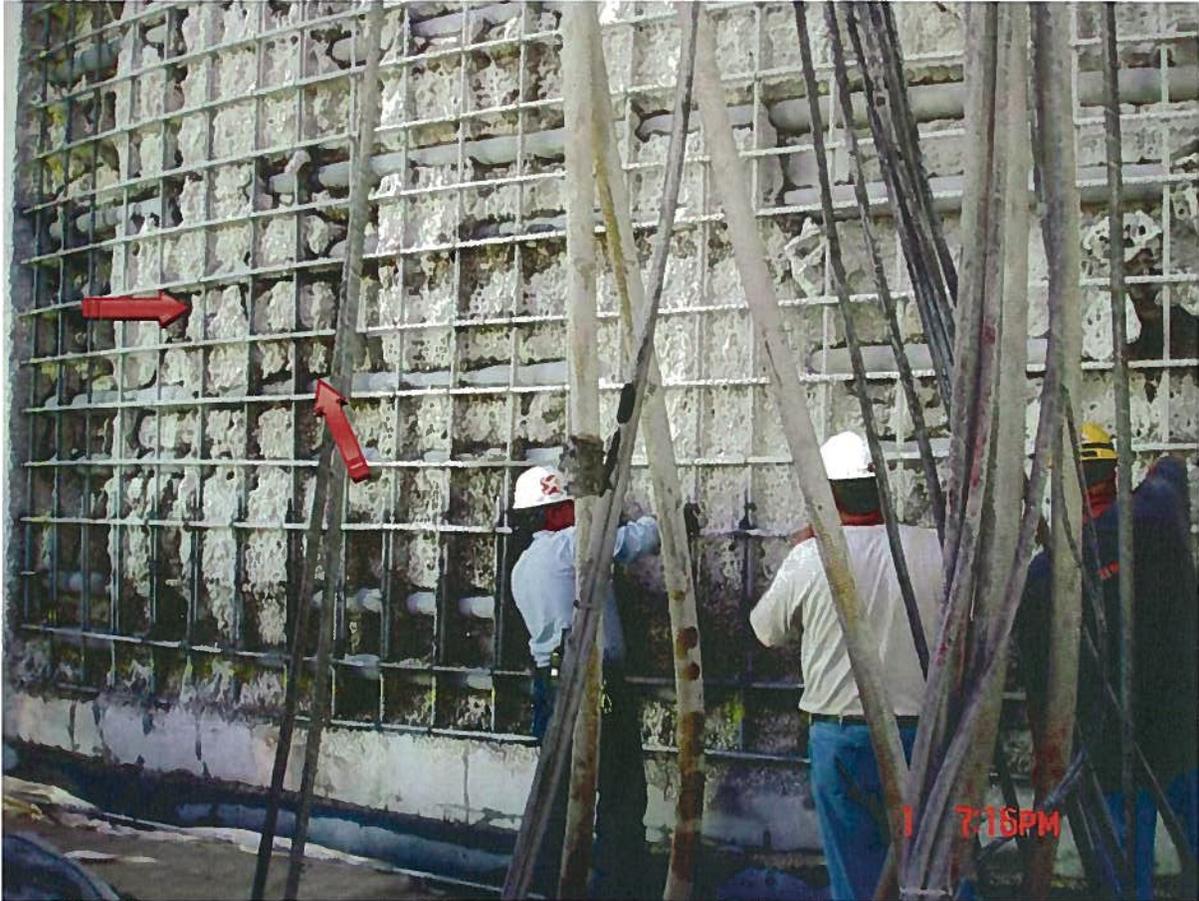
Figure A4.4 Photograph of demolition on the evening of 10/1/09. Note the large blocks of broken concrete in the middle of the opening.

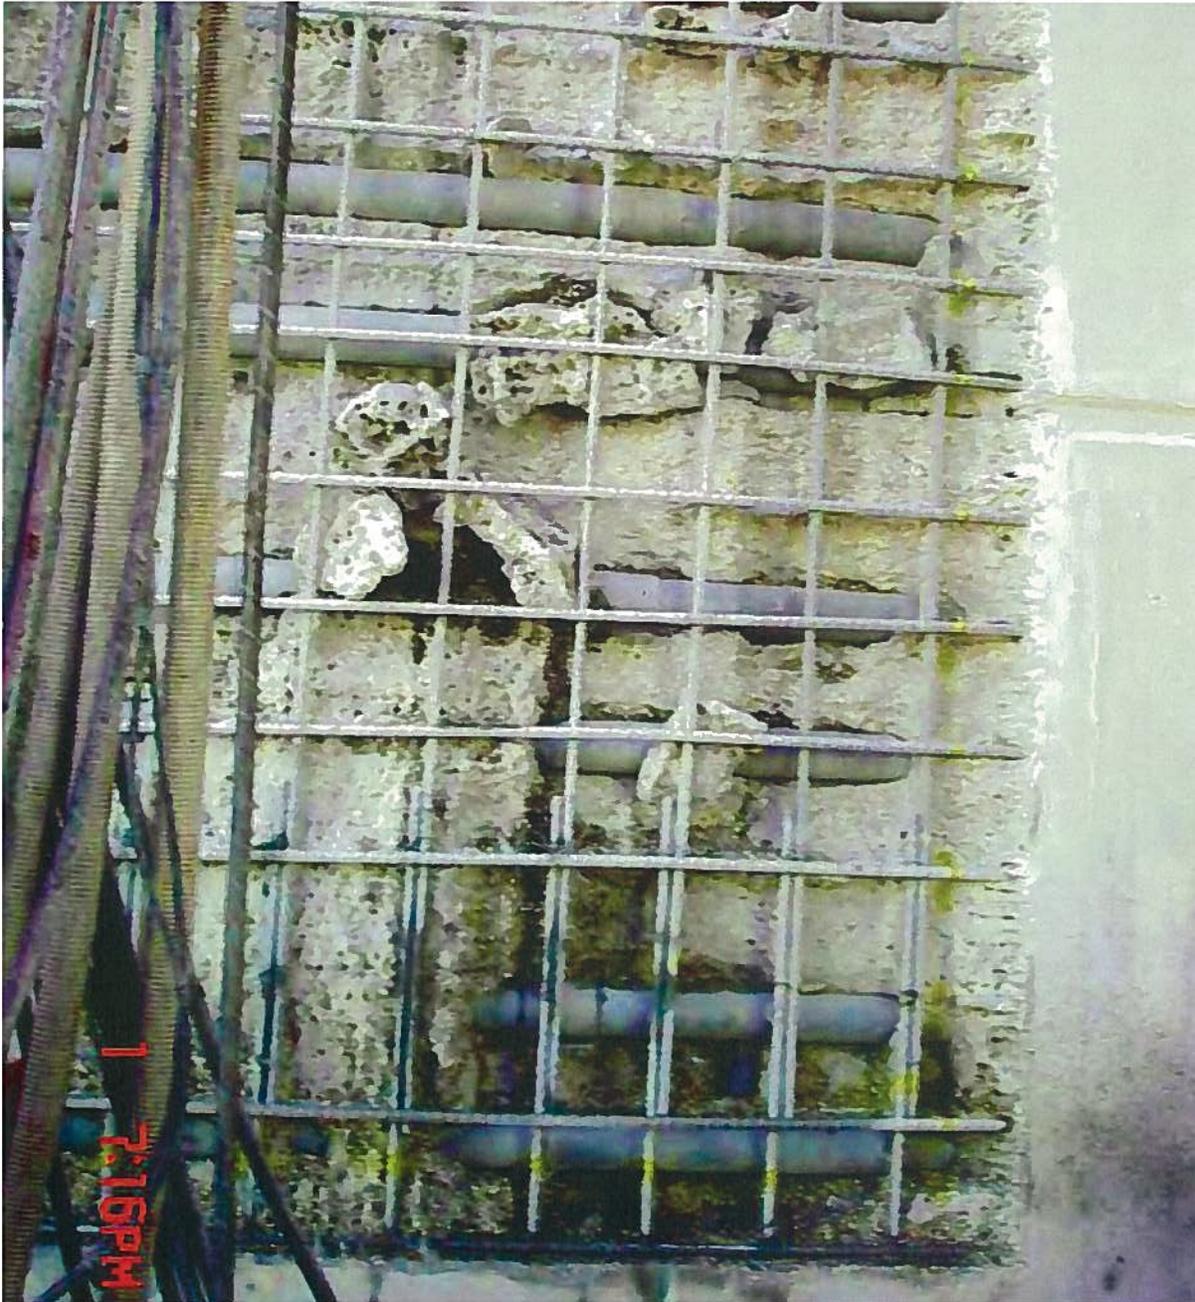
Figure A4.5 Another early photograph (10/1/09) of concrete debris, showing the distribution of horizontal tendons. The horizontal tendons come in pairs centered 13 inches apart. The distance between pairs is 26 inches. The horizontal tendons are outside the vertical tendons and define the transition from radial tension stress to radial compression stress in the concrete.
