**SUBJECT: CRYSTAL RIVER NUCLEAR PLANT - SPECIAL INSPECTION REPORT
05000302/2009007**

The purpose of this inspection was to examine activities associated with the delamination identified in the Unit 3 containment. The inspection was conducted in accordance with the Special Inspection charter issued by the Region II Administrator on October 13, 2009. As part of the inspection, the NRC examined your evaluation of extent of condition, your evaluation of root cause, and your planned corrective action for continued operability. The inspectors interviewed personnel and conducted plant walk downs, including visual examination of accessible portions of the outside and inside surfaces of the containment.

ROOT CAUSE ASSESSMENT CRYSTAL RIVER UNIT 3 CONTAINMENT CONCRETE DELAMINATION

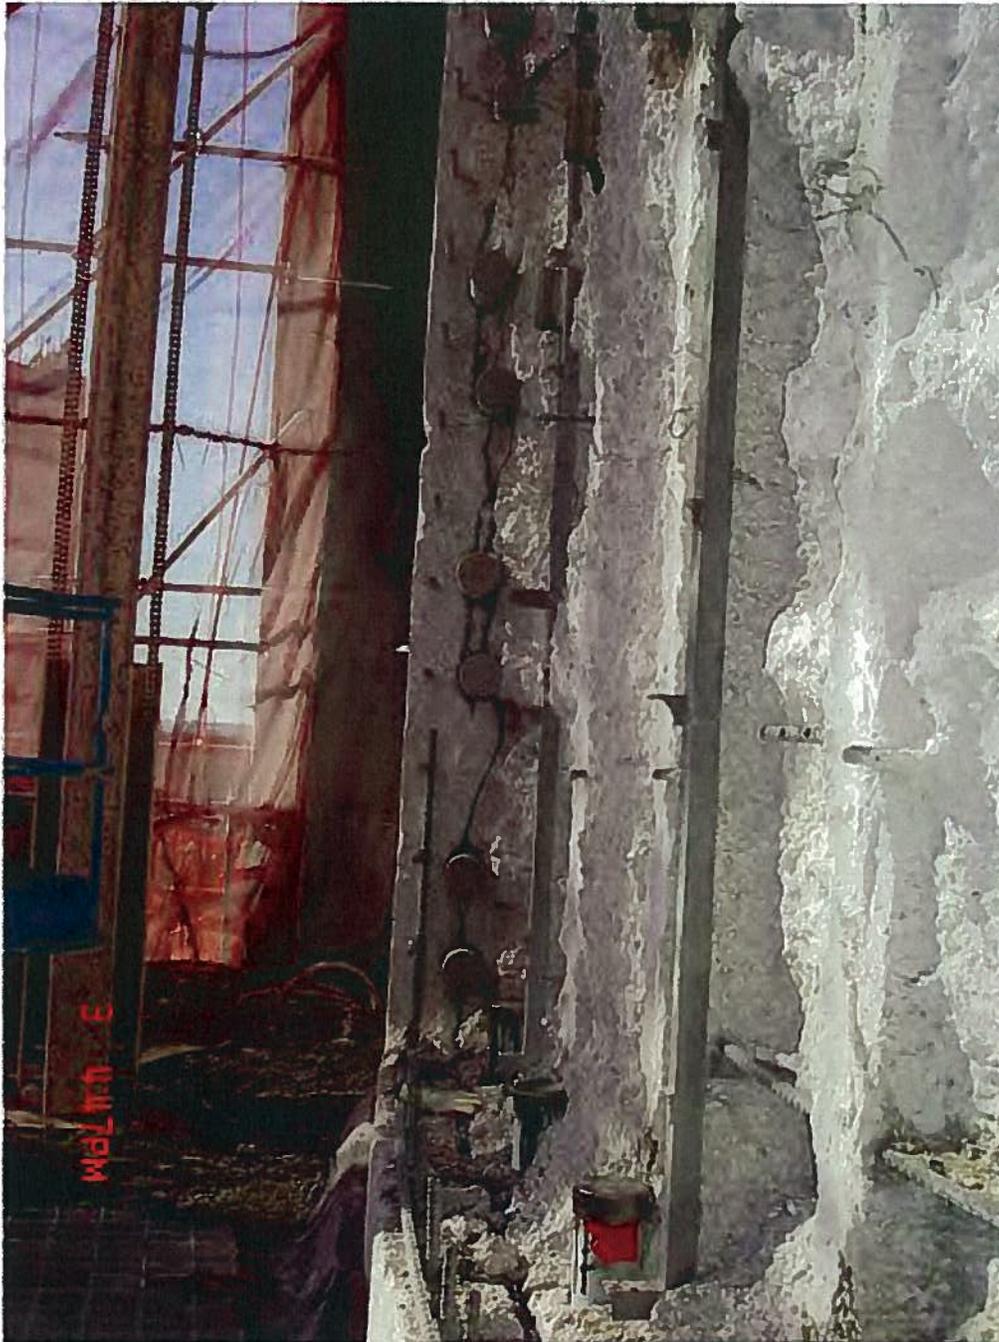
Figure A4.6 Delamination crack running vertically between horizontal tendons about 10" deep.
Taken on 10/3/2009

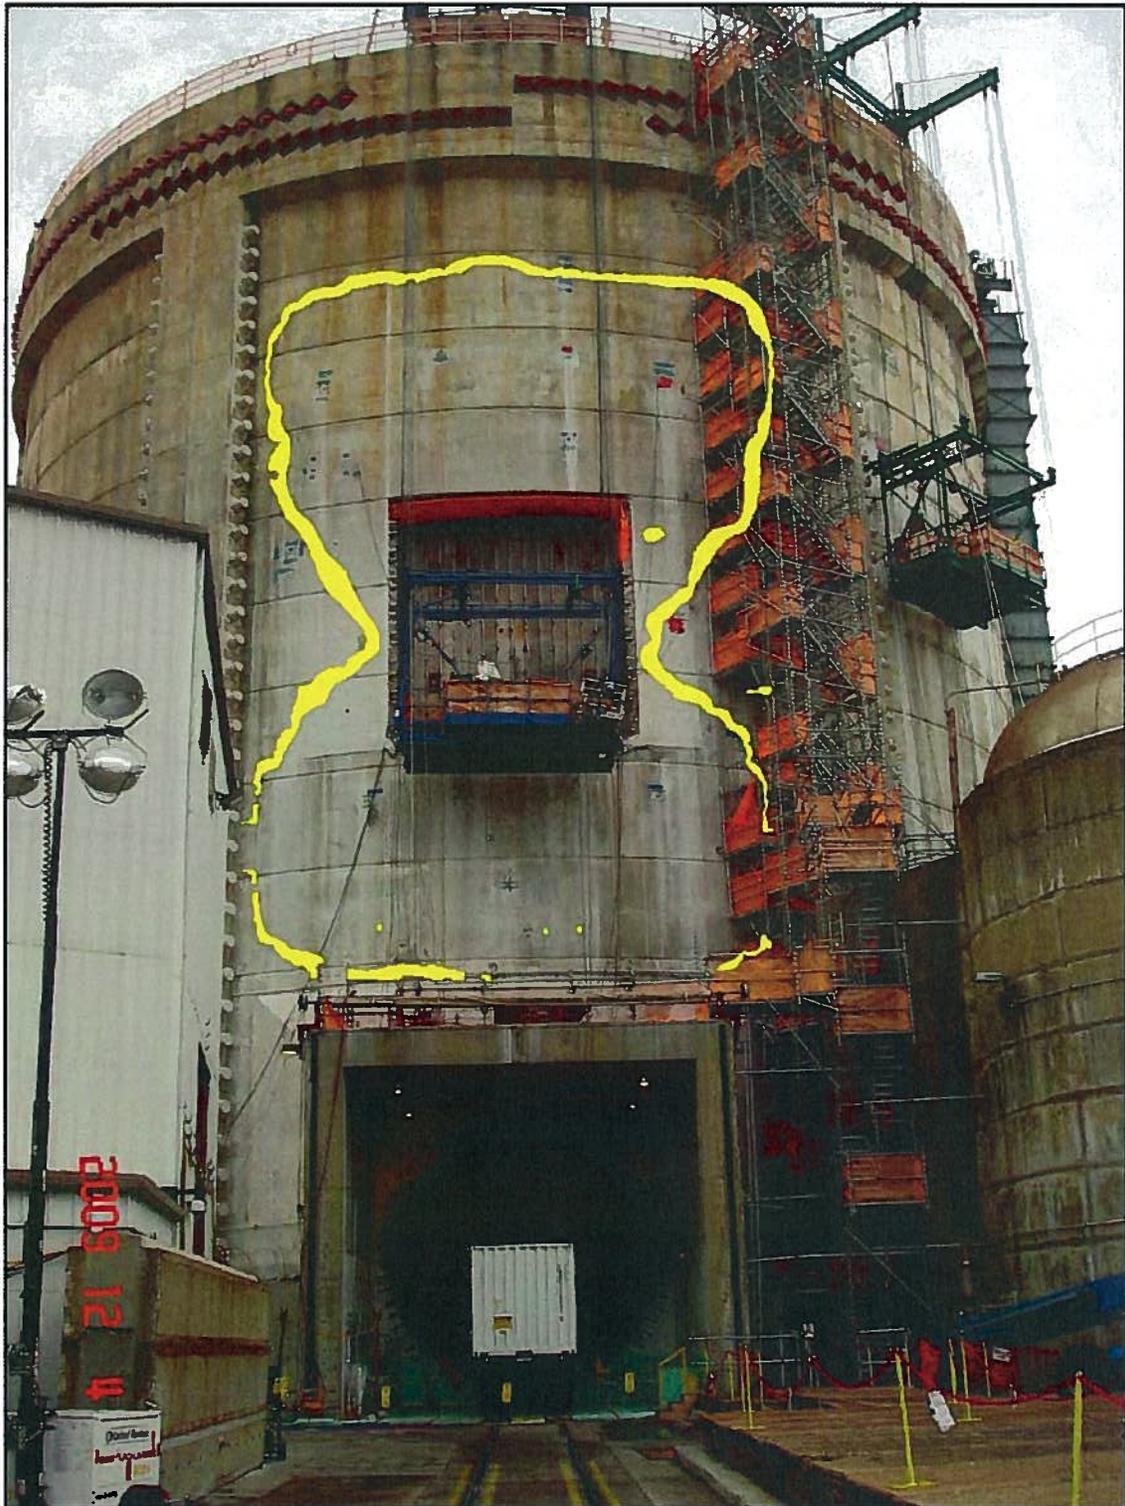
Figure A4.7 Delamination zone outline overlaid on the containment wall above and below the SGR opening

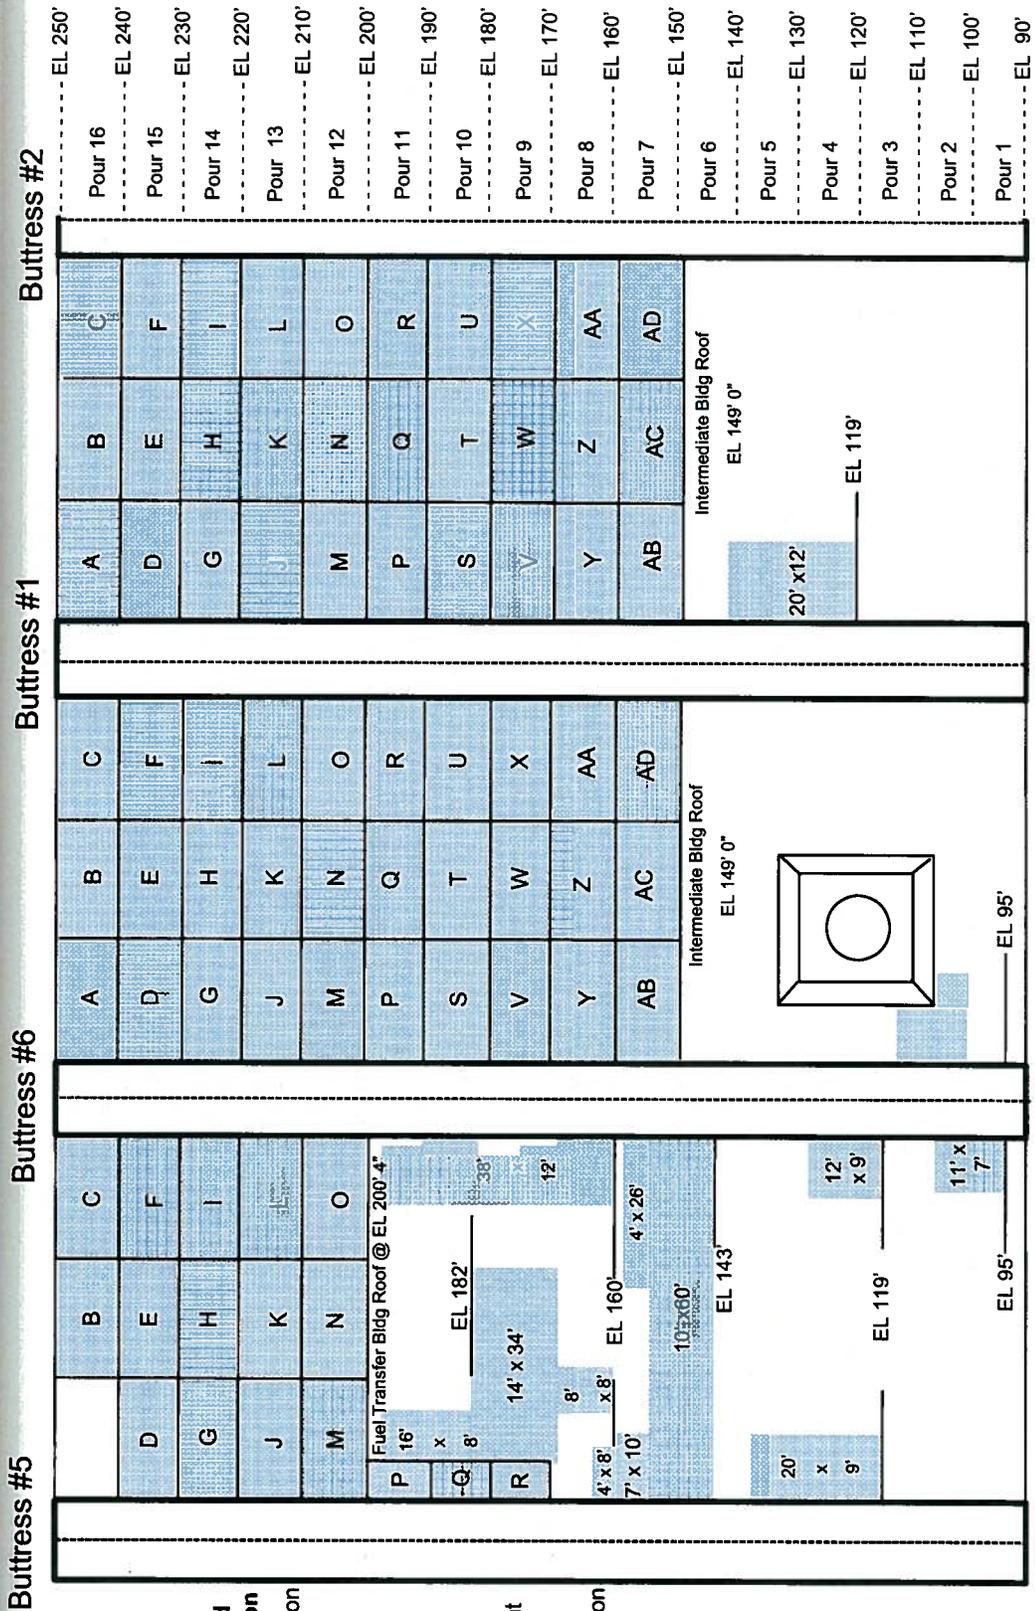
IR scans completed with no delamination
Blue = no delamination
