Florida Power & Light Company, 6501 S. Ocean Drive, Jensen Beach, FL 34957

L-2010-223
10 CFR 50.55a
10 CFR 50.36

Re: St. Lucie Unit 2
Docket No. 50-389
RAI Reply for Refueling Outage SL2-18
Steam Generator Tube Inspection Report

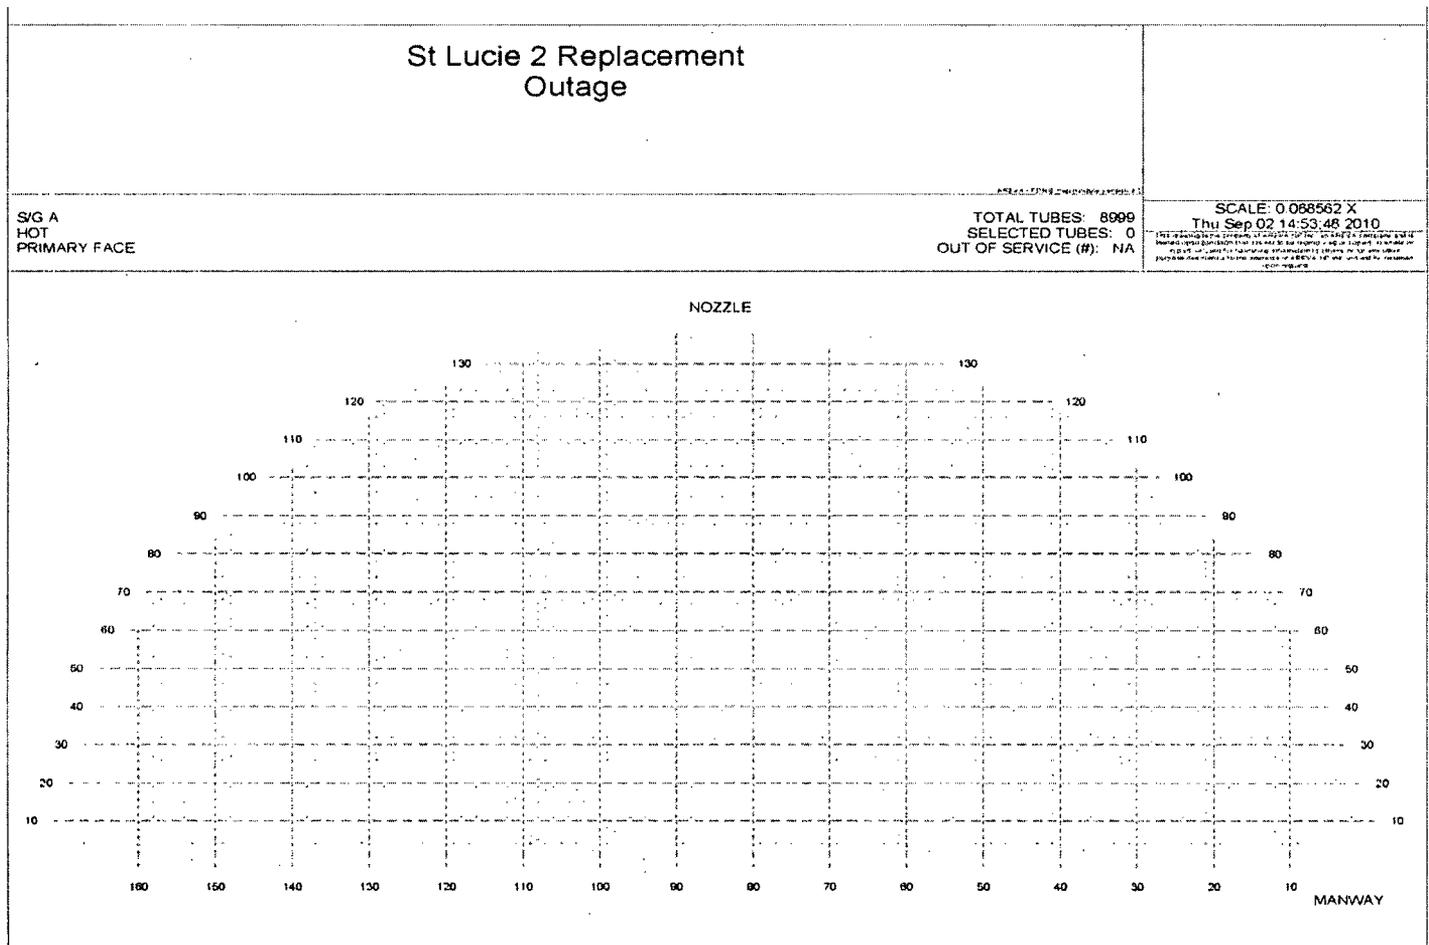
a. A tubesheet map depicting the row and column numbers,

Response: The tubesheet map below is generated from Areva software using SG configuration information. Rows run parallel to the divider plate and columns run perpendicular to the divider plate.
