2.8 Inadequate Support of Tendons during Pouring

Preliminary

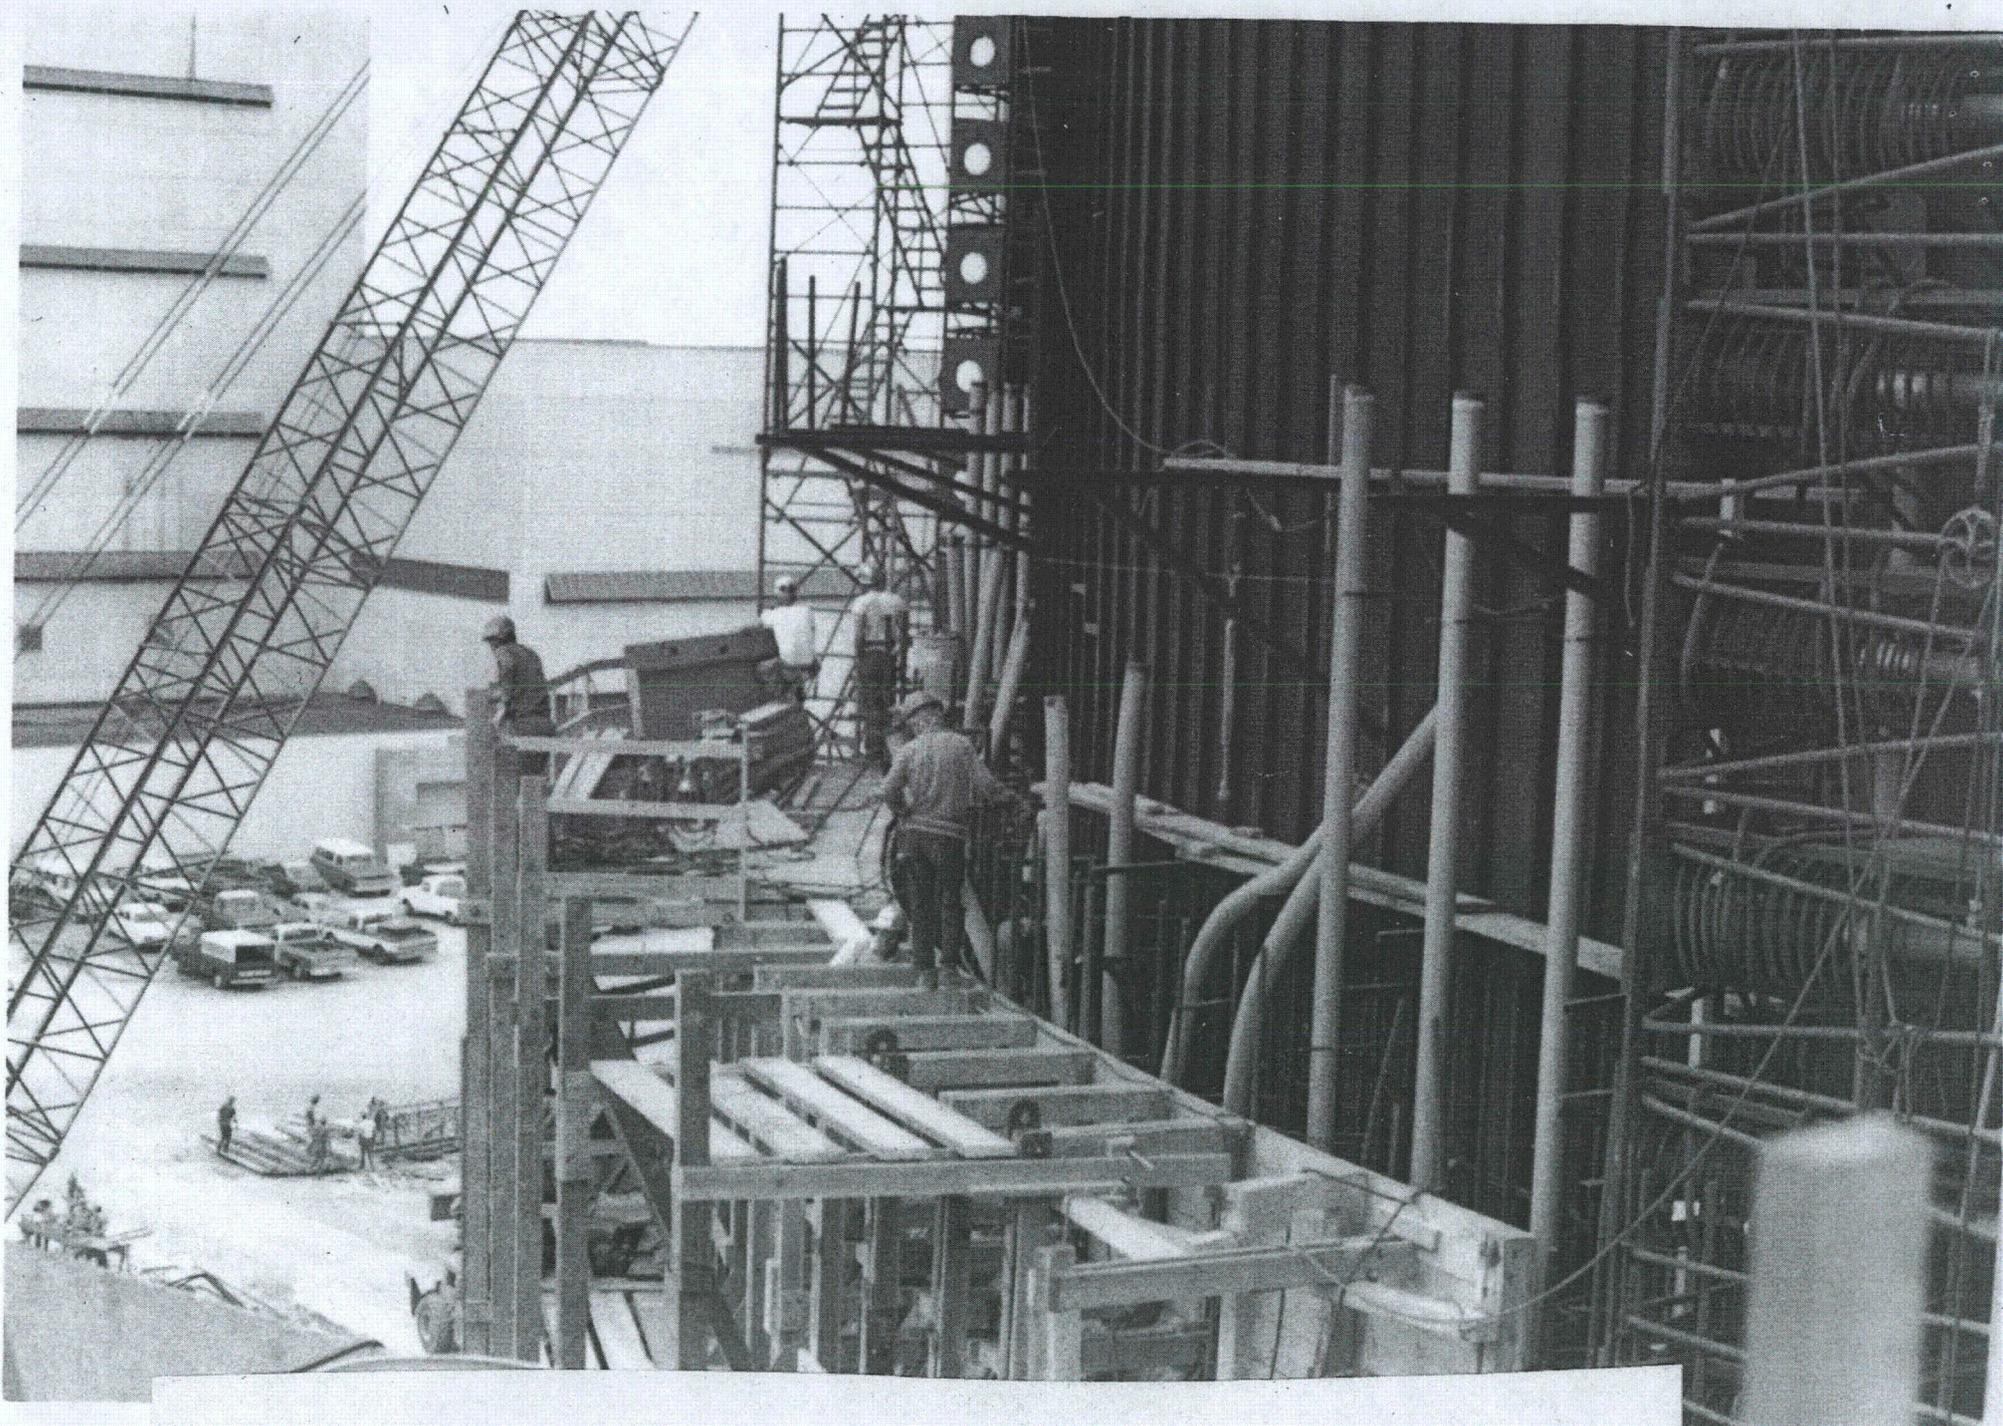
REACTOR BLDG EQUIP ACCESS OPENING

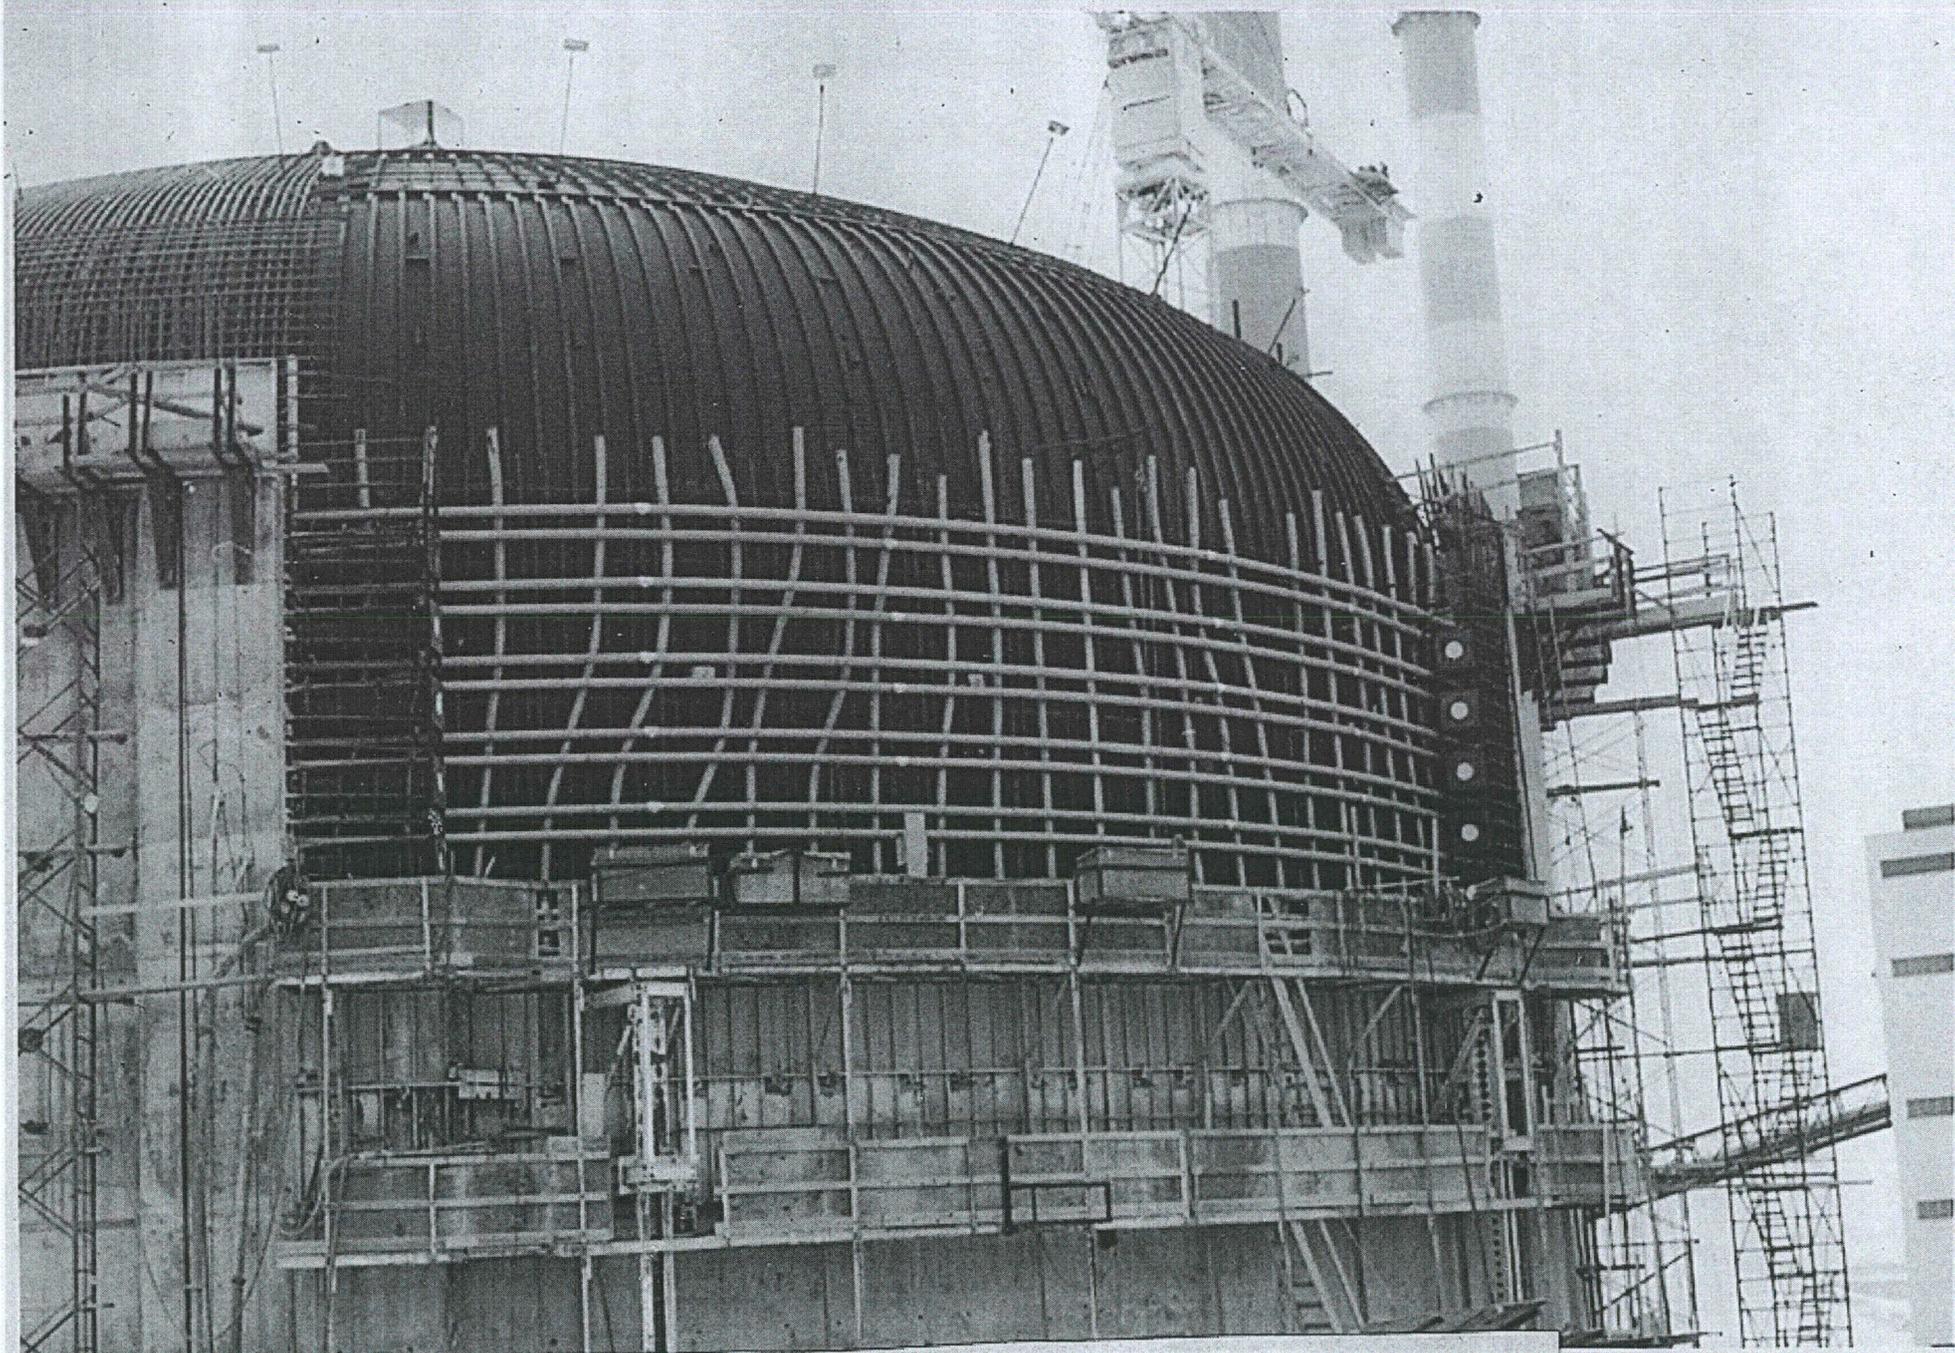
5 APRIL 73
REACTOR BLDG EXT WALL 300°-360°
