### Containment Exterior Surface Survey Data

Surveys were performed of the containment dome and buttresses (field date 11/21/09). Attachment 1 includes a map of the dome and buttresses. The dome survey was performed to identify if there are significant changes on the surface of the dome by comparing the current survey data to the final dome survey performed in 1981. The dome was surveyed between 1977 and 1982 as technical specification surveillance required based on the dome delamination event. Procedure SP-180, Reactor Building Structural Integrity Dome Surveillance Program, was initiated to perform a survey of the dome to identify changes in dome elevation and an inspection of the dome surface identifying crack width and crack pattern. The final surveillance was performed in 1981 with an additional survey performed 3 months later due to exceeding acceptance criteria. The buttress survey was performed to determine the relative position of the buttress corners.

**SPECIFIC PURPOSE SURVEY FOR PROGRESS ENERGY**

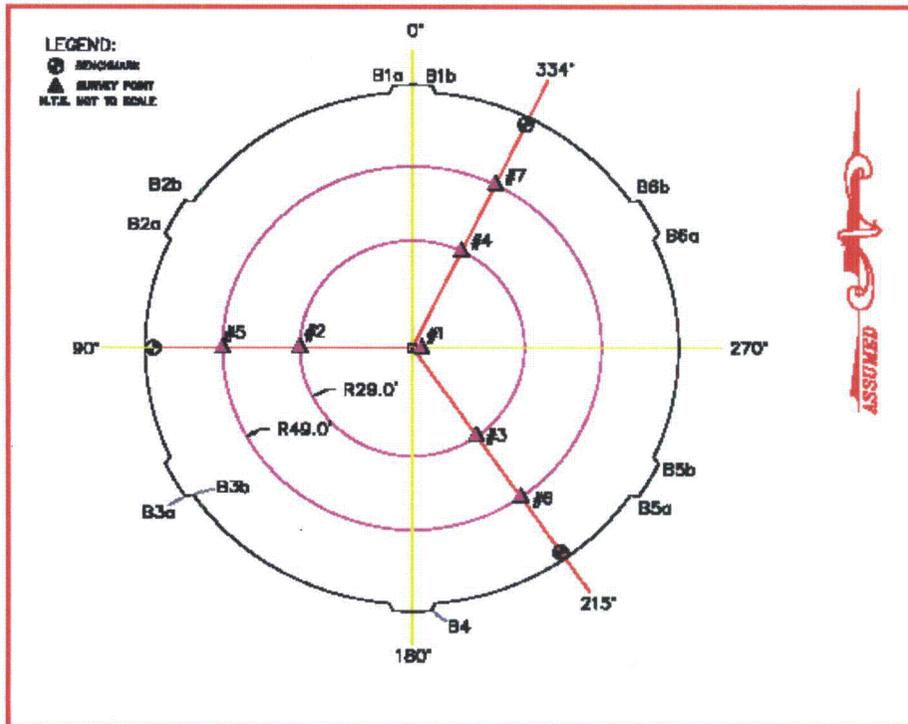
Attachment 1

The current survey of the dome was performed using SP-180 as a guide. The original benchmark and survey point pins were found on the surface of the dome. Elevations were taken at each of the benchmarks and survey points. Delta elevations were determined by subtracting the elevation of each survey point from the average of the three benchmark elevations. The change in elevation is shown below as well as the original acceptance criteria and the results from the last survey performed in 1982.

The % change from the 1982 survey is considered insignificant with respect to detecting a change in the structure similar to the delamination found between buttress 3 and 4. In addition, a review of the boroscope video of the seven core bores in the dome did not find any delamination.

These conditions affect the accuracy of the survey data. As noted above, eliminating one survey point at Buttress ID B1b reduced the lateral offset by 0.9". The vertical alignment tolerance provided in ACI 117-90 is considered to be satisfied based on the localized surface variations affecting the accuracy of the survey data.
