December 23, 2009

Subject: **Report of Petrographic Observations
Crystal River Containment Wall
Steam Generator Replacement Project
Crystal River Nuclear Generating Facility, Florida
MACTEC Project 6468-09-2535**

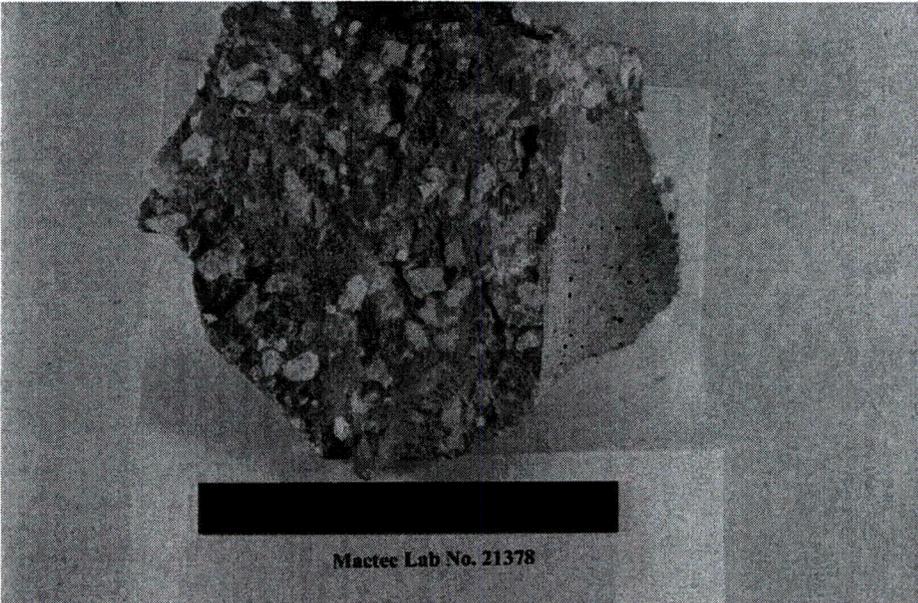
Photograph #1	Remarks

<p data-bbox="576 919 782 947">Mactec Lab No. 21378</p>	Sample as received.

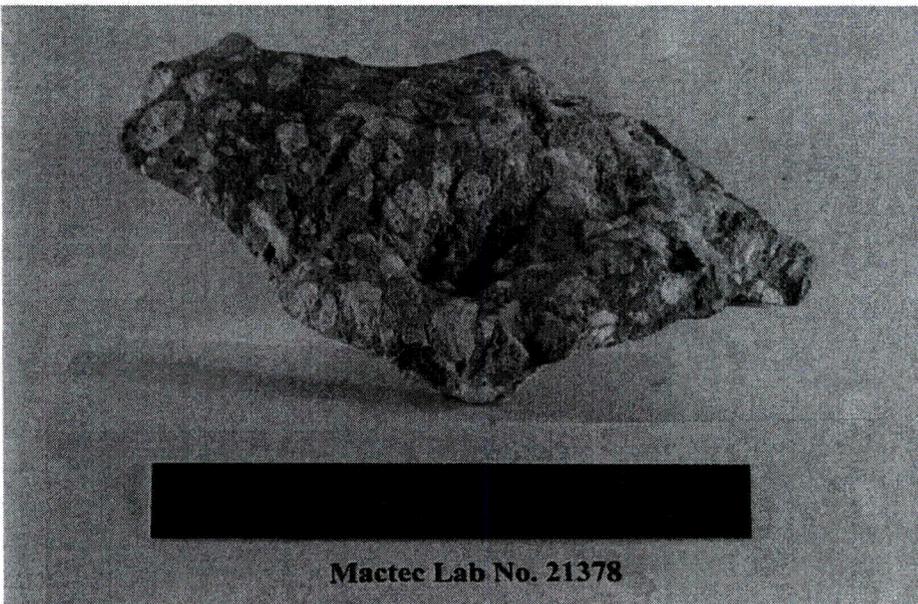
Photograph #2	Remarks

<p data-bbox="576 1749 873 1776">Mactec Lab No. 21378</p>	Sample as received.

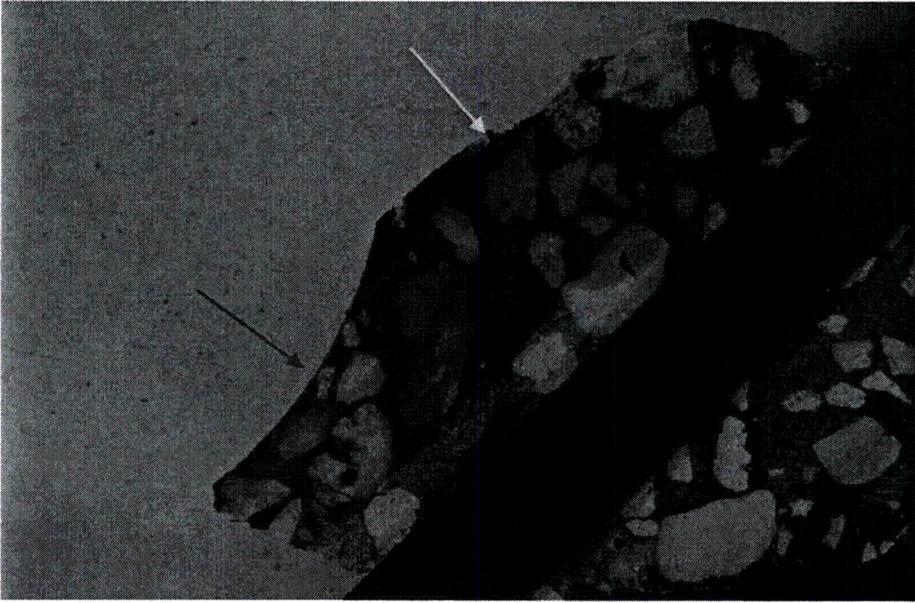
Photograph #3	Remarks

The fractured surface and the surface that was cast against the tendon duct showed surficial carbonation that may be due to exposure to the atmosphere after removal from the structure. Significant carbonation or differences in the distribution of hydrated and partially hydrated cement particles was not observed between the two surfaces.

<p>A cut section of the sample after staining one area with phenolphthalein to observe for carbonation (only the pink area was treated with the phenolphthalein). Carbonated areas remain clear and non-carbonated areas turn pink. The portion of the surface cast against the tendon duct is shown by the red arrow. The fractured surface is shown by the yellow arrow.</p>

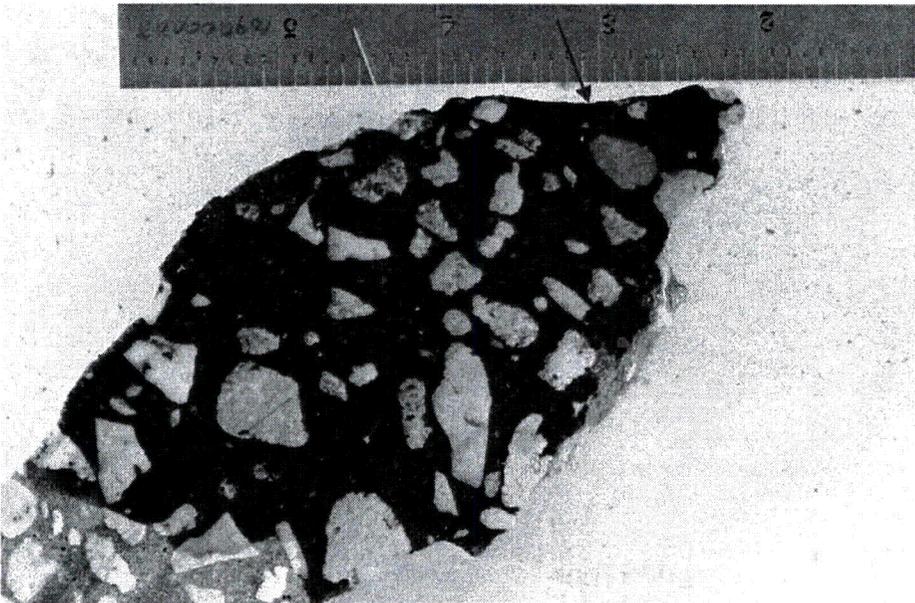
Photograph #4	Remarks

<p>A cut section of the sample after staining one area with phenolphthalein to observe for carbonation (only the pink area was treated with the phenolphthalein). Carbonated areas remain clear and non-carbonated areas turn pink. The portion of the surface cast against the tendon duct is shown by the red arrow. The fractured surface is shown by the yellow arrow.</p>

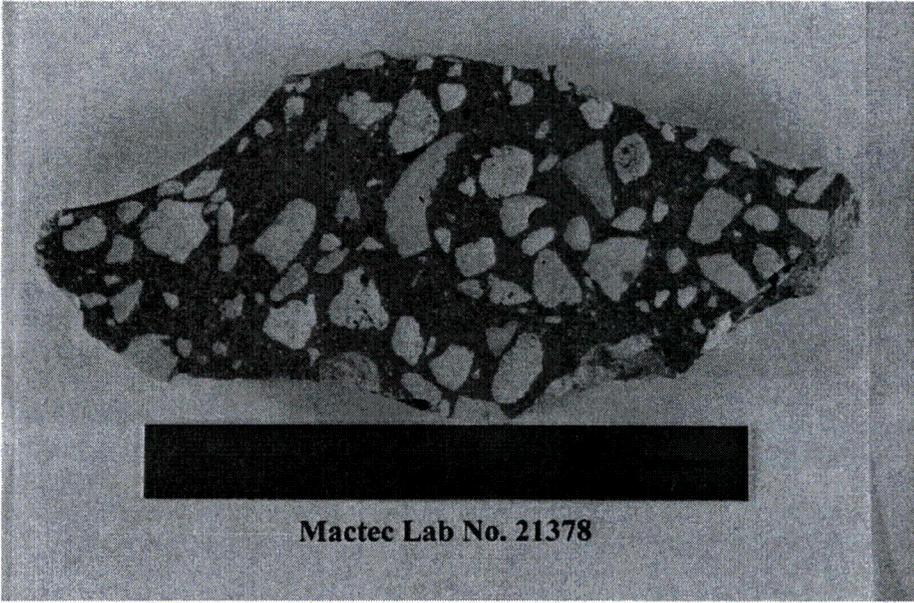
Photograph #5	Remarks

<p data-bbox="553 877 846 909">Mactec Lab No. 21378</p>	<p data-bbox="1198 338 1437 432">The polished section prepared from the sample.</p>

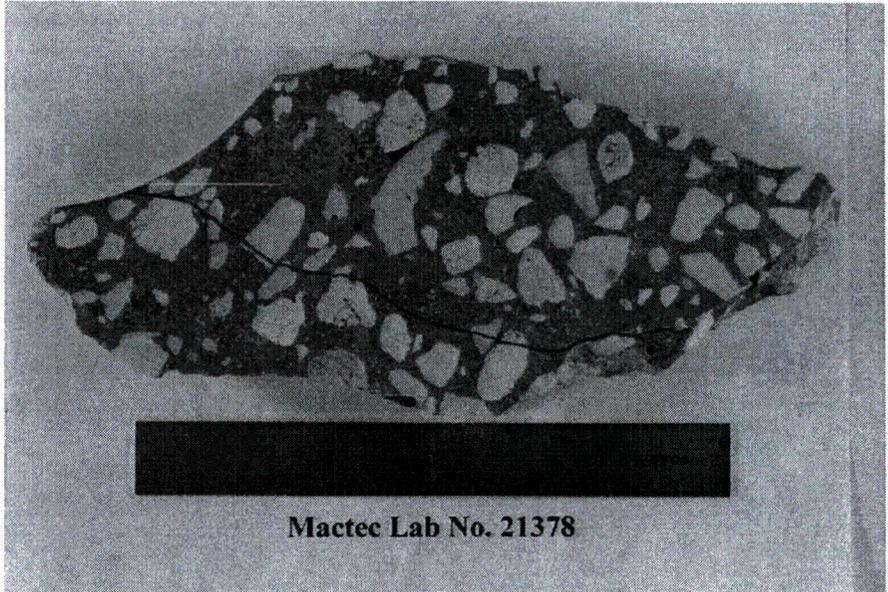
Photograph #6	Remarks

Some limited minor fractures were observed on the fractured surface and the surface cast against the duct. One lone hairline fracture was observed and shown in photograph 6.

<p data-bbox="553 1751 846 1782">Mactec Lab No. 21378</p>	<p data-bbox="1198 1173 1474 1331">The red line shows the approximate location of the hairline crack that was observed in the polished section.</p>

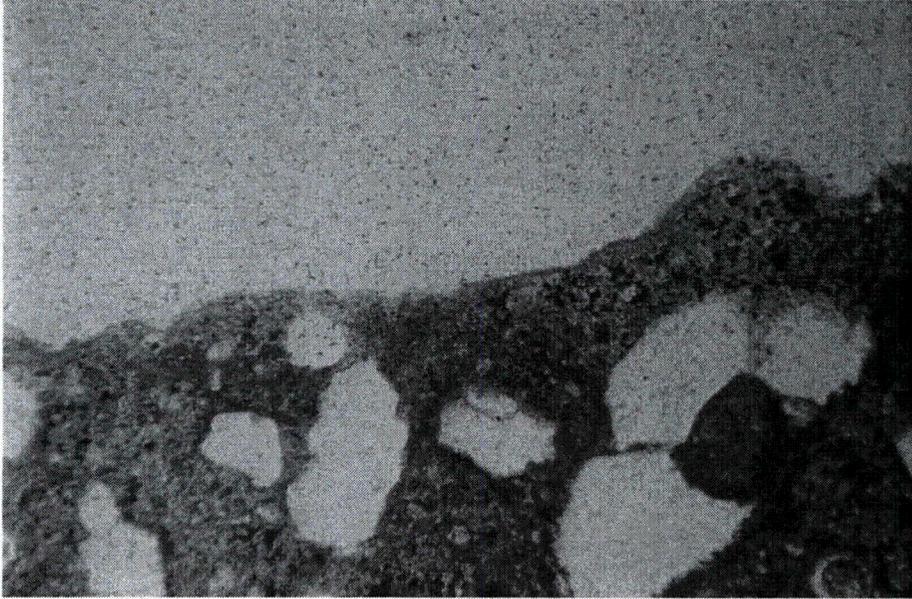
Photograph #7	Remarks

A photomicrograph showing a fractured concrete surface. The image displays a dark, granular matrix with several lighter, irregularly shaped regions, likely representing aggregate particles or voids. The fracture surface is visible as a dark, jagged line running across the middle of the image.	Photomicrograph in plane polarized light showing the fractured surface. Width of view is approximately 0.05 inch.

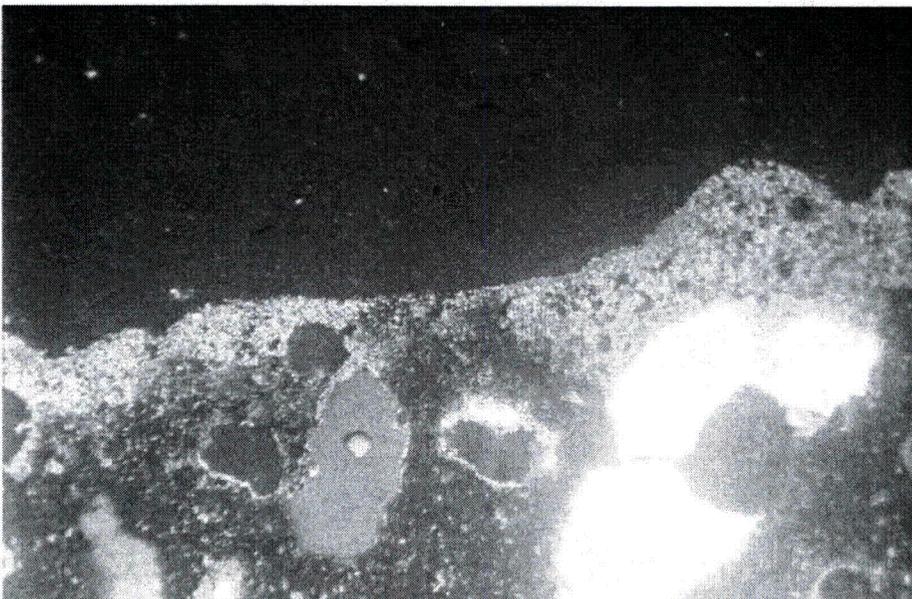
Photograph #8	Remarks

A photomicrograph showing a fractured concrete surface. The image displays a dark, granular matrix with several lighter, irregularly shaped regions, likely representing aggregate particles or voids. The fracture surface is visible as a dark, jagged line running across the middle of the image.	Photomicrograph in plane polarized light showing the fractured surface. Width of view is approximately 0.05 inch.

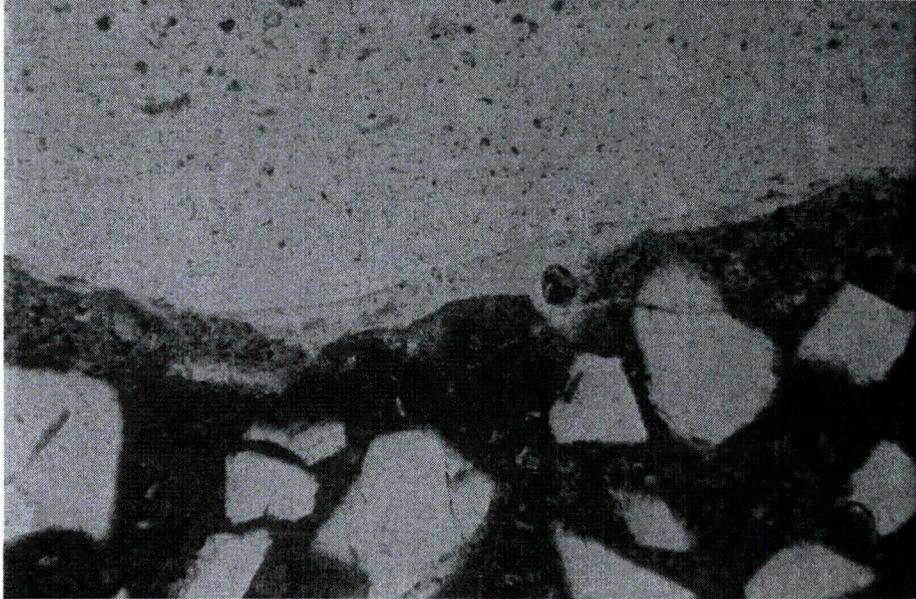
Photograph #9	Remarks

Photomicrograph in plane polarized light showing the fractured surface. Width of view is approximately 0.05 inch.

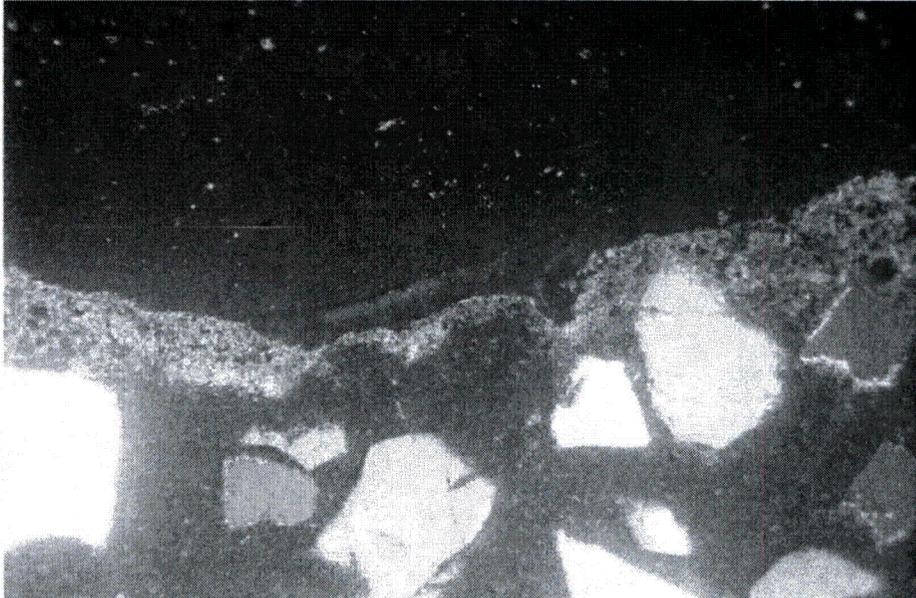
Photograph #10	Remarks

Photomicrograph in plane polarized light showing the fractured surface. Width of view is approximately 0.05 inch.

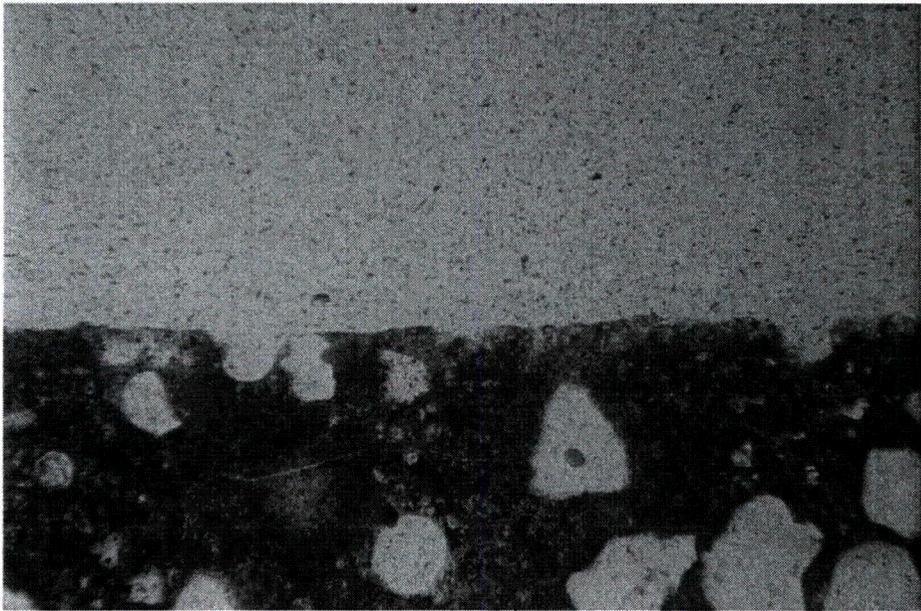
Photograph #11	Remarks

Photomicrograph in plane polarized light showing the fractured surface. Width of view is approximately 0.05 inch.

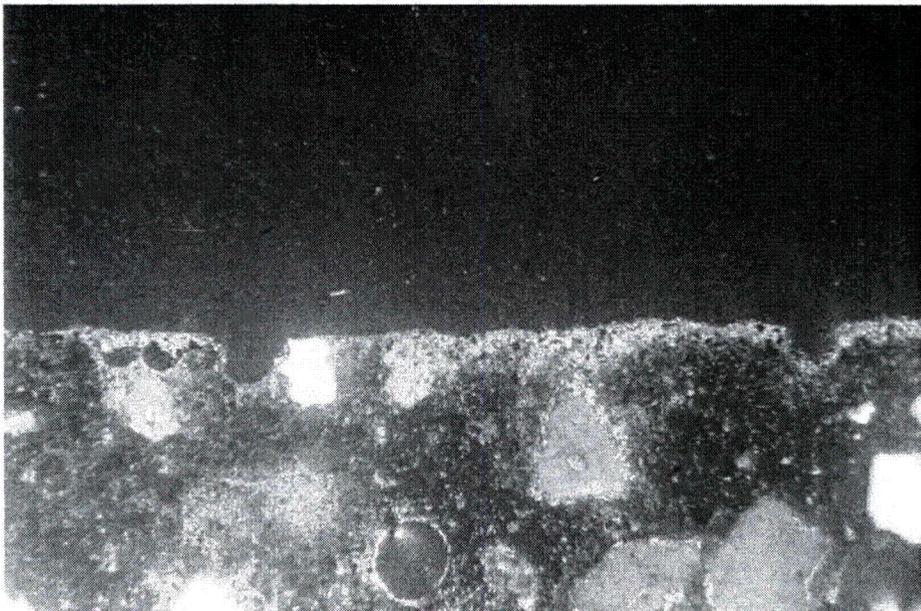
Photograph #12	Remarks

Photomicrograph in plane polarized light showing the fractured surface. Width of view is approximately 0.05 inch.

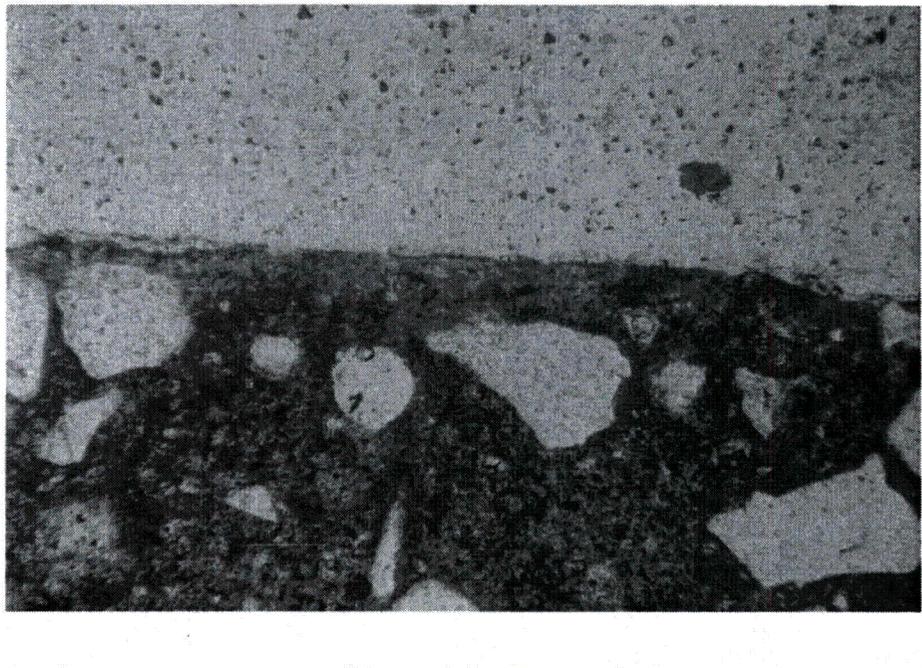
Photograph #13	Remarks

A photomicrograph showing a fractured concrete surface. The top half of the image is a relatively uniform, light gray area. A dark, irregular horizontal line separates this from the bottom half, which is filled with a complex, dark matrix containing several large, light-colored, angular fragments of aggregate. The overall appearance is that of a fractured concrete core.	Photomicrograph in plane polarized light showing the fractured surface. Width of view is approximately 0.05 inch.

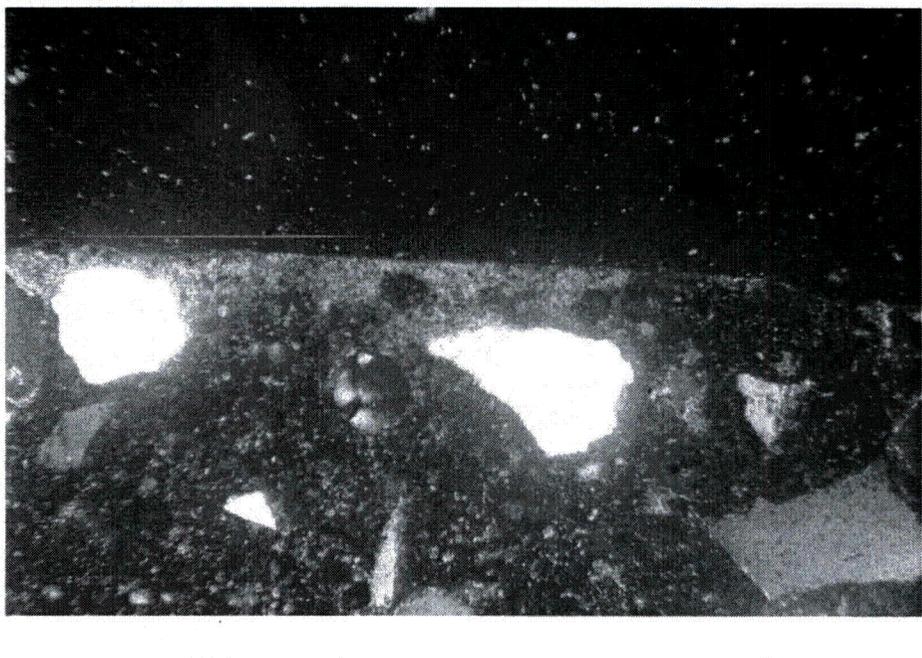
Photograph #14	Remarks

A photomicrograph showing a fractured concrete surface. The top half of the image is a dark, almost black area. A light, irregular horizontal line separates this from the bottom half, which is filled with a dark matrix containing several large, bright, angular fragments of aggregate. The overall appearance is that of a fractured concrete core.	Photomicrograph in plane polarized light showing the fractured surface. Width of view is approximately 0.05 inch.
