## 9.3 Ground Movement (sink holes or geo-sliding)

<p><b>Description:</b> Ground movement caused by sink holes and/or dissolution of the limestone under the containment can result in lack of foundation support.</p>	
<p><b>Data to be collected and Analyzed:</b></p> <ol style="list-style-type: none"><li>1. Geo-technical report – Gilbert Geotechnical Study Section 1.2.11 (1971) (FM 9.3 Exhibit 1)</li><li>2. FSAR Chapter 2 Section 2.5.7.2 (FM 9.3 Exhibit 2)</li><li>3. E-mail from Glen Pugh to Craig Miller (FM 9.3 Exhibit 3)</li><li>4. Buttress and Dome Survey Data (FM 9.3 Exhibit 4)</li></ol>	
<p><b>Verified Refuting Evidence:</b></p> <ol style="list-style-type: none"><li>a. The limestone supporting the containment was cement grouted to assure the continuity and integrity of the material. (FM 9.3 Exhibit 1)</li><li>b. There is no record of an observation of building cracking or sinkhole consistent with FSAR conclusions. (FM 9.3 Exhibits 2 and 3)</li><li>c. The Buttress and dome survey data show that the containment structure remains plum and the containment has not settled. (FM 9.3 Exhibit 4) See FM 1.5 for a more detailed discussion.</li></ol>	<p><b>Verified Supporting Evidence:</b><

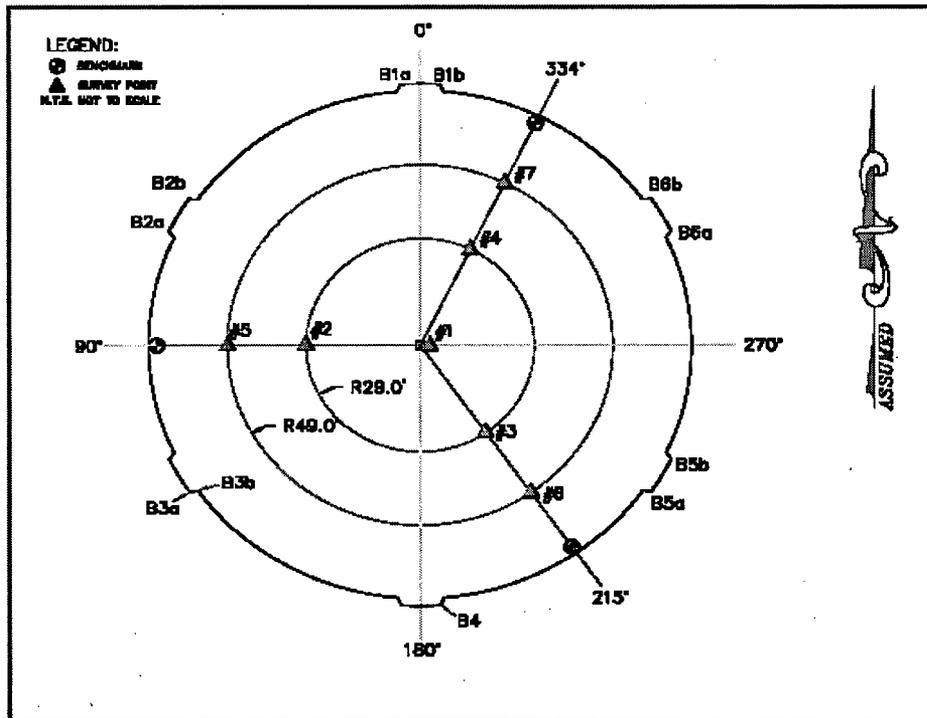
Attachment 1

The current survey of the dome was performed using SP-180 as a guide. The original benchmark and survey point pins were found on the surface of the dome. Elevations were taken at each of the benchmarks and survey points. Delta elevations were determined by subtracting the elevation of each survey point from the average of the three benchmark elevations. The change in elevation is shown below as well as the original acceptance criteria and the results from the last survey performed in 1982.

The % change from the 1982 survey is considered insignificant with respect to detecting a change in the structure similar to the delamination found between buttress 3 and 4. In addition, a review of the boroscope video of the seven core bores in the dome did not find any delamination.

\*The top two survey points were compared and found to have a lateral offset, from the highest to lowest survey point, of 0.9" in the East direction over a length of 6.8'. Surface variations exist that can cause a shift in lateral locations. The lateral offset for this location is reduced to less than 3" by eliminating the highest survey point.

- Uneven surfaces between placements along form edges
- Cosmetic grout repairs along the face of the buttresses along the corner causes a radial change in to or out of the plane of the buttress
- Corners exhibit loss of cover concrete along the tendon bearing plate area, which causes a shift in lateral location of the corners

These conditions affect the accuracy of the survey data. As noted above, eliminating one survey point at Buttress ID B1b reduced the lateral offset by 0.9". The vertical alignment tolerance provided in ACI 117-90 is considered to be satisfied based on the localized surface variations affecting the accuracy of the survey data.
