**From:** Chou, Rich  
**Sent:** Wednesday, December 02, 2009 9:02 AM  
**To:** Lake, Louis  
**Cc:** Franke, Mark; Sykes, Marvin; Ninh, Son; Morrissey, Thomas; Reyes, Rogerio; Chou, Rich; Powell, Sid  
**Subject:** FW: Monday NCRs  
**Attachments:** 0015\_insideAverage Moblity.jpg; Nov 21 markup - Containment Unfolded Graphics\_IR Mosaic.pdf

# Containment "Unfolded" – Buttress 2 to 5

Updated Nov 20<sup>th</sup> (Mosaic IR Overlay scale is approximate)

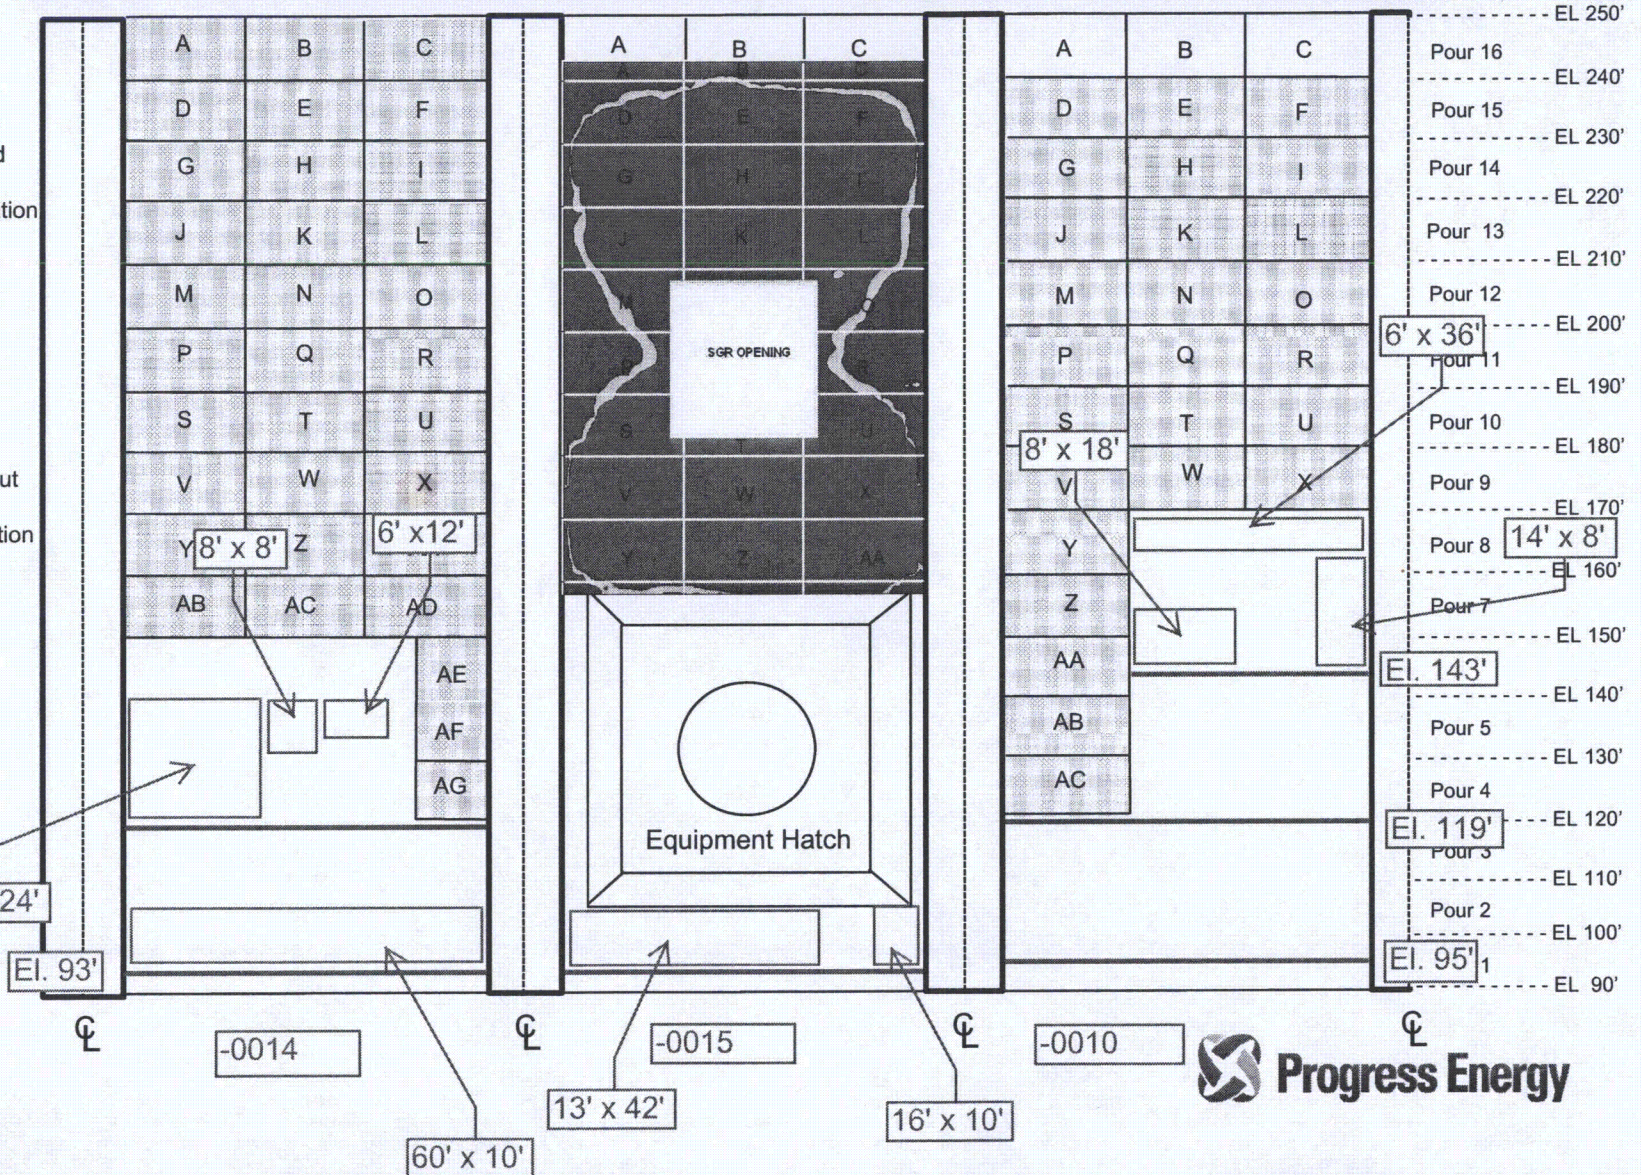
The first file is the scan data for the area below the equipment hatch. The red indicates where the crack was found. The second file is the layout of 180 degrees of the building. The scan data in the first file is the 13' x 42' rectangle below the equipment hatch

NCR 368389 identified a crack in the containment wall inside the Intermediate Building in the area below the equipment hatch based on the Impulse Response (IR) Testing and confirmed by Core Boring. The Core Boring was in the vicinity of the **highest average IR mobility value** and the crack width or gap was measured at 0.009" to 0.016" which is equivalent to 1/64". Please provide the picture or drawing to show the exact location and more detail information.

IR scans completed per PT-407T:  
Blue = no delamination

Actual IR scan output data:  
Blue = no delamination  
Yellow = transition  
Red = delaminated
