PROJECT: CRYSTAL RIVER UNIT NO. 3 GROTHER:	NONCONFO	ER CORPORATION ORMANCE AND ACTION REPORT	Green: Pink:	Quality Engineer Dir. Gen. Construction Mgr. Gen. Q. & S. Extra Copy

Pour #528 R.B. buttress 3 to 4, @ el. 98, contained a "lens" type void, approximately 6' long x 2" thick x about 12" deep.

CRYSTAL RIVER UNIT #3

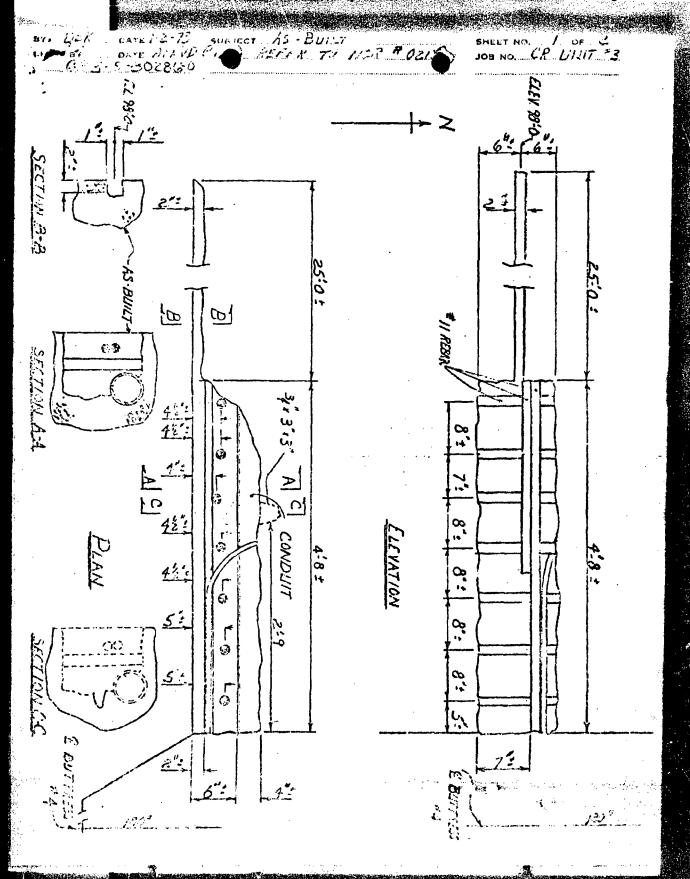
SECTION A-A

SECTION C.C.

SECTION 8-B

This "lens" was caused by failure to remove sand blast sand from the depression into which it accumulated, prior to concreting. Similar condition occurred in pour #644 R.B.

I] CHIP CAVITY SUCH THAT TOP SLOPES 1:3 OR STEEPER

2) COAT DUST-FREE, DRY SURFACES WITH EPOXY BONDING COMPOUND.

3.1 POUR WITH DM-7, 39" STONE MIX, 5000 PSI, 70°F, 3" SLUMP MAN

4.) MOIST CURE FOR TORYS

I) WET CONTACT SURFACES & FILL WITH PORTLAND CEMENT & SAND DRYPACK

To avoid recurrence, it is vital that a final thorough cleanliness inspection be made immediately before actual placement of concrete.
