Crystal River Unit #3 Containment Delamination Investigation

07/08

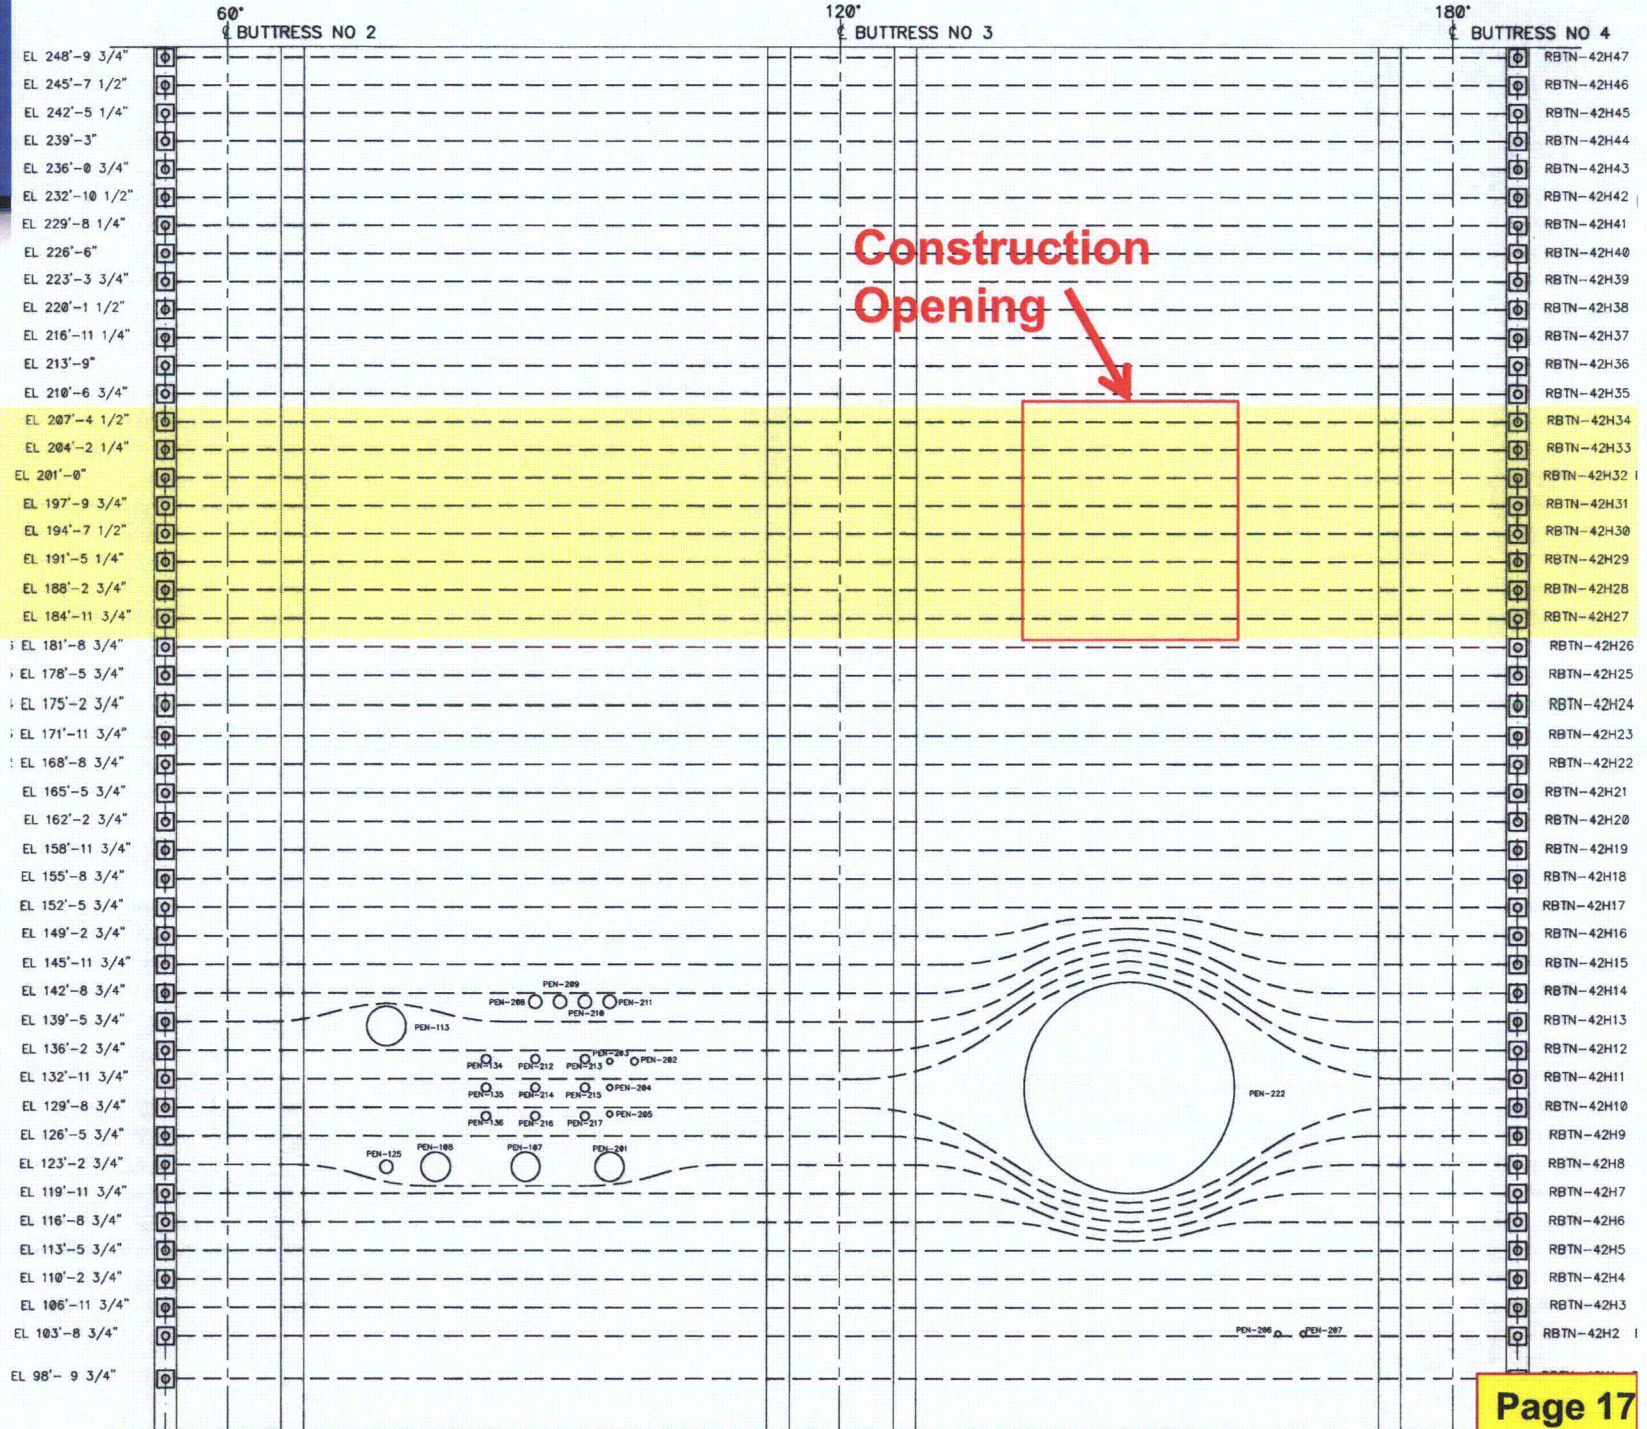
Horizontal Tendons Buttress 2 - 4

**Tendons
Removed**

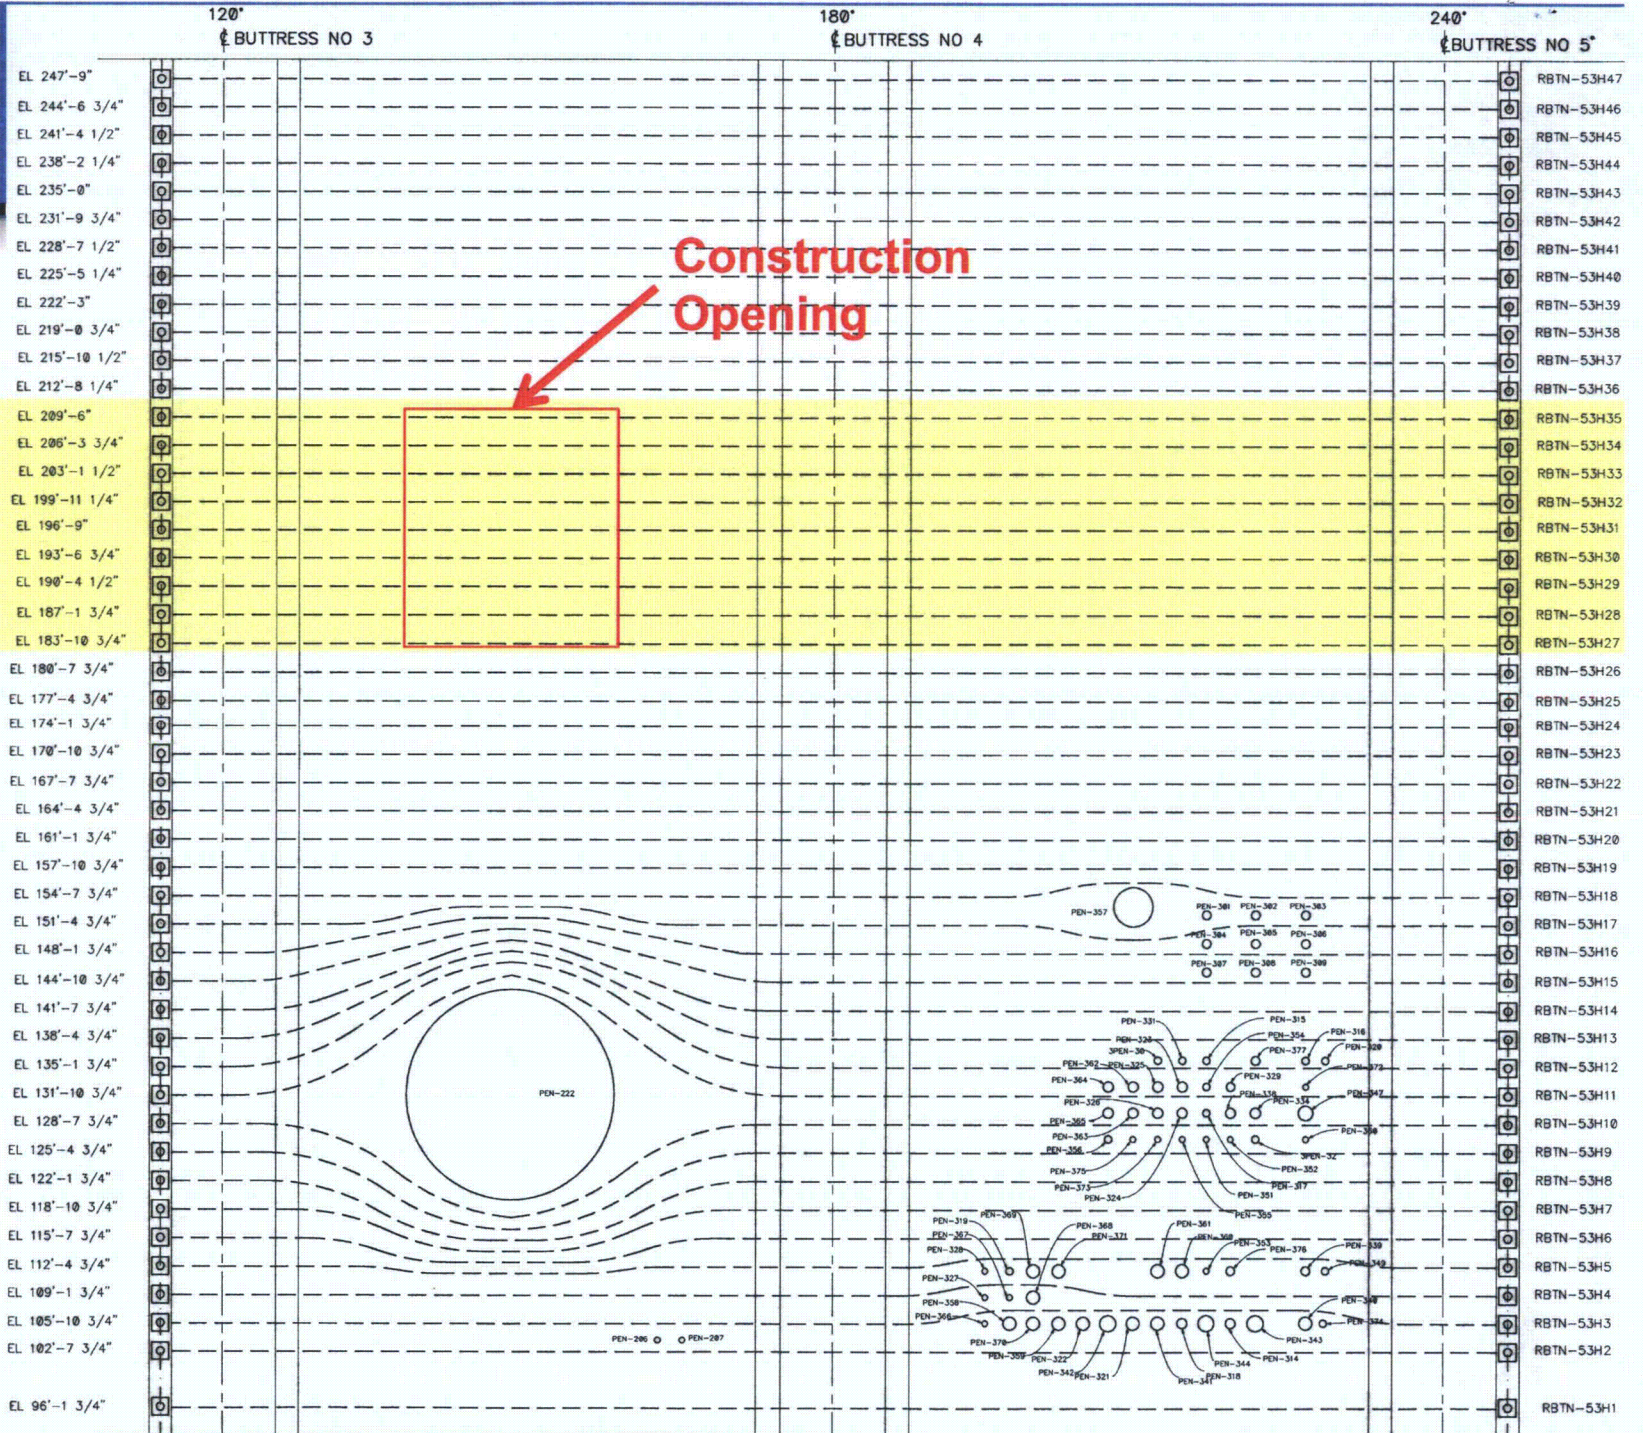
Horizontal Tendons Buttress 3 - 5

**Tendons
Removed**
