**From:** Lake, Louis  
**Sent:** Friday, December 04, 2009 12:37 PM  
**To:** Dan naus; Masters, Anthony; Carrion, Robert; Thomas, George  
**Cc:** Chou, Rich  
**Subject:** FW: Requested Information  
**Attachments:** Request for Information - Core #54 Attachments.pdf; Request for Information - Core #54.docx  
**Categories:** Perform Review

The attached files reflect the current information available on core bore #54 located below the equipment hatch.

## Core Bore #54 Information

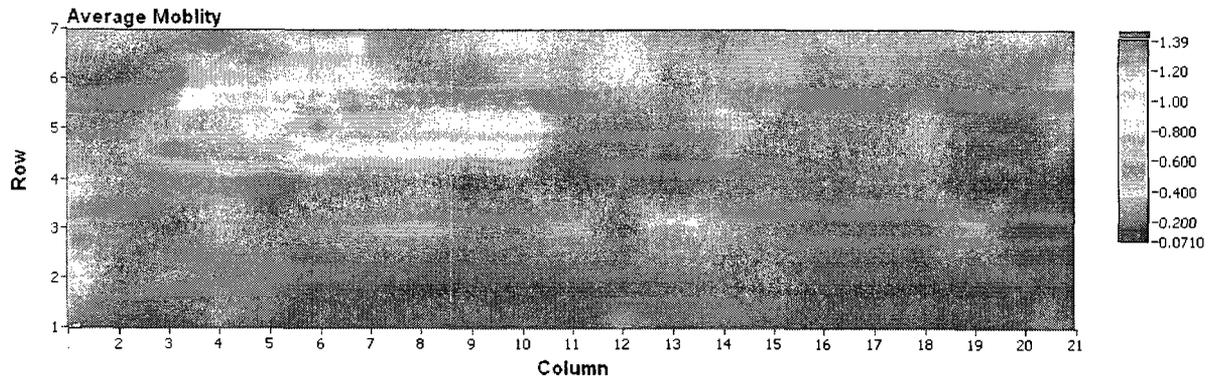
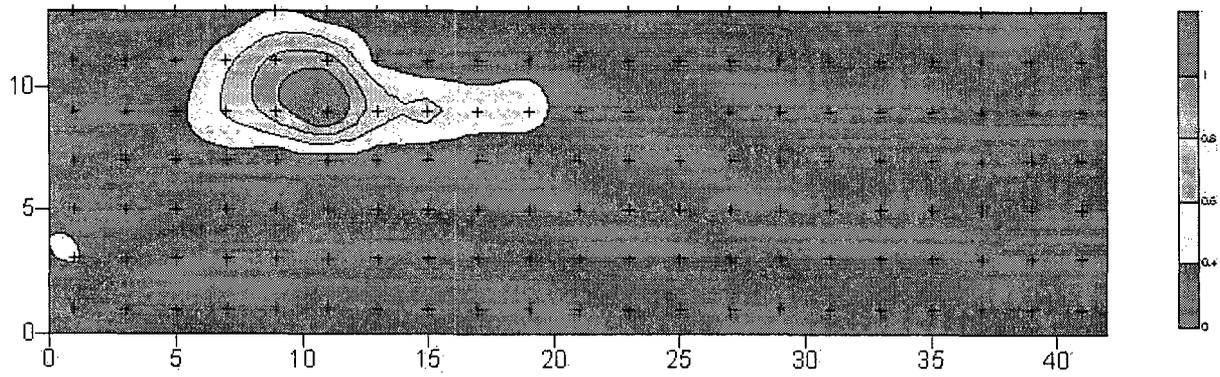
PT-407T, Enclosure 8, for bay designation RBCN-003B, documents an IR mobility range of 0.071 to 1.391. Core bore #54 was made near the scan grid point with the highest IR mobility value. Attachment 1 shows the graphical image of the IR data showing the anomaly area. The first image is the smoothed and the second shows the 0.20 increments. The outer boundary of the anomaly is shown in yellow and graduated by 0.20 increments to 1.0. PT-407T includes the following threshold values:

The area with an IR mobility value above 1.0 is approximately 4 sq. ft. The area within the “grey” range is approximately 48 sq. ft.

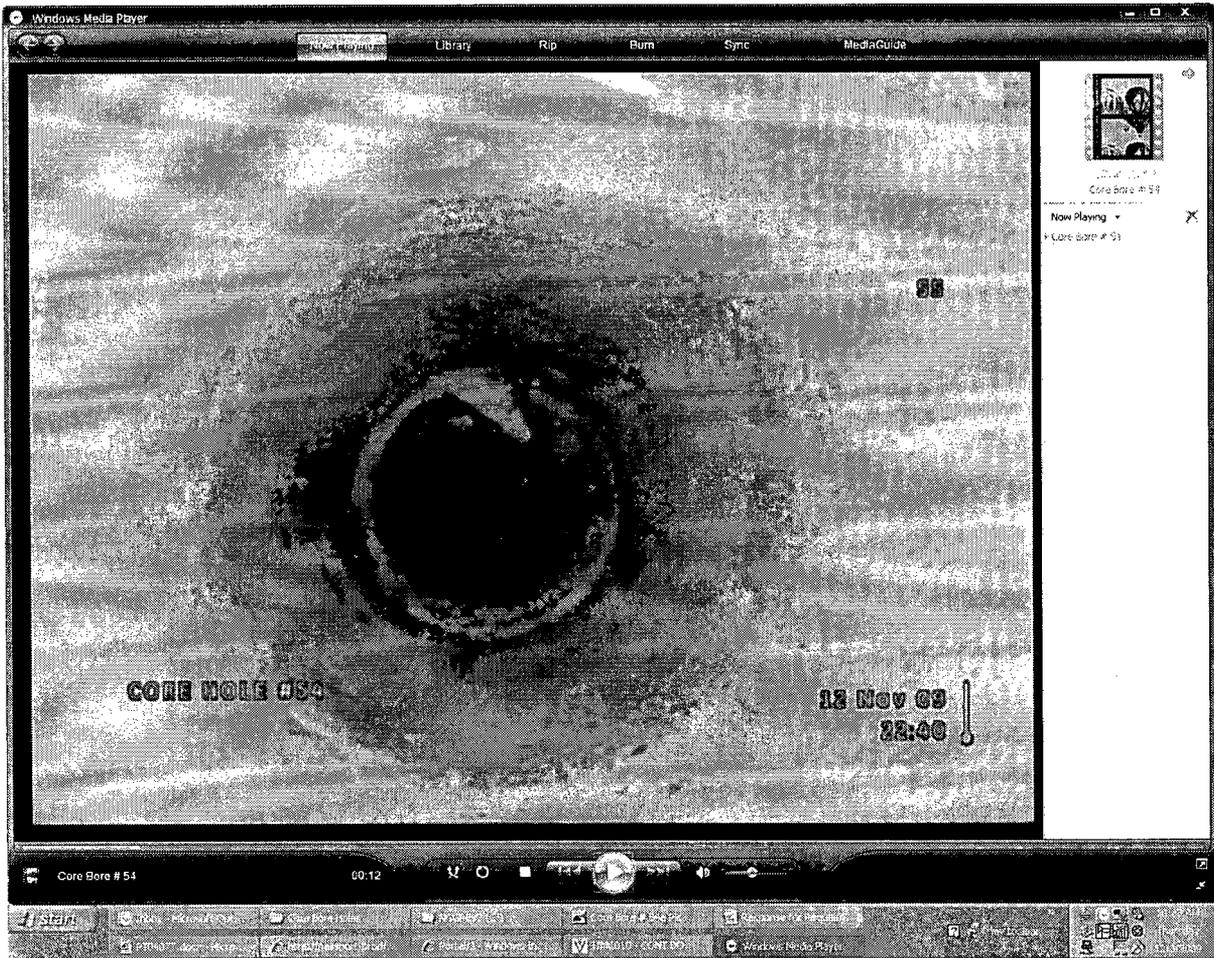
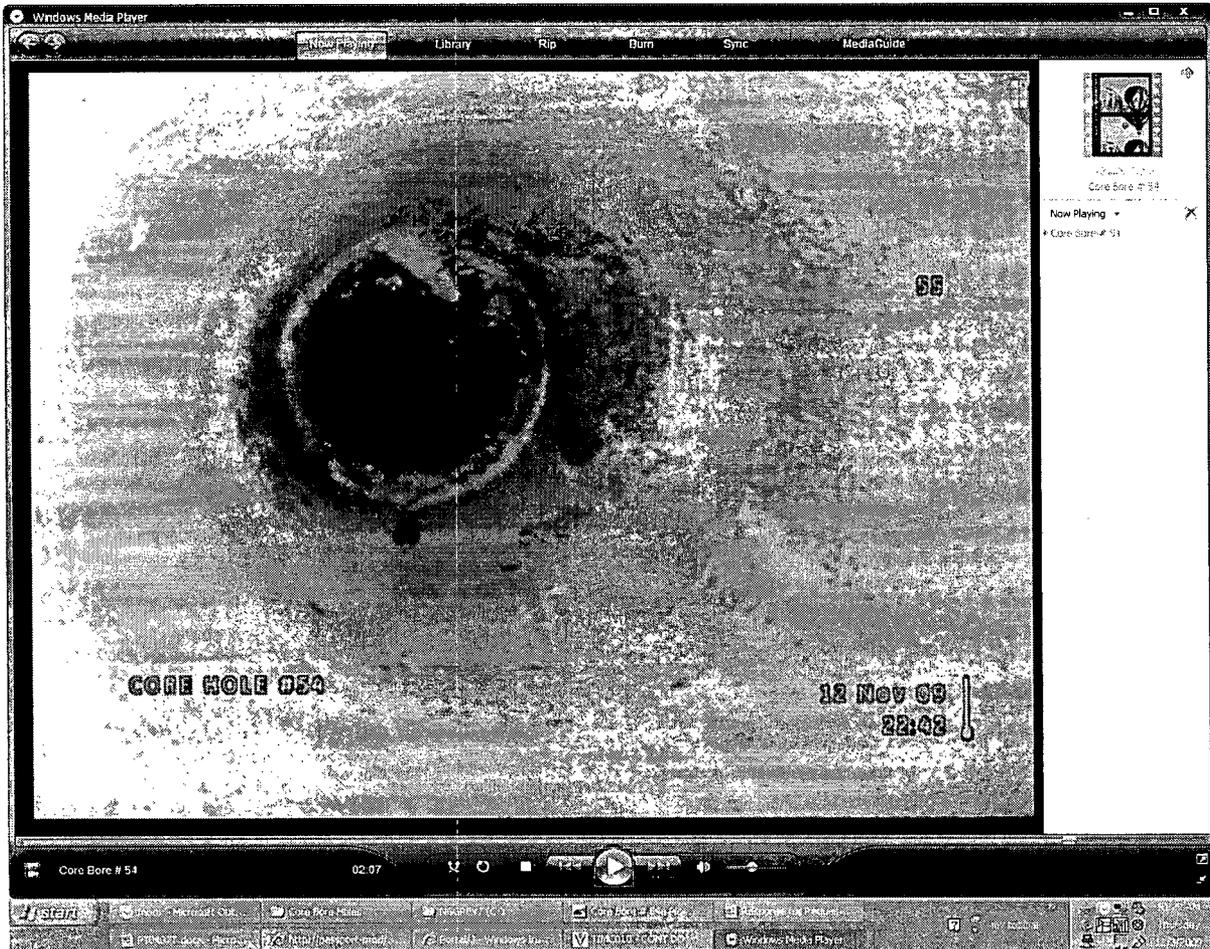
Attachment 2

Video image of 2" diameter core

A 2” diameter core bore was first drilled at the anomaly. The boroscope video revealed an area that appeared to be a crack or damage caused during the drilling process. A 4” diameter core bore was made over the 2” hole in an effort to better characterize the anomaly. The boroscope video clearly showed a crack that was mostly in the plane of the wall but did have ligaments that changed direction. The crack was shown to propagate through aggregate. (See Attachment 2)

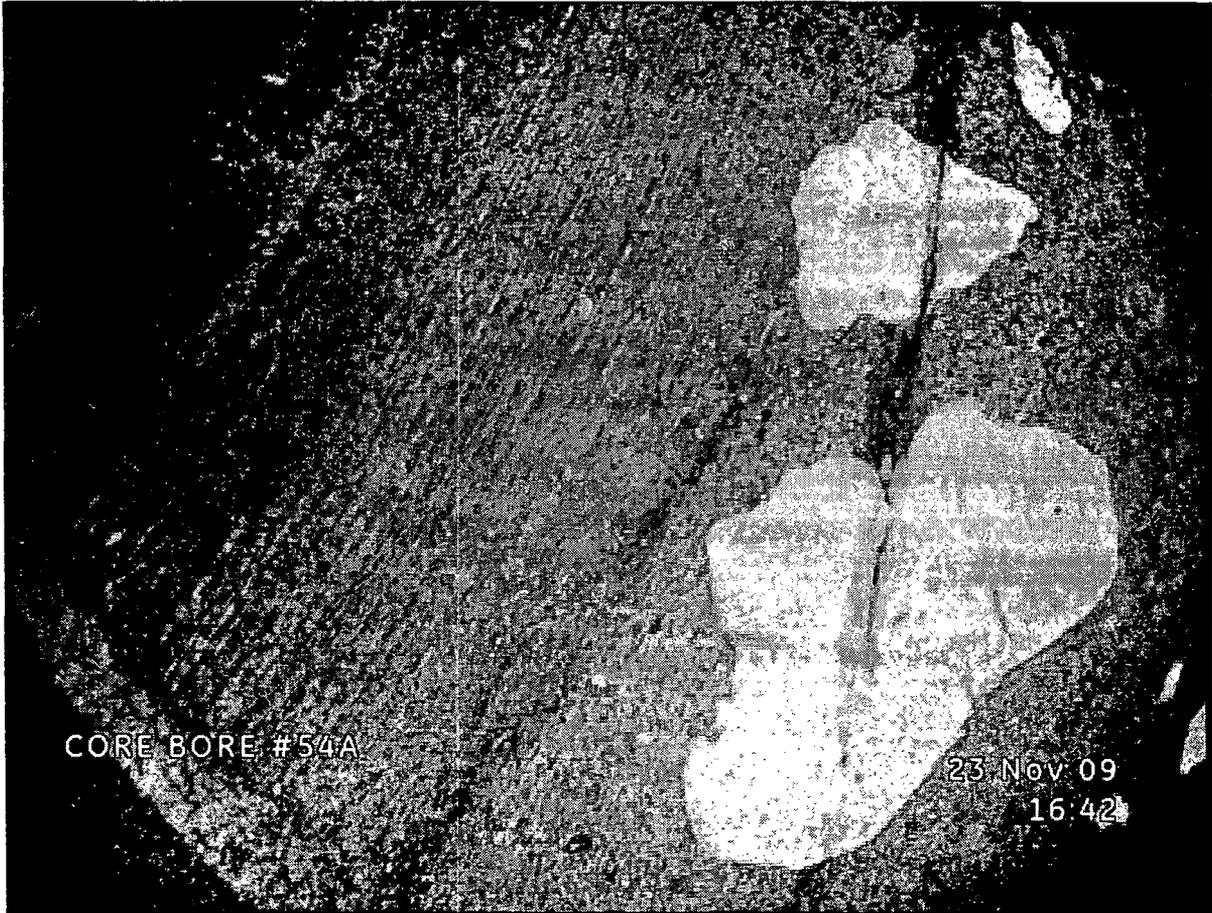
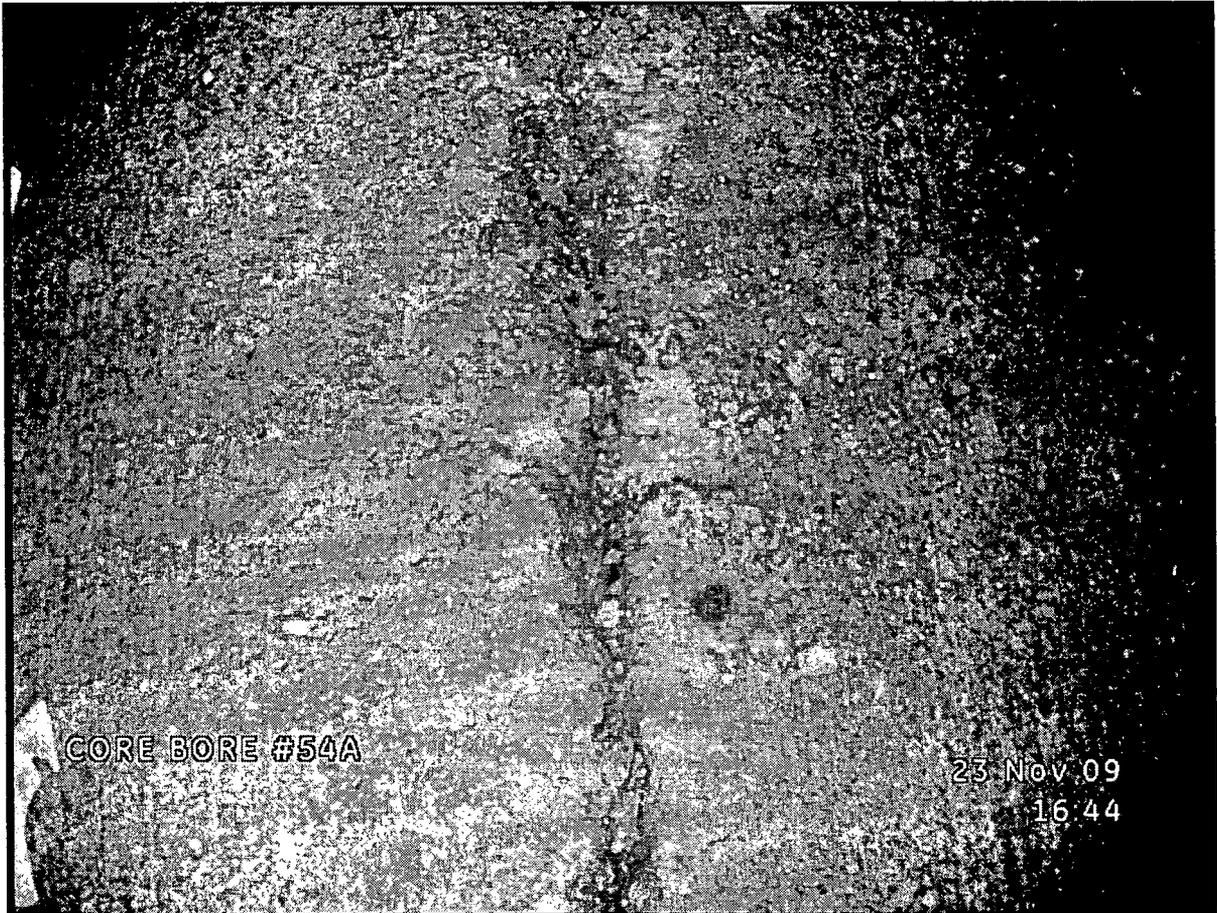
Attachment 2

Video image of 4" diameter core

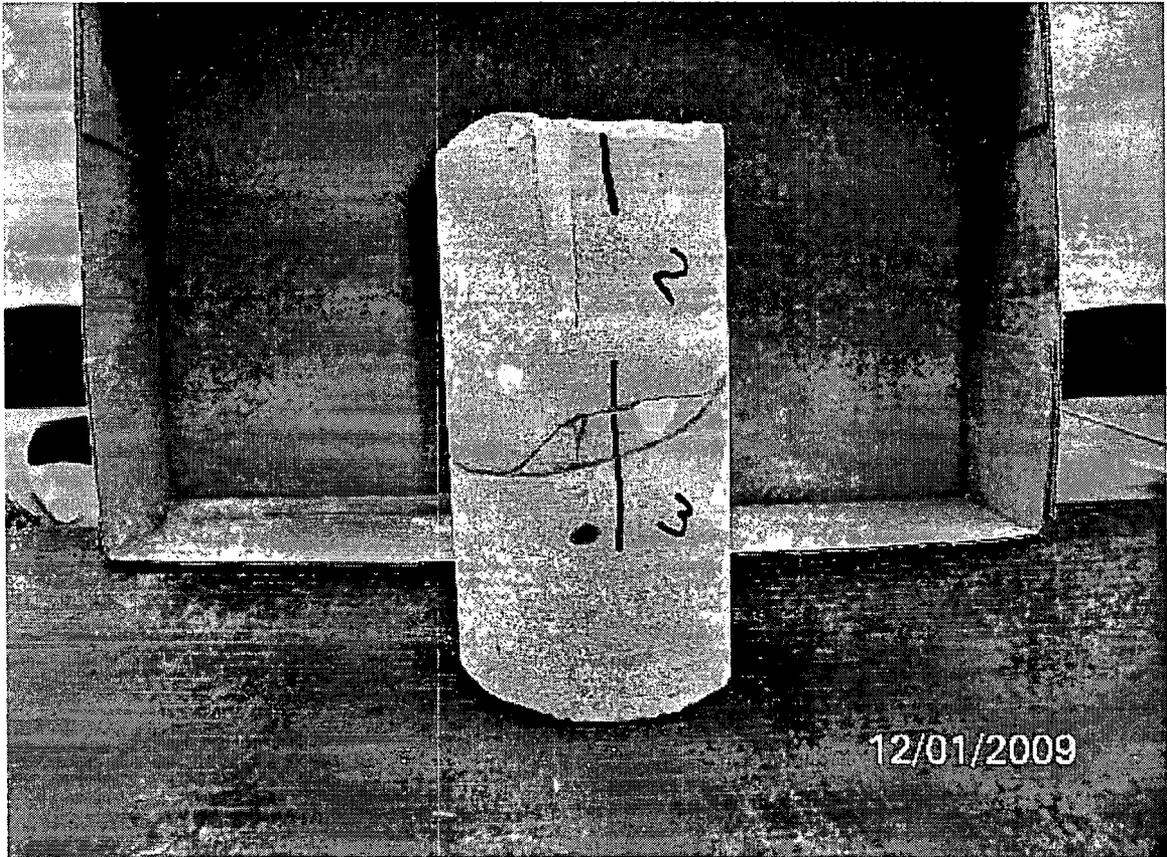
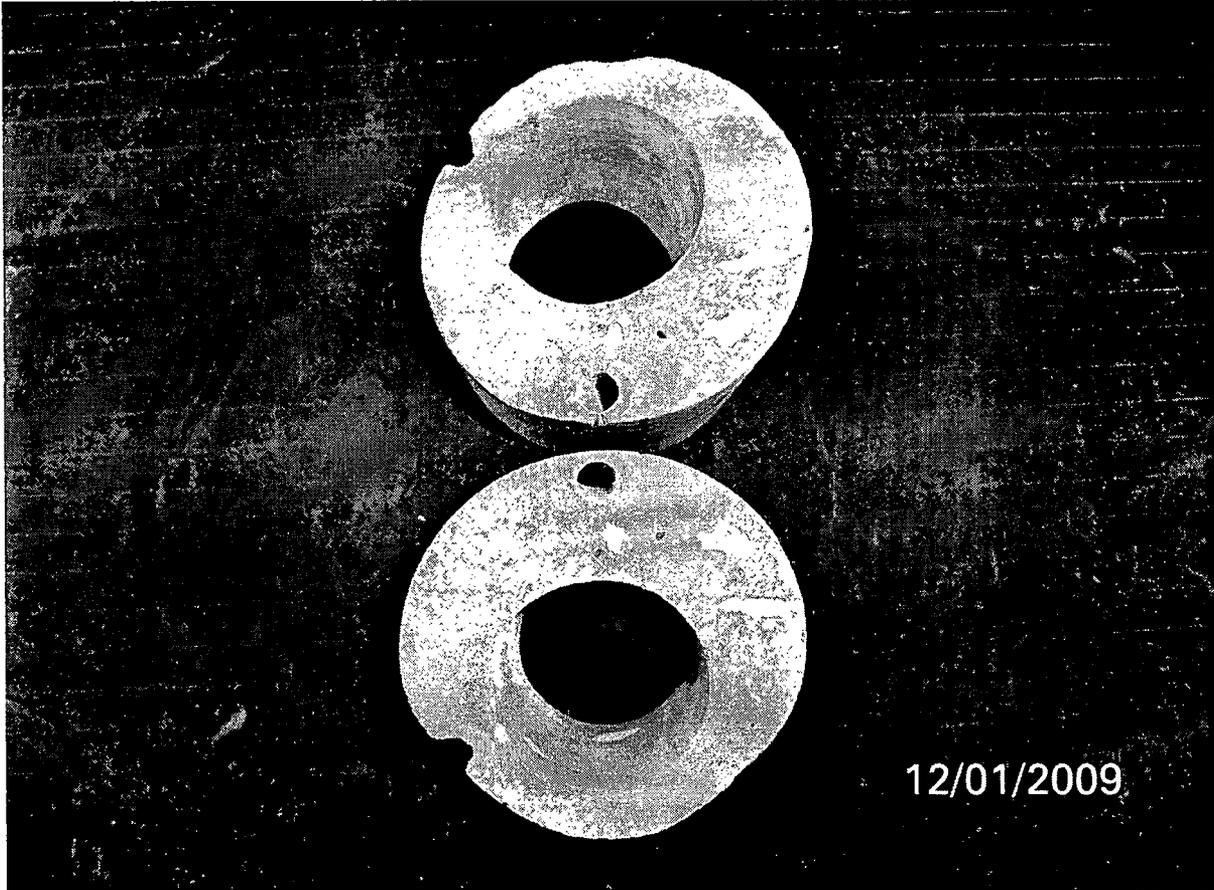
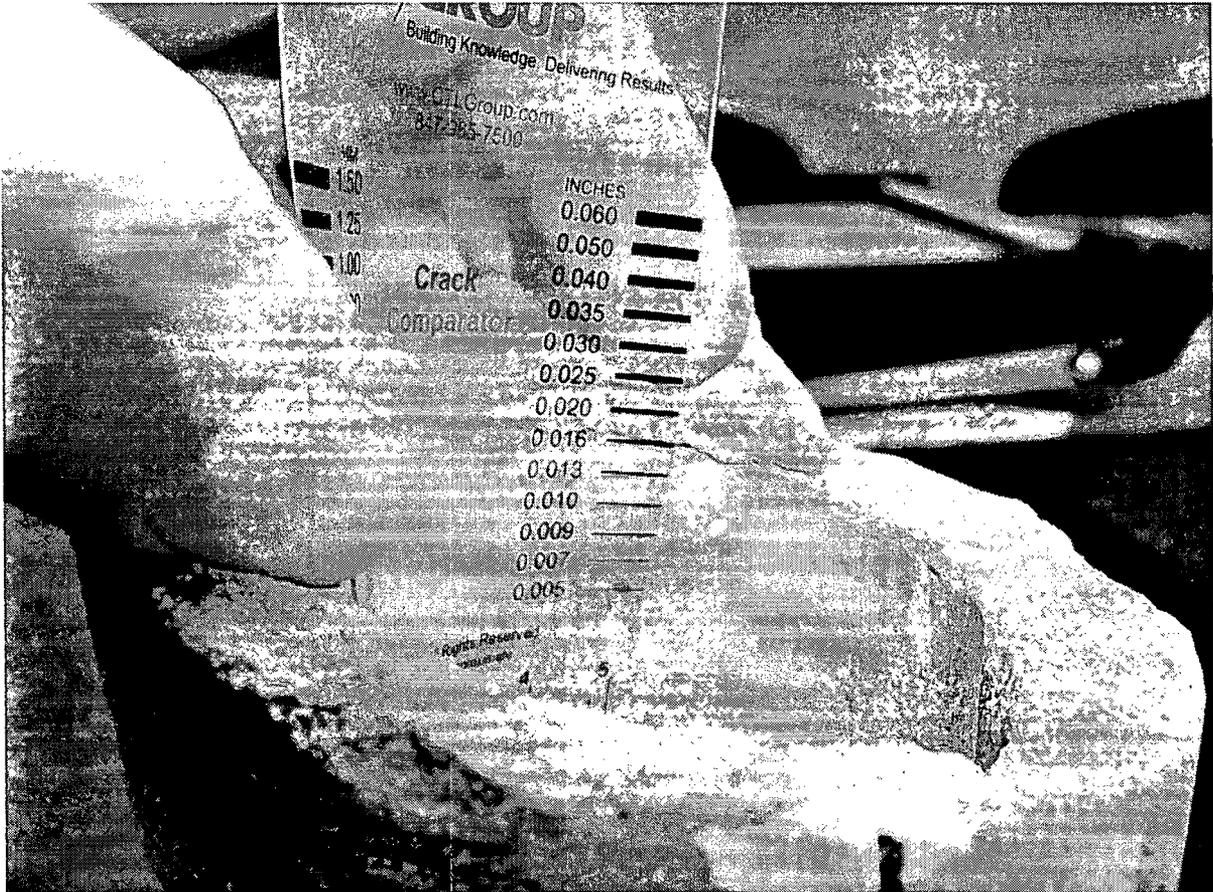
Attachment 3

The inspection of the sample confirmed the boroscope inspection. The crack is mostly in the plane of the wall but did have ligaments that changed direction. A portion of the sample where the change in direction was seen was detached from the sample. The crack at this interface was measured to be ~0.016" with smaller measurements seen near 0.009". Piece #2 and #3 interface showed aggregate that the crack passed through as well as the small portion that was detached. The difference in hardness of the paste and aggregate was investigated by performing a scratch test. This is a test used by geologists to identify minerals based on Mohs scale of hardness. A pointed metal awl was used to scratch a piece of aggregate as well as the paste in the sample. Four similar scratches, one directly over the other, of similar force were made. The scratches in the aggregate produced a noticeable groove with powder residue. The scratches in the paste produced a barely noticeable groove with little or no residue. This simple test would indicate that the paste is harder than the aggregate. (See Attachment 3)

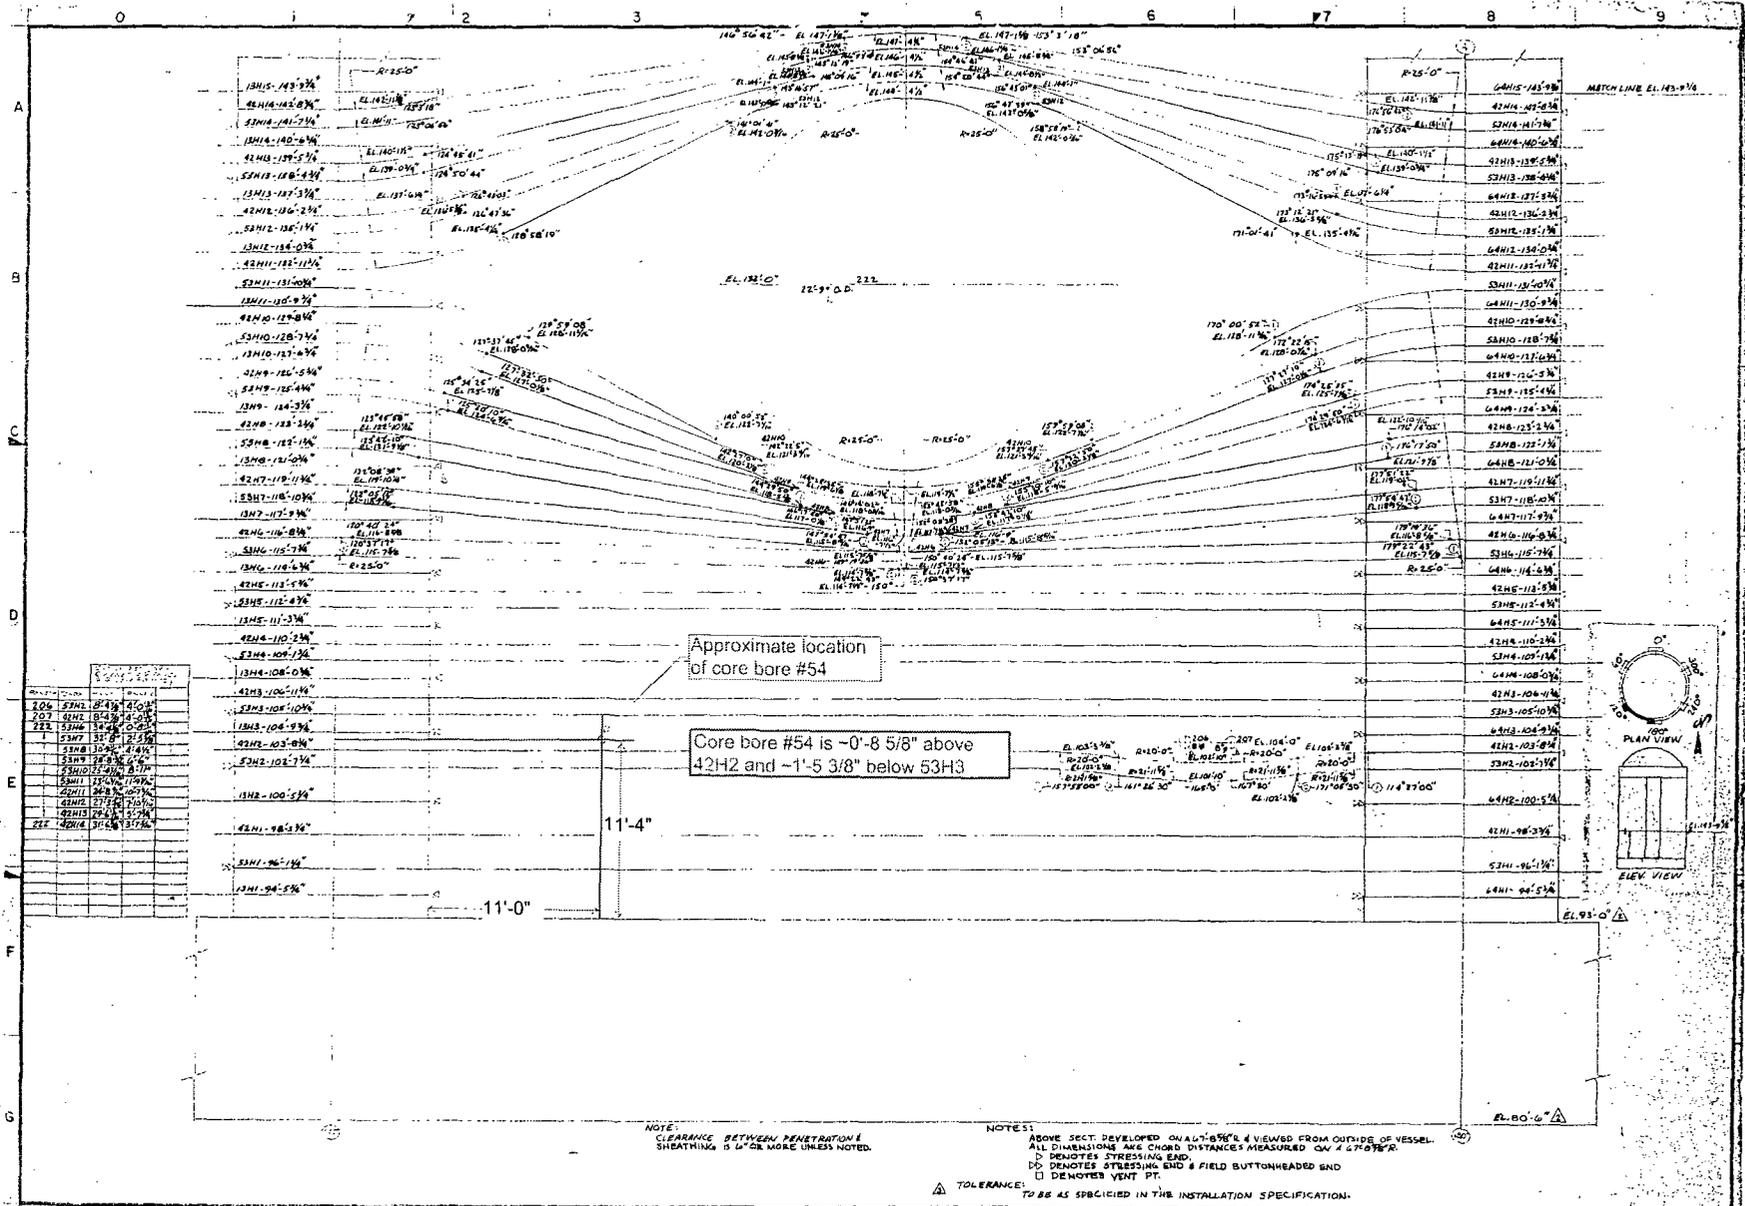
Approximate location of core bore #54

Core bore #54 is -0'-8 5/8" above 42H2 and -1'-5 3/8" below 53H3

Core #54 is located at approximately 134.5 degrees at 104' 5 3/8". This location is between vertical tendons 34V18 (136° 15'), 34V19 (133° 45') and horizontal tendons 42H02 (103' 8 3/4"), 35H03 (105' 10 3/4"). No tendons in this general area have been detensioned in prior surveillances. (See Attachment 4)
