# 3.1 Inadequate Air Content

Reported herein are the results of petrographic studies of a concrete fragment submitted by J. Artuso of Construction Engineering Consultants. The specimen is from the dome of the containment structure of the Florida Power Corporation, Crystal River, Unit III.

**Petrographic Examination of Concrete Half  
Core from Delaminated Containment Wall,  
Crystal River, Florida**

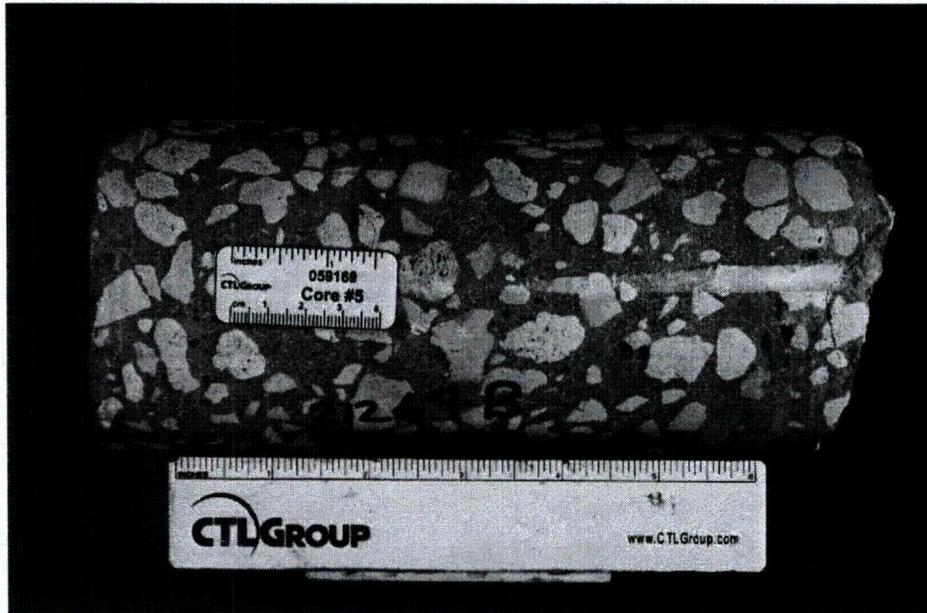
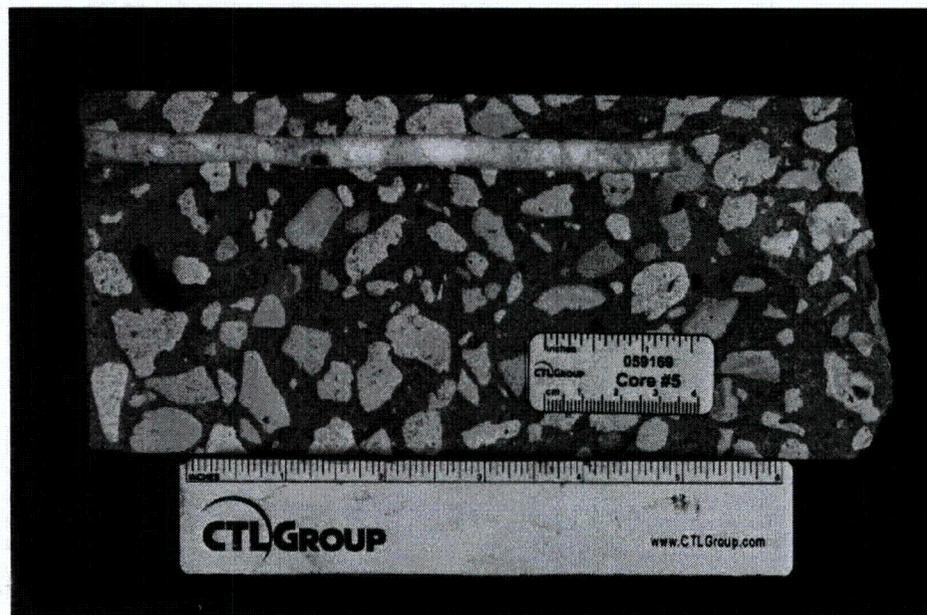
Fig. 1 Side views of Core #5, as received for examination.

1a. Curved surface. Outer end is to the left.

1b. Saw cut surface. Outer end is to the left

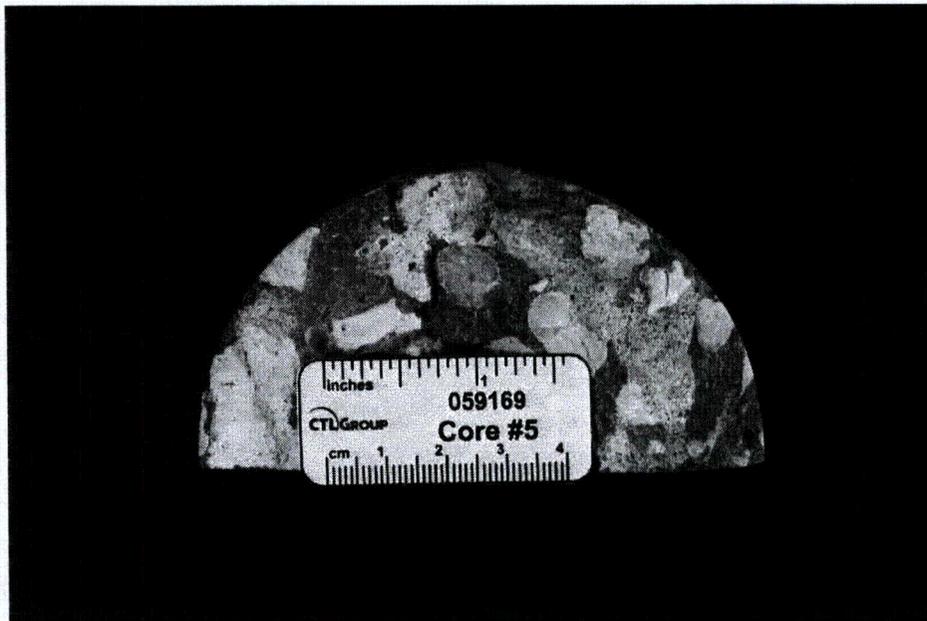
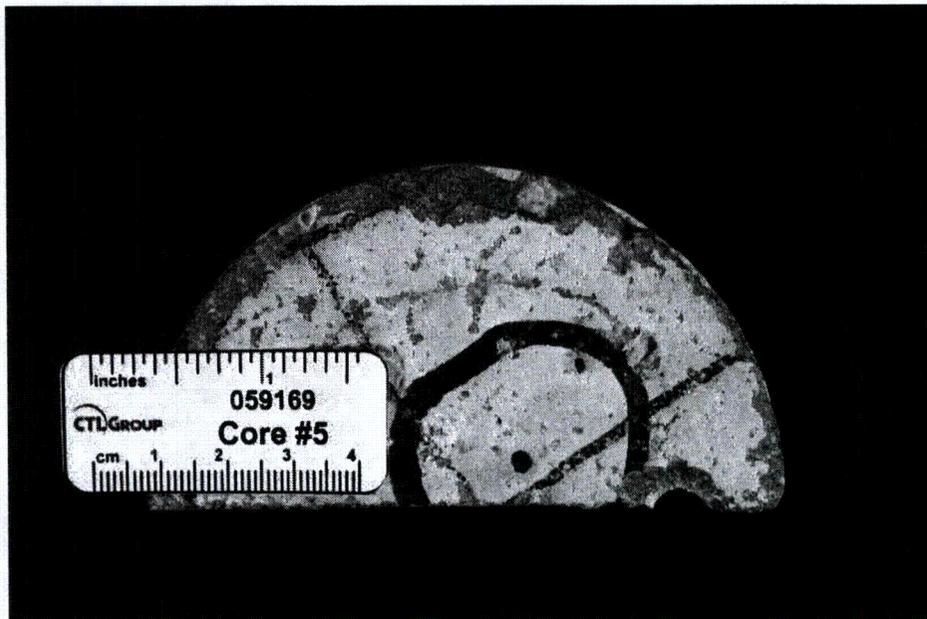
Fig. 2 End views of Core #5, as received for examination.

2a. Inner end.

2b. Outer end.

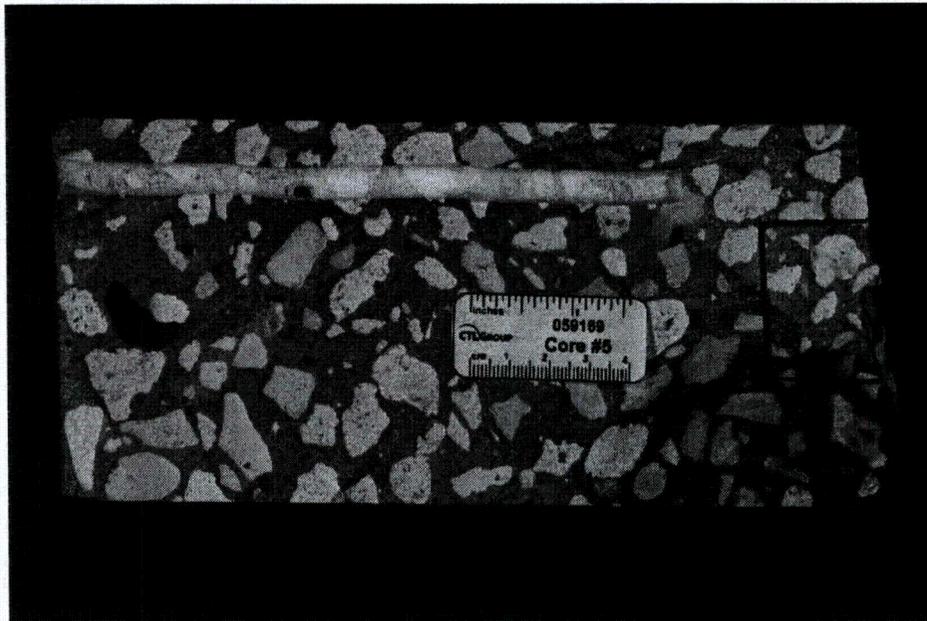
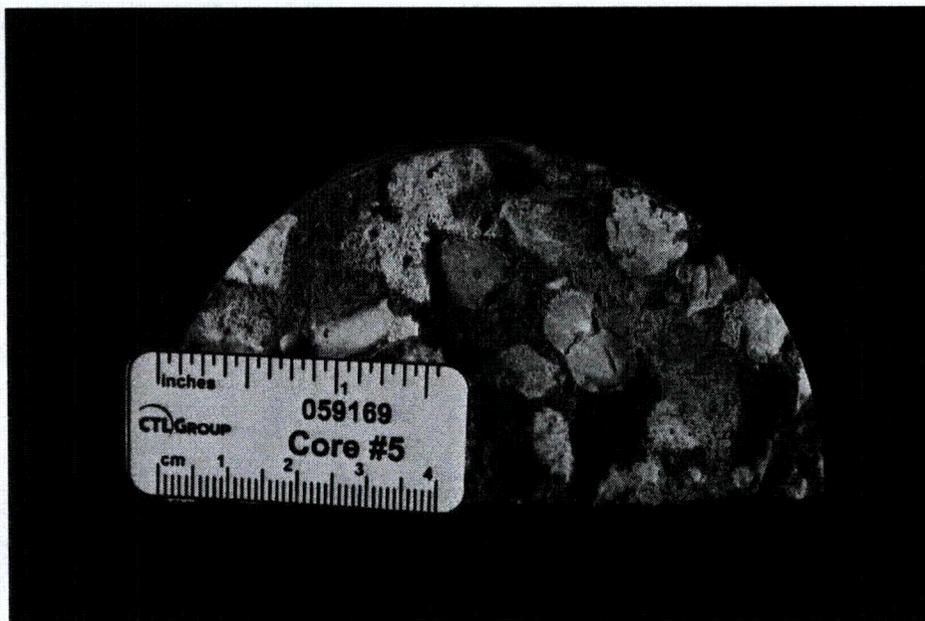
Carbonation to any significant depth from the fracture surface into the outer concrete is not observed (Fig. 3). Incipient carbonation is exhibited in thin section at the immediate fracture surface (Fig. 6a). However, an older delamination surface that was not exposed to air due to the depth of outer concrete, and other possible wall coverings, may also have such an absence of carbonation.

3a. Saw cut side. Outer surface is to the left.

3b. Fractured inner end.

**Fig. 3** Views of the portions of Core #5 treated with phenolphthalein, a pH indicator. All the pink regions exhibited denote the limits of where the indicator was applied. No colorless, low pH (carbonated) regions were observed at the fractured end regions.

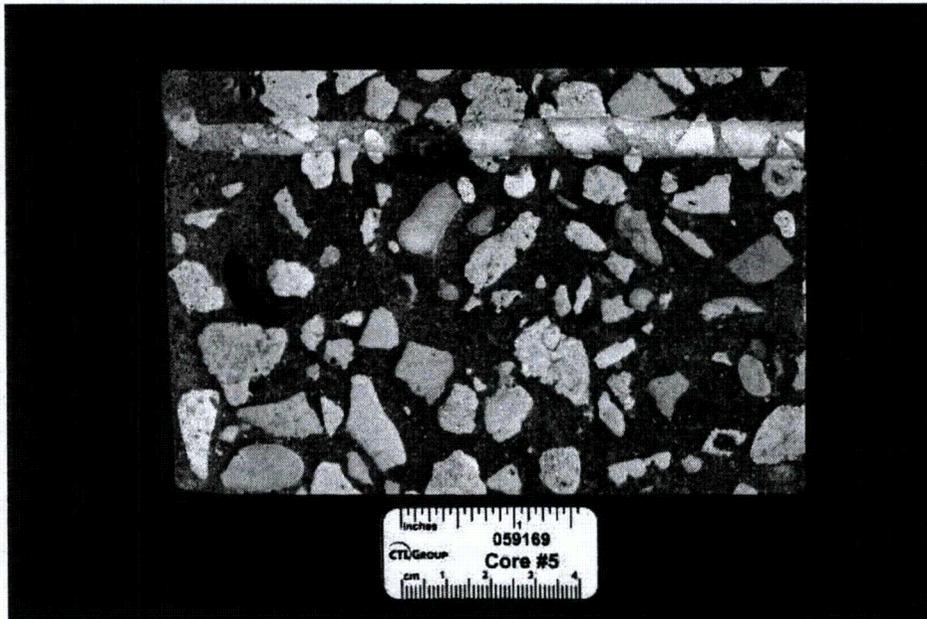
The concrete represented by Core #5 is well consolidated and free of any cracks or excessive microcracks (Fig. 4). The concrete consists of crushed carbonate rock coarse aggregate and natural sand fine aggregate, well distributed in a portland cement paste. No evidence is exhibited of any deleterious chemical reactions involving the cement paste and / or aggregates. The concrete could be considered marginally air entrained based on an approximate volume of 1 to 2% of small, spherical entrained air voids in the hardened cement paste (Fig. 5).

**Fig. 4** View of the lapped surface of a portion of Core #5 showing the general appearance of the concrete.

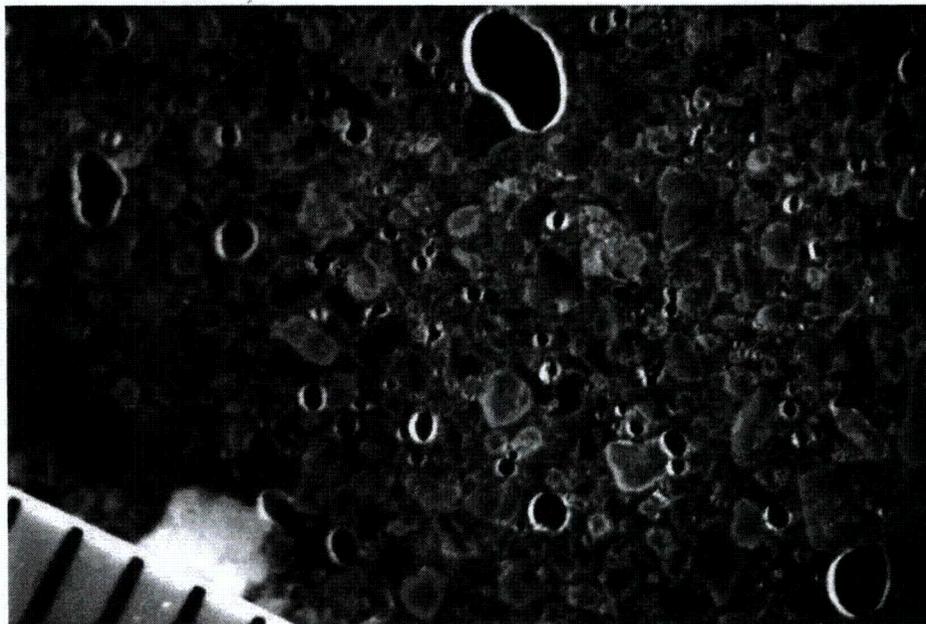
**Fig. 5** View of the concrete hardened air-void system of Core #5 illustrating the moderate quantity of both coarse and fine air voids. Scale is millimeter increments.

**Air Content:** Estimated 2 to 4% total. Approximately 1 to 2% of the total air is larger entrapped air voids of up to 3 mm (0.12 in.) in size, plus a few large voids of 4 to 10 mm (0.16

to 0.4 in.). Somewhat uneven distribution of voids. Marginally air entrained based on the very low volume of moderate to small sized spherical air voids in the hardened cement paste.

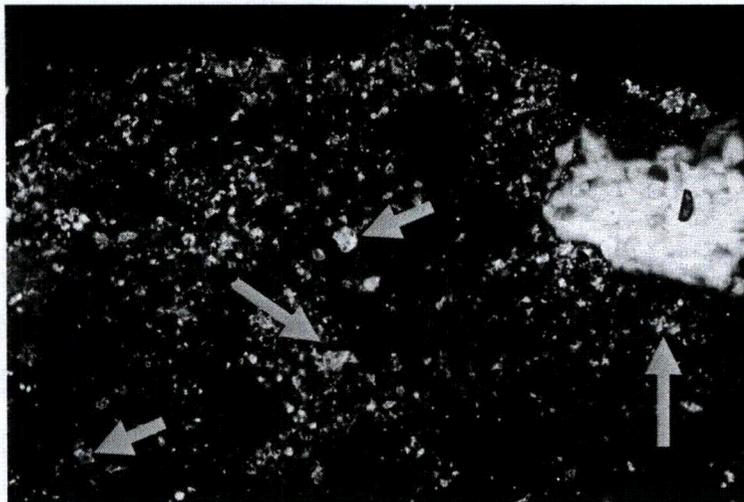
**6a. Crossed-polarized light view of the paste adjacent to the inner fractured surface. Only incipient carbonation is indicated by the speckled high birefringence colors in the paste. Carbonate fines are arrowed yellow. Width of view is approximately 0.5 mm.**

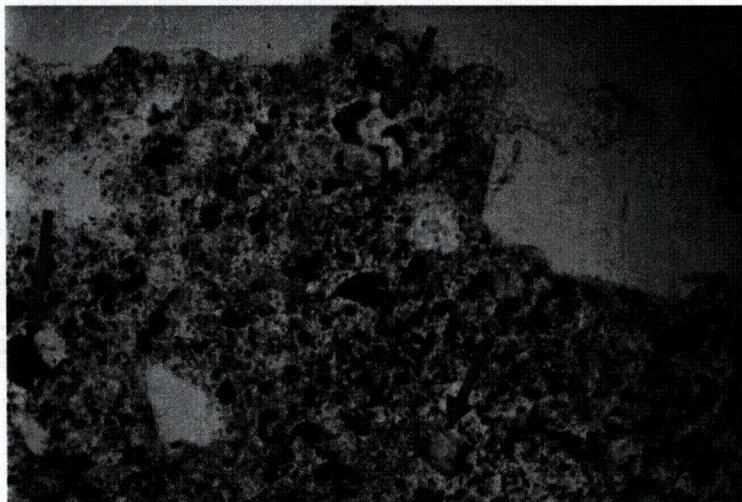
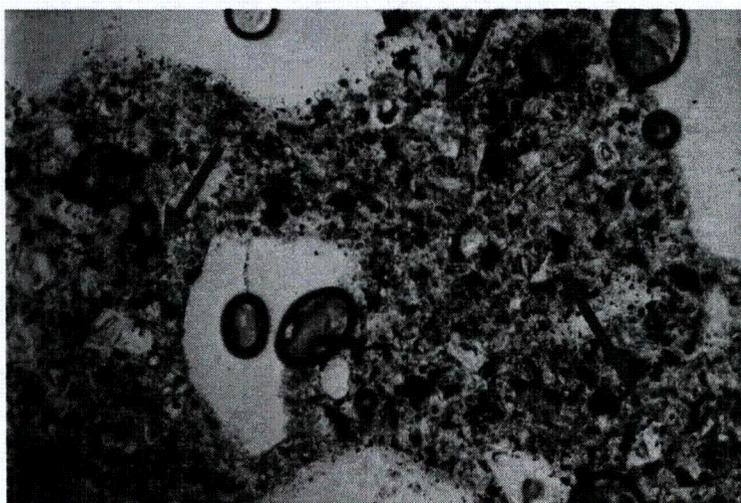
The cement hydration adjacent to the fracture is well advanced and comparable to that of the body of the core (Figs. 6b and 6c). This suggests that there was no moisture ingress to the fracture surface, over a period of time long enough, to change the general degree of hydration. This is supported by an absence of secondary deposits within air voids adjacent to the fracture surface.

**6b. Plane-polarized light view of the paste adjacent to the inner fractured surface (same field of view as 6a.). A low to moderate number of unhydrated and partially hydrated cement particles (arrowed red) are exhibited by the paste. The amount is comparable to that in the body of the core in Fig. 6c. below. Width of view is approximately 0.5 mm.**

**6c. Plane-polarized light view of the paste in the body of the core. A low to moderate number of unhydrated and partially hydrated cement particles (arrowed red) are exhibited by the paste. The amount is comparable to that near the fracture surface in Fig. 6b. above. Width of view is approximately 0.5 mm.**
