Crystal River Unit #3

Presentation to PNSC Containment Update & Discussion of Repair Options

**November 16th 2009
Presented by Garry Miller**

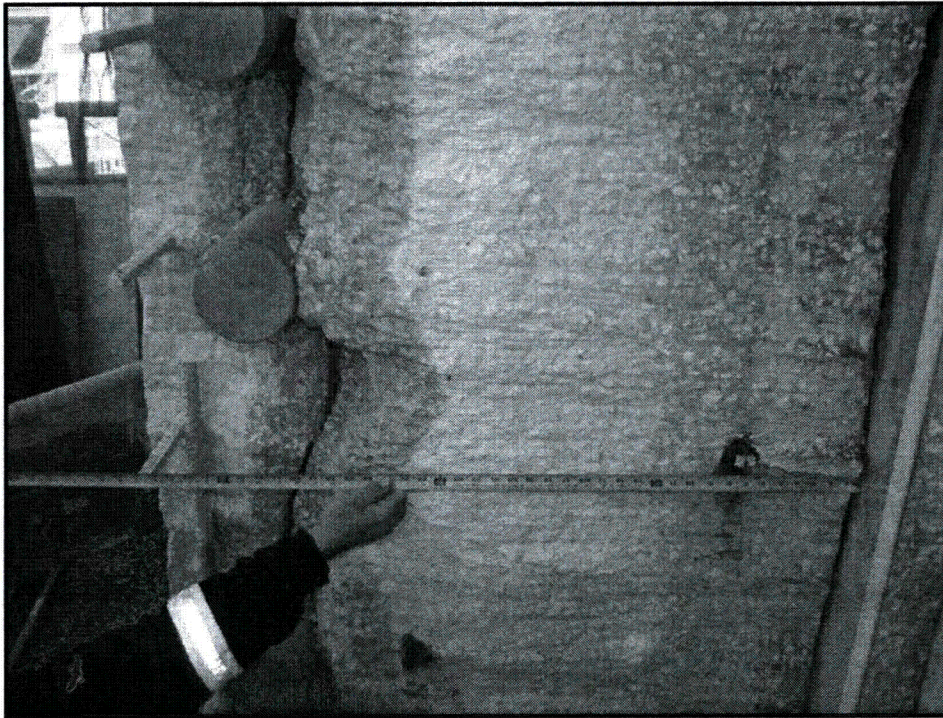
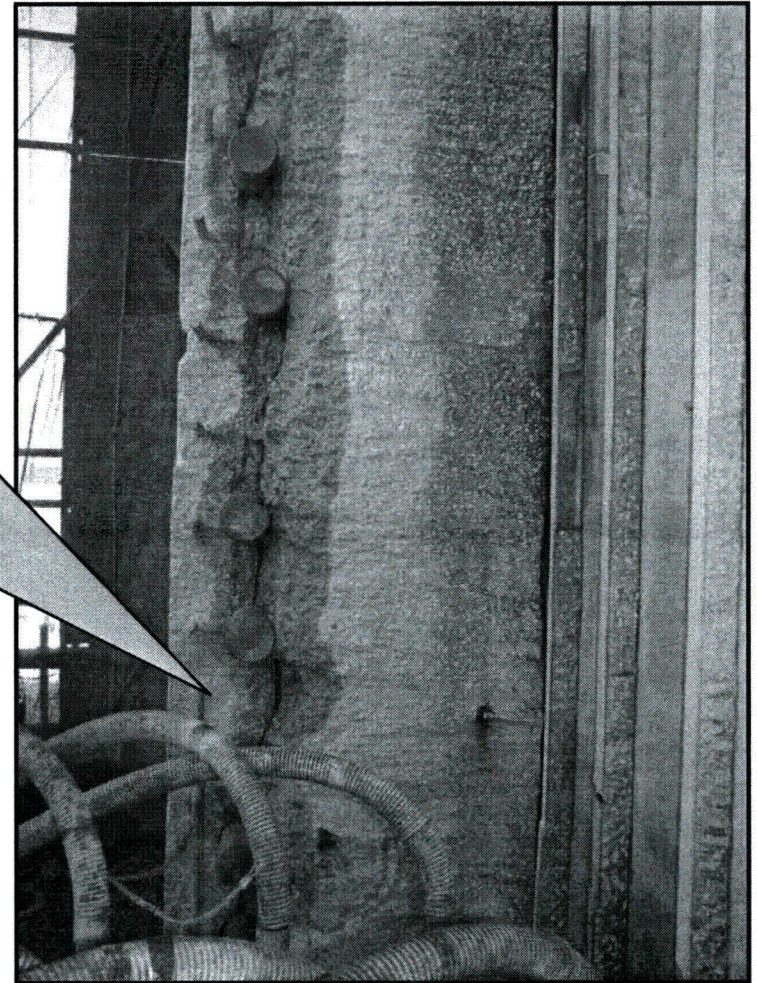
Delamination Close-up

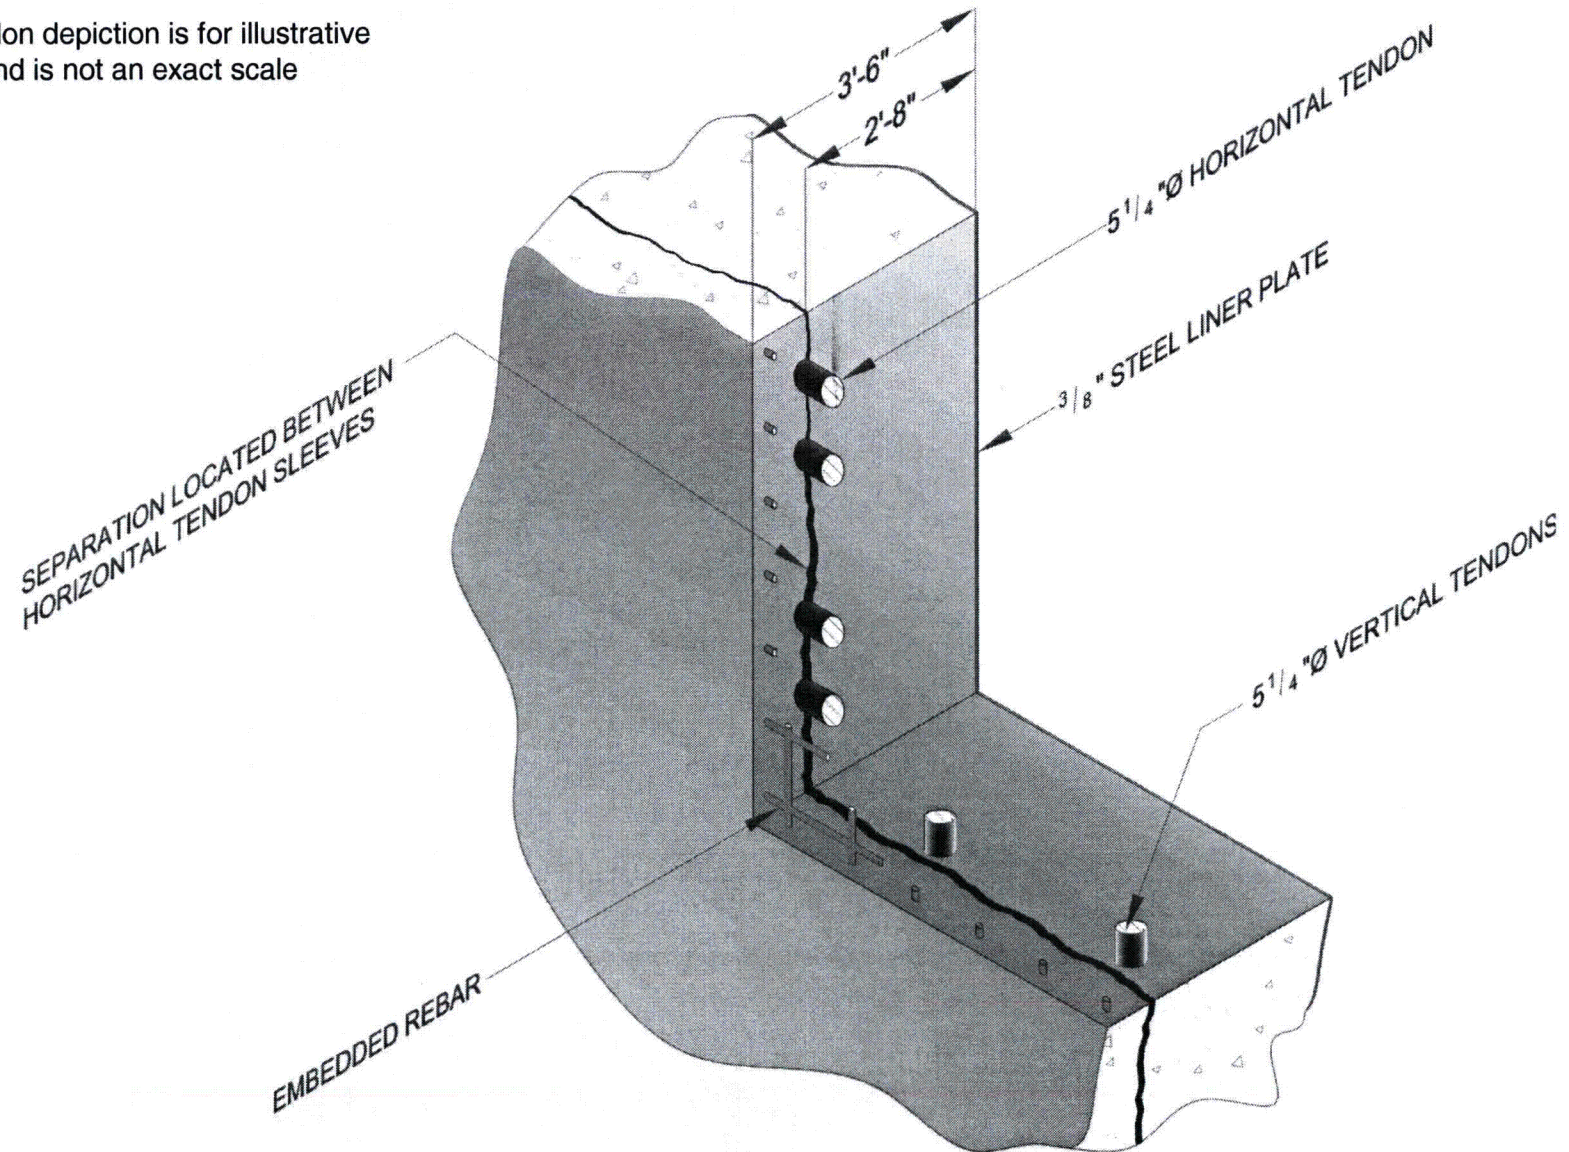
Location of the Delamination

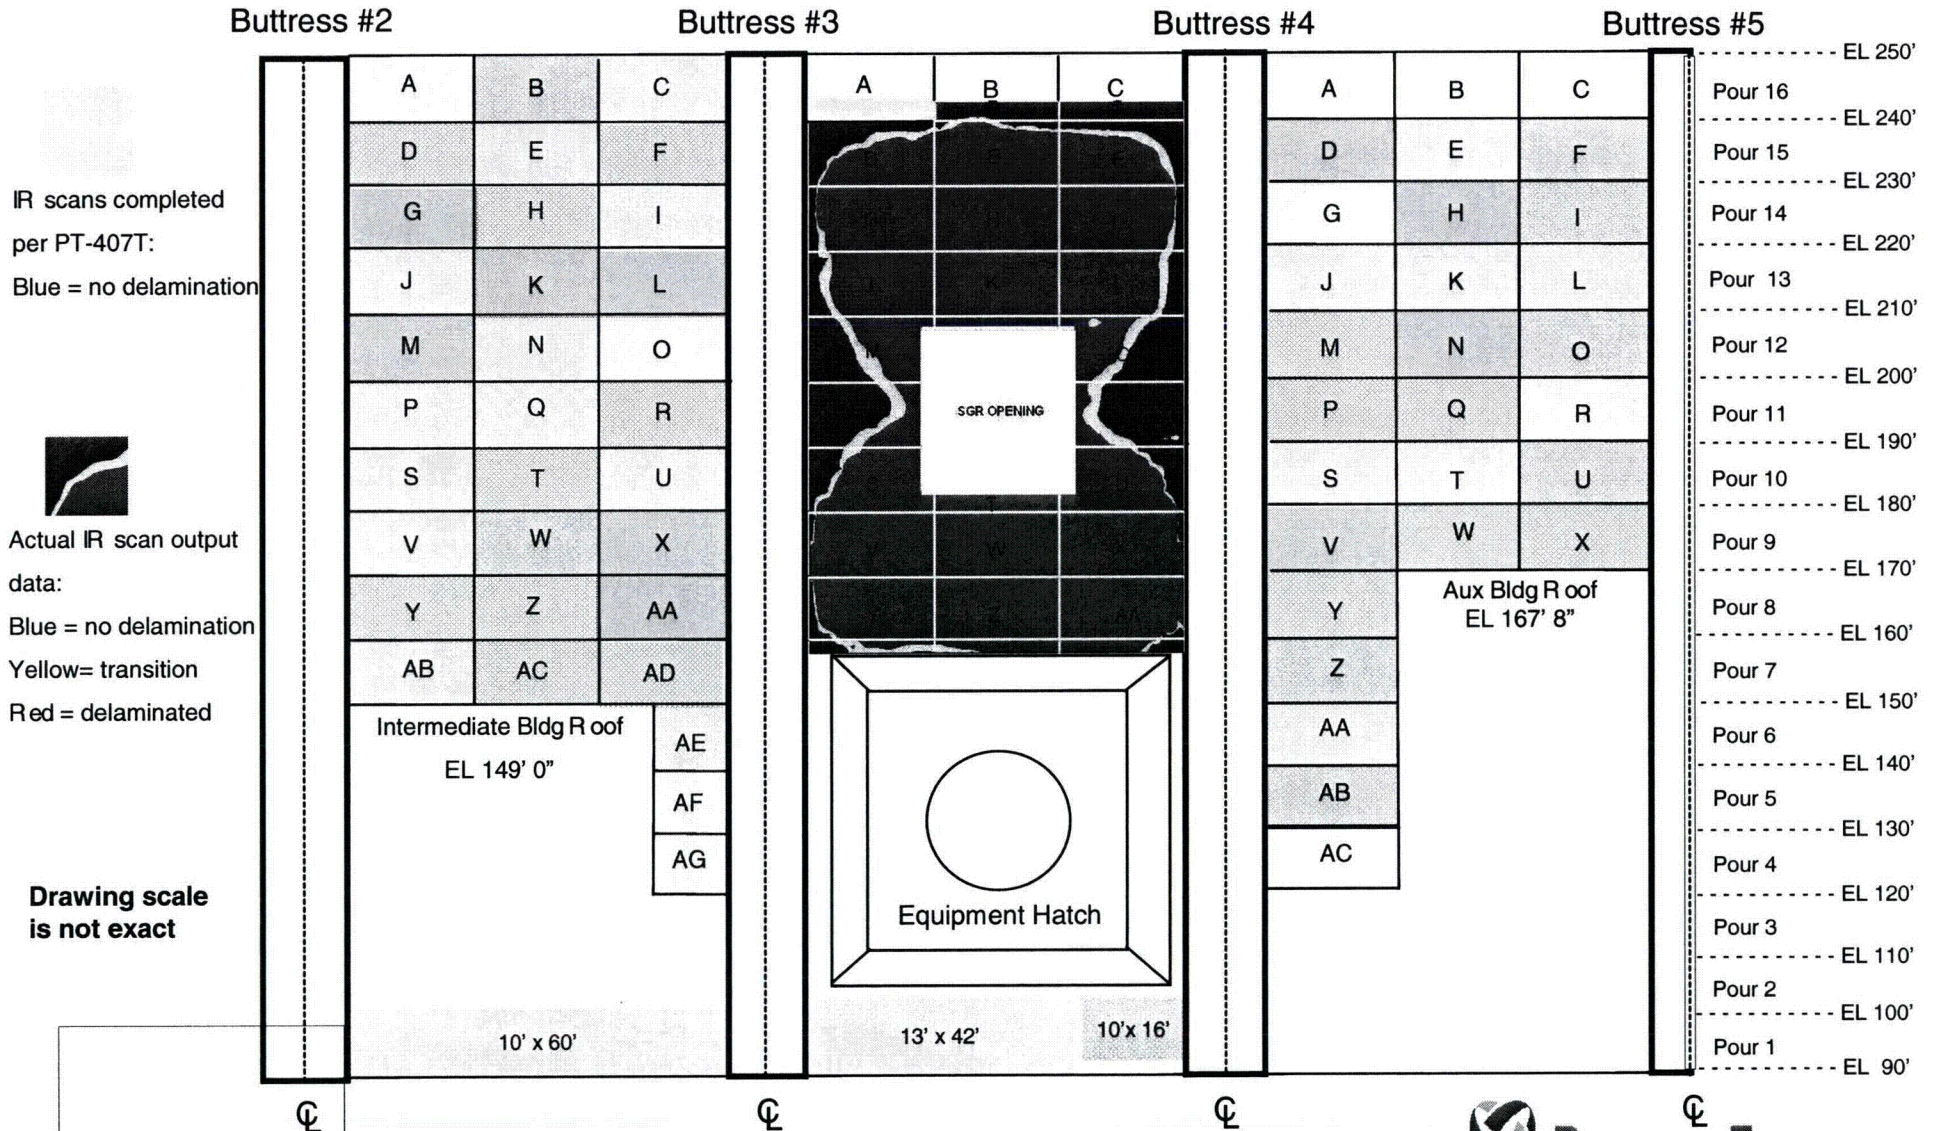
Containment "Unfolded" – Buttress 2 to 5

Updated Nov 16th, Mosaic IR Overlay scale is approximate

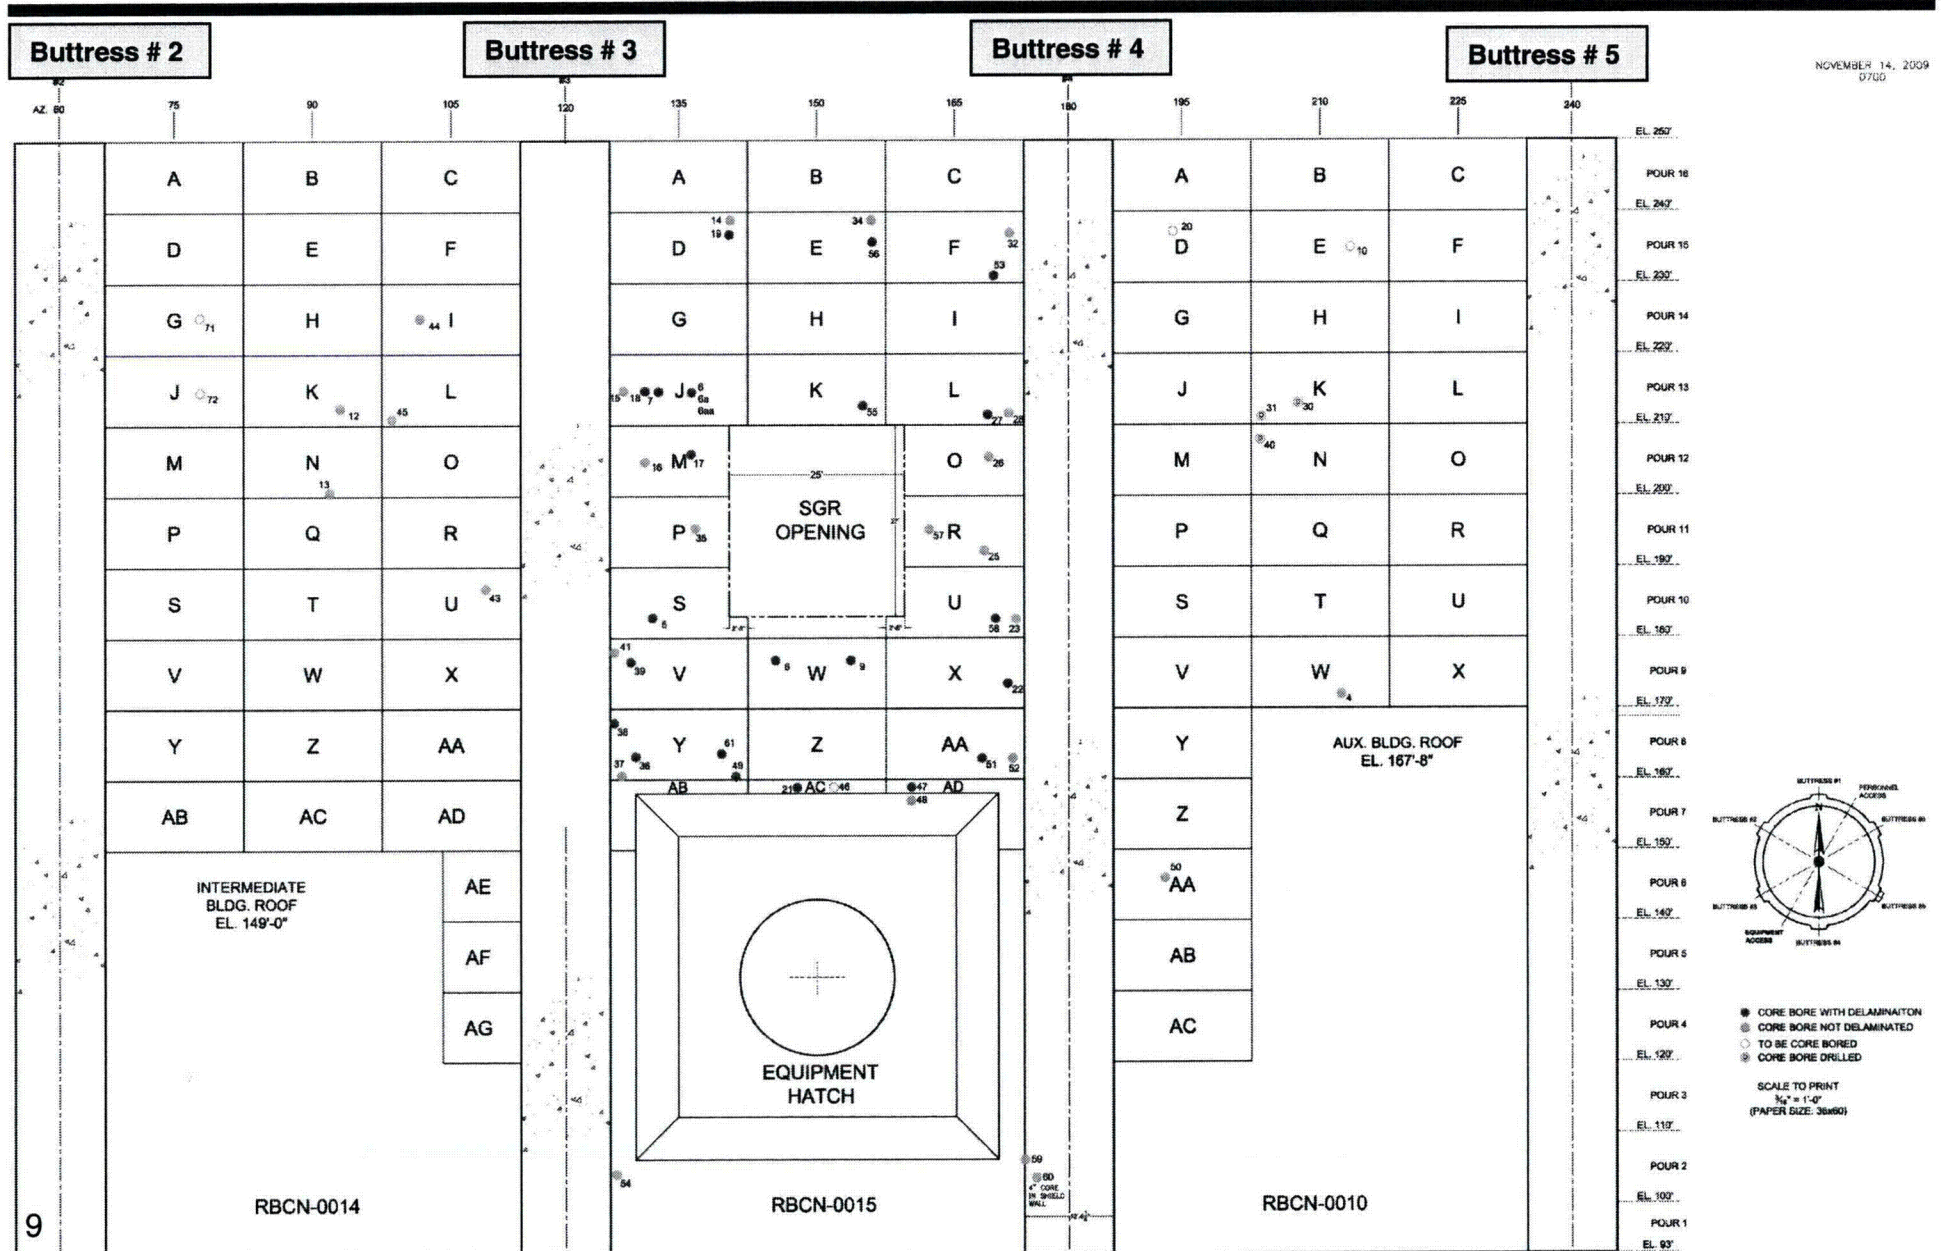
Core Bores

Buttress spans 2- 3- 4- 5 (as of Nov 14th 2009)

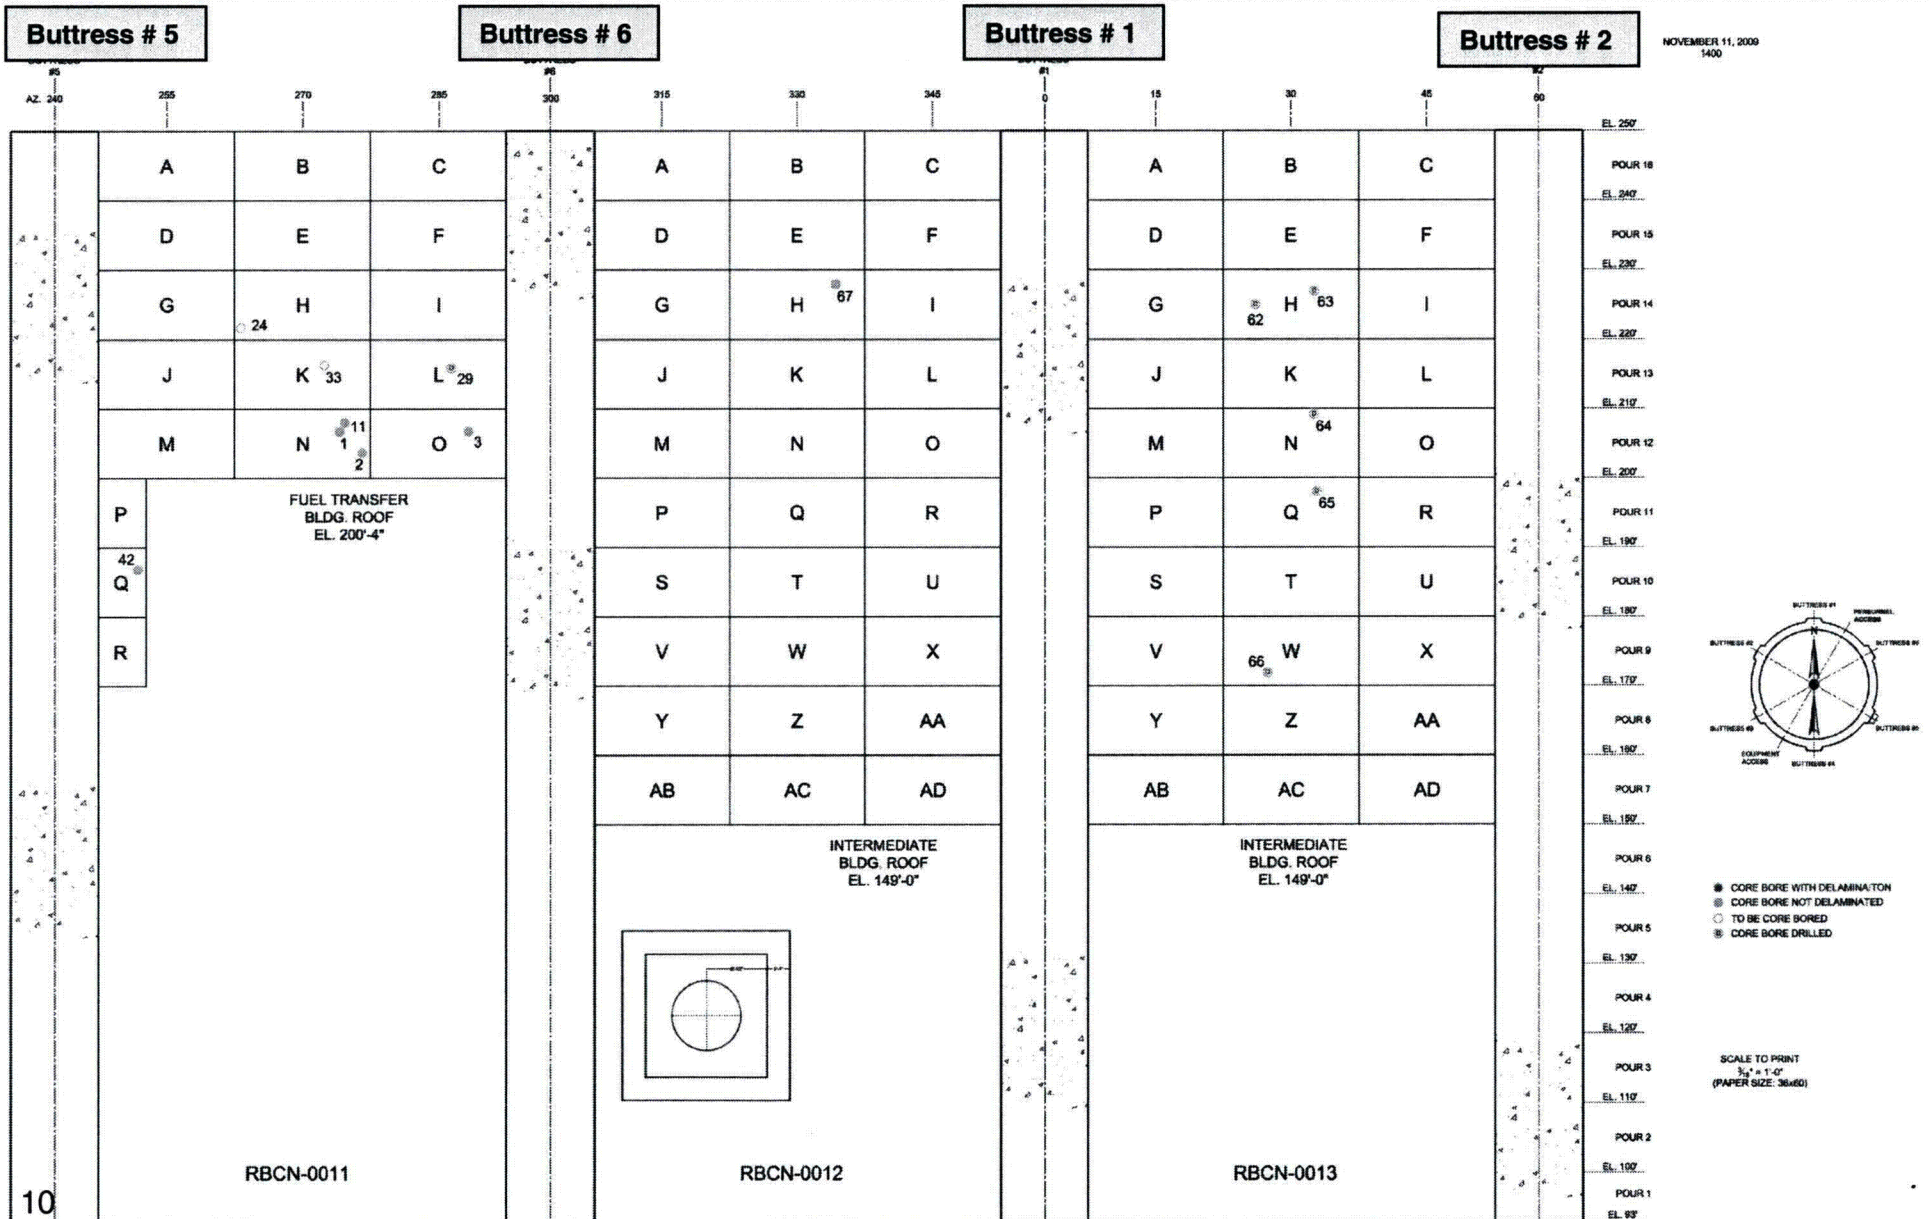
Core Bores

Buttress Spans 5 - 6 - 1 - 2 (as of Nov 14th 2009)

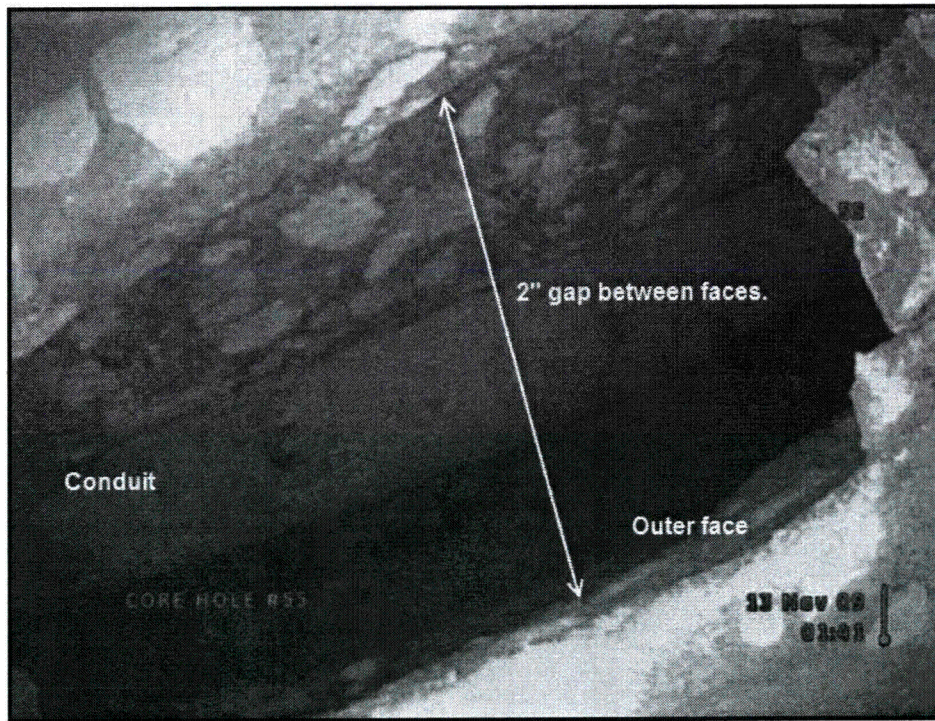
Buttress 3-4, Cell K, Core #55

Delamination Gap Dimensions

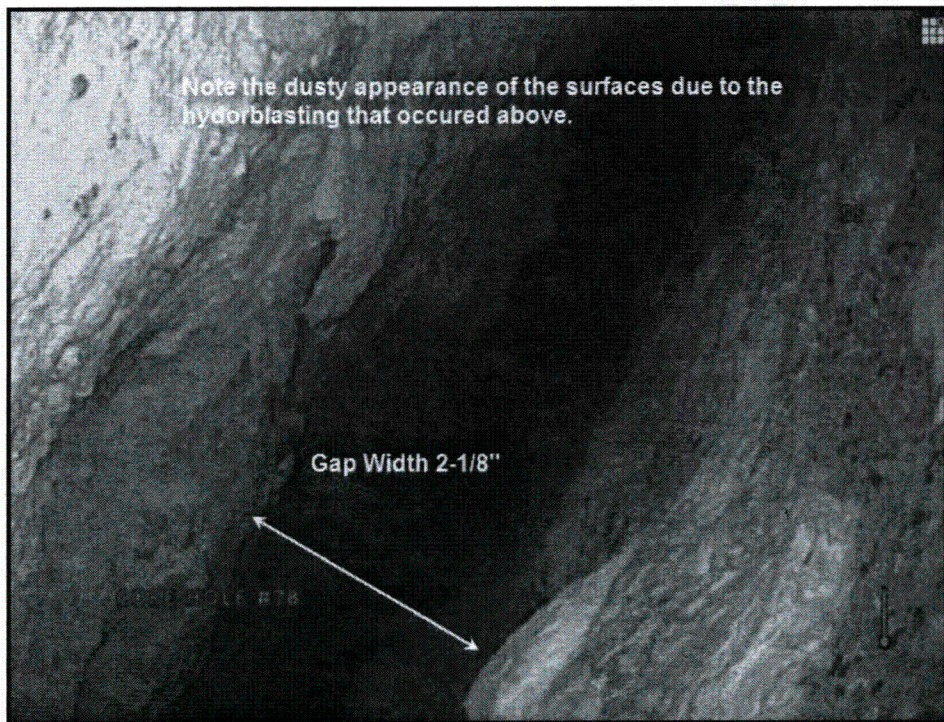
Buttress 3-4, Cell Z, Core #78

Delamination Gap Dimensions

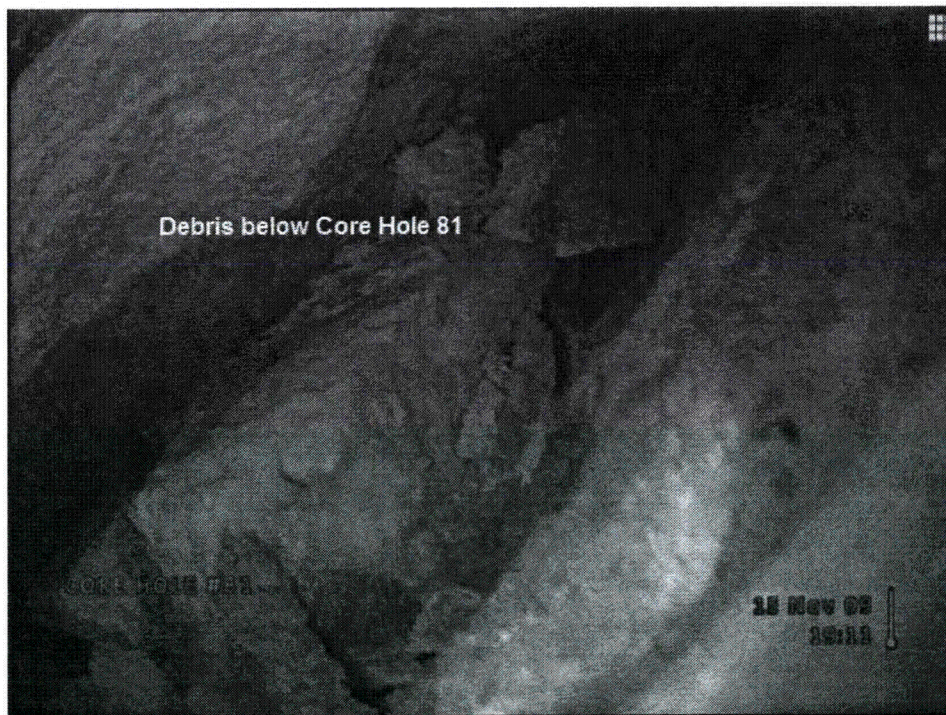
Buttress 3-4, Cell H, Core #81

Debris in the Delamination Gap

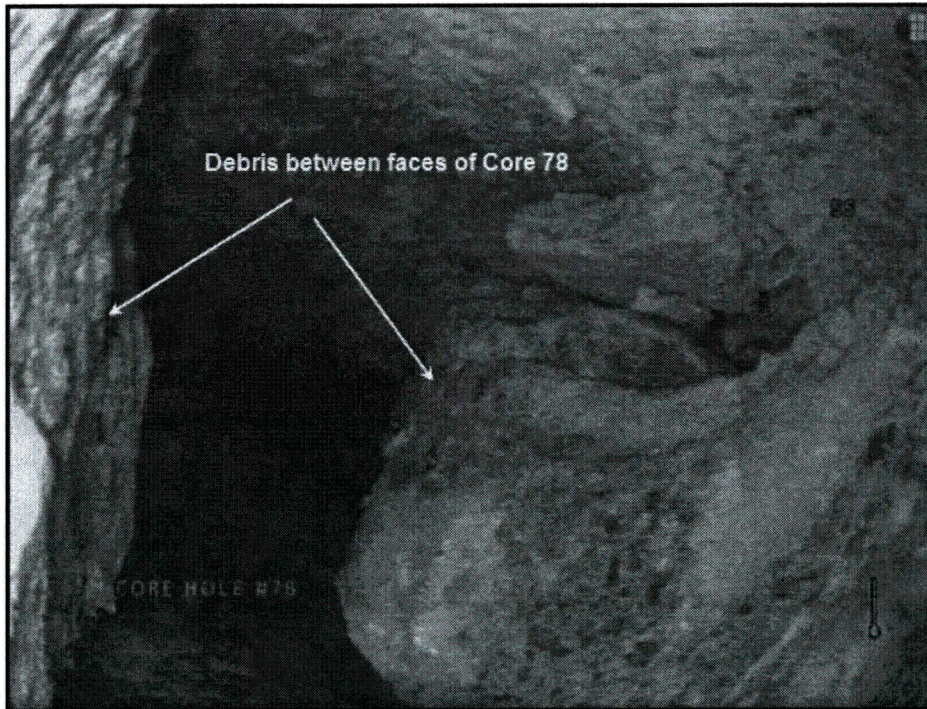
Buttress 3-4, Cell Z, Core # 78

Debris in the Delamination Gap

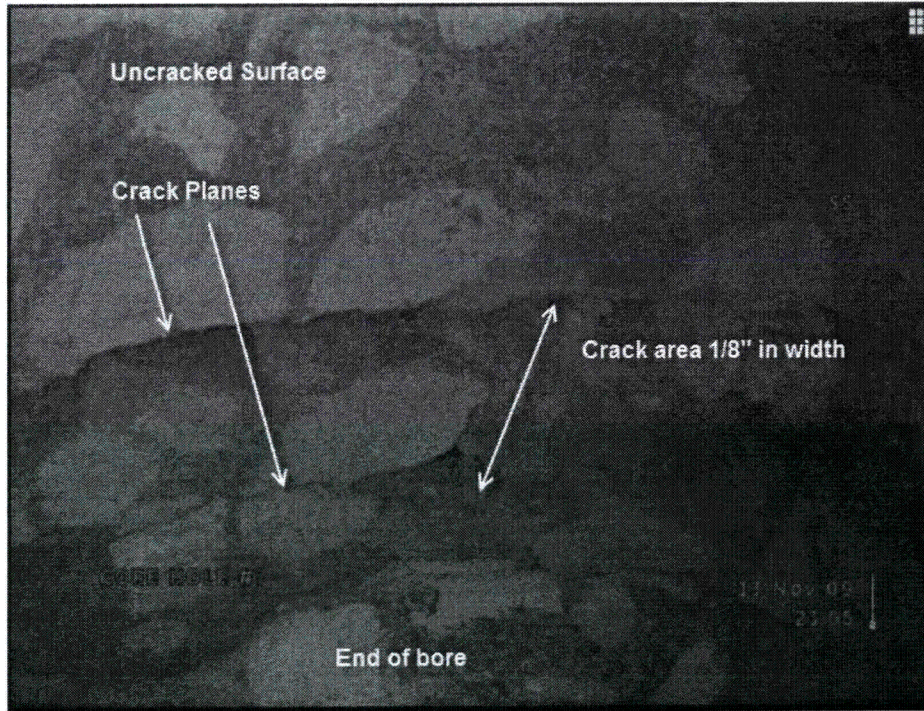
Butress 3-4, Cell J, Core #7

Fissures in the Delamination Gap

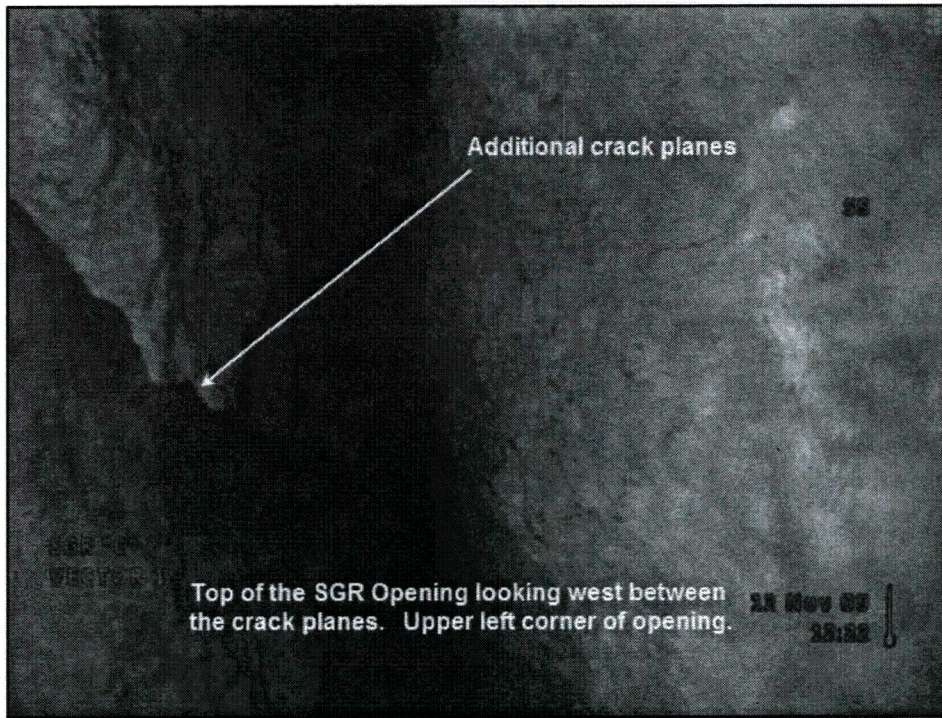
Buttress 3-4, Top of SGR Opening
Upper Left Corner, Looking West

Fissures in the Delamination Gap
