**From:** Williams, Charles R. [Charles.Williams@pgnmail.com]  
**Sent:** Tuesday, November 24, 2009 7:10 AM  
**To:** Lake, Louis; Thomas, George; nausdj@ornl.gov  
**Cc:** Herrin, Dennis W.  
**Subject:** Refute 2,8 for Review  
**Attachments:** FM 2.8.ppt; Picture 013.jpg; 4 jan 73 emailsize.jpg; 5 april 73.bmp.jpg; DSC04768.JPG; DSC04776.JPG; Picture 006.jpg

# 2.8 Inadequate Support of Tendons during Pouring

Description: If the tendons are not supported well, they may move during concrete pouring resulting in either or both, (1) localized friction between the tendon and its sleeve and (2) non-uniform stress in the concrete over the length of the tendon.

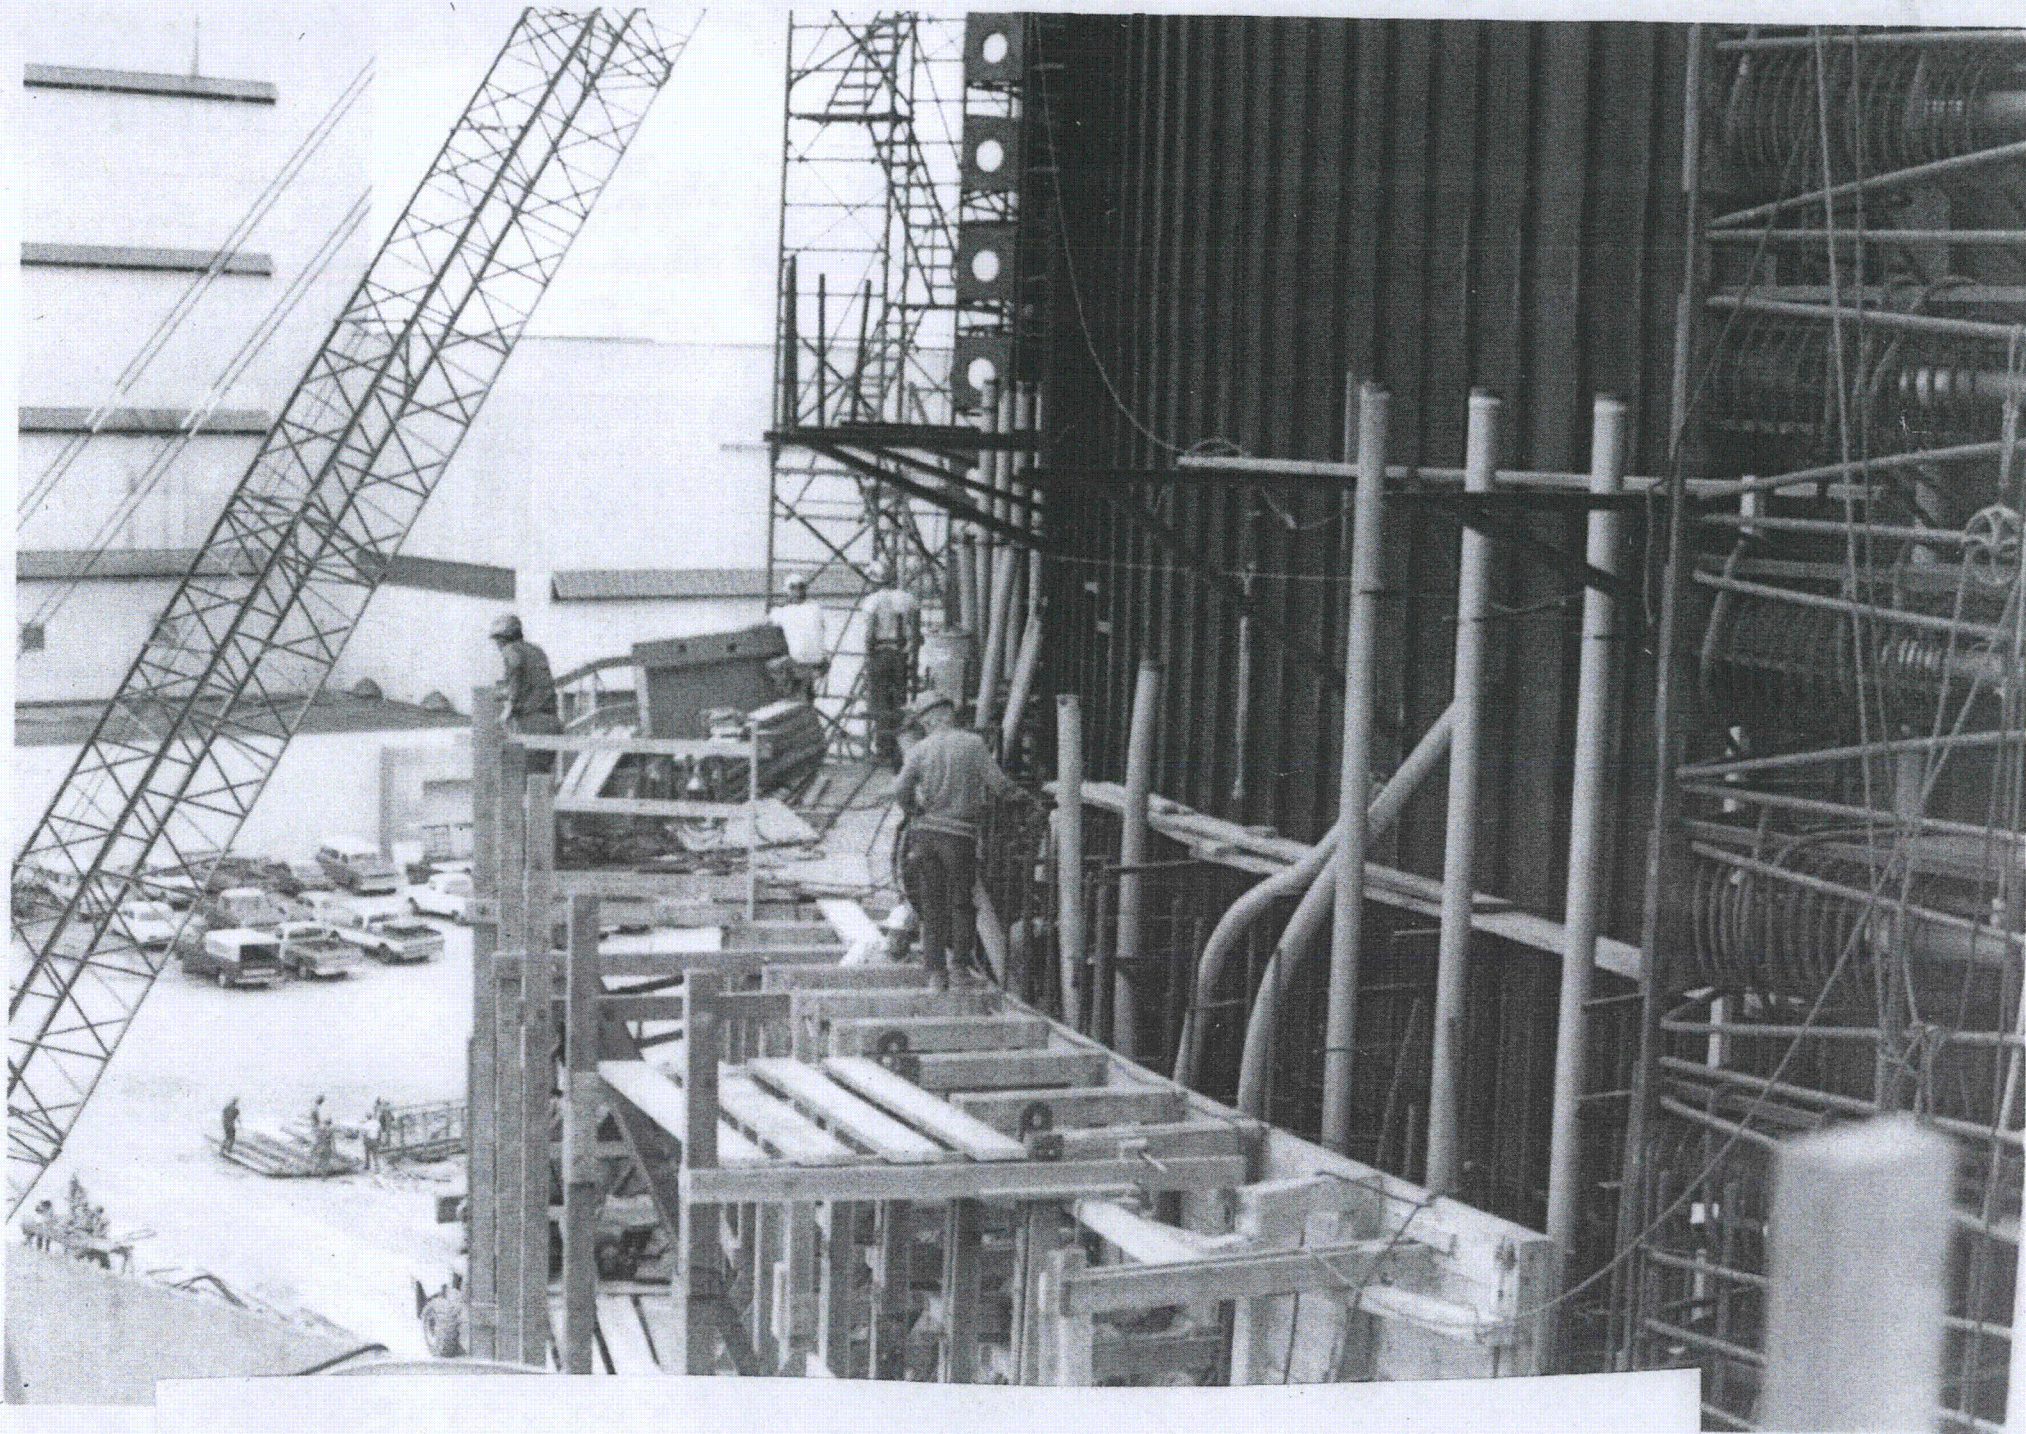
4 JAN 73  
REACTOR BLDG EQUIP ACCESS OPENING

1. Photos from original construction demonstrate the support system.
2. Photos taken during demolition show that the sleeves were evenly distributed in the zone and not deformed.
