Crystal River Unit #3

**Presentation to PNSC
Containment Update & Discussion
of Repair Options**

November 16th 2009
Presented by Garry Miller

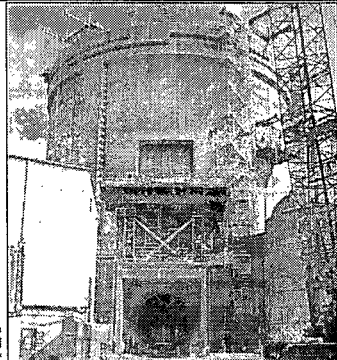
**Steam Generator Replacement (SGR) Opening
(between Buttresses 3 and 4)**

SGR Opening Dimensions
 @ Liner 23' 6" x 24' 9"
 @ Concrete Opening 25' 0" x 27' 0"
