Crystal River Unit #3

Presentation to PNSC Containment Update & Discussion of Repair Options

November 16th 2009 Presented by Garry Miller

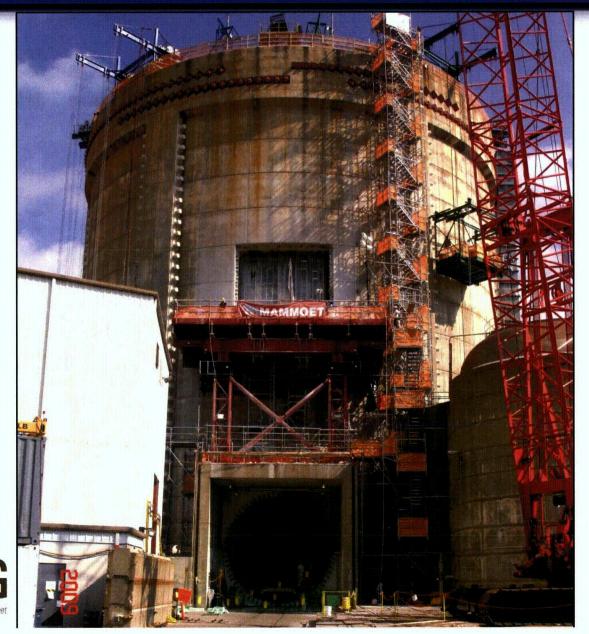
Steam Generator Replacement (SGR) Opening (between Buttresses 3 and 4)

SGR Opening Dimensions

@ Liner 23' 6" x 24' 9"

@ Concrete Opening 25' 0" x 27" 0"

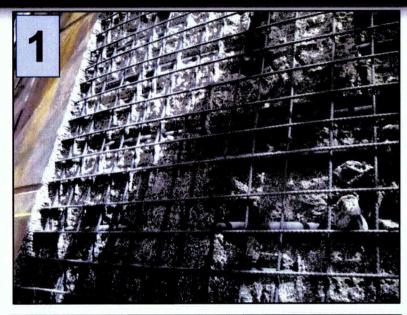
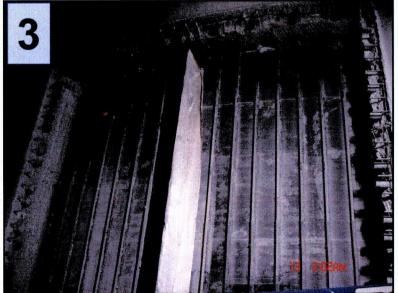
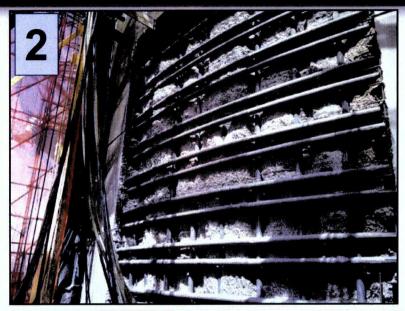
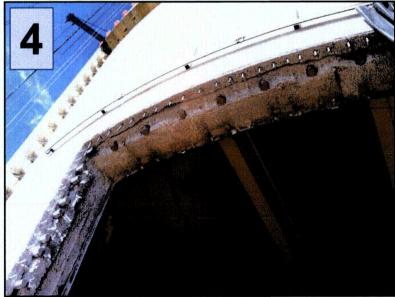
Hydro-Demolition & Liner Removal Sequence

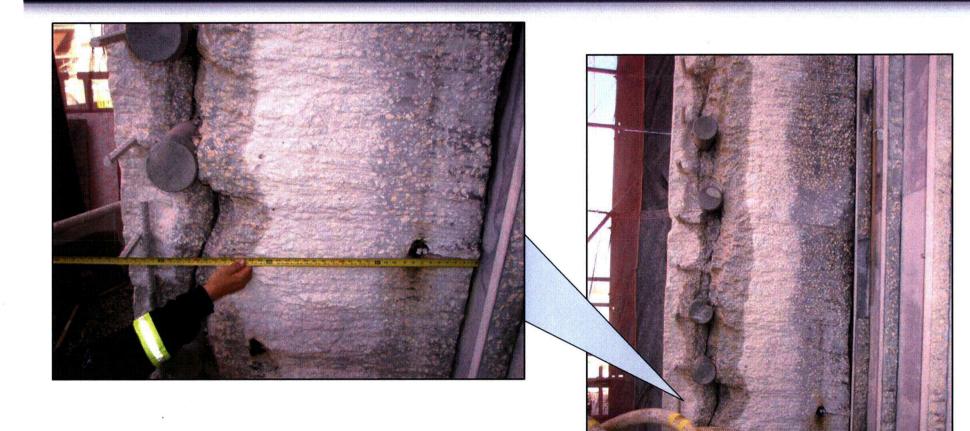
Delamination Close-up

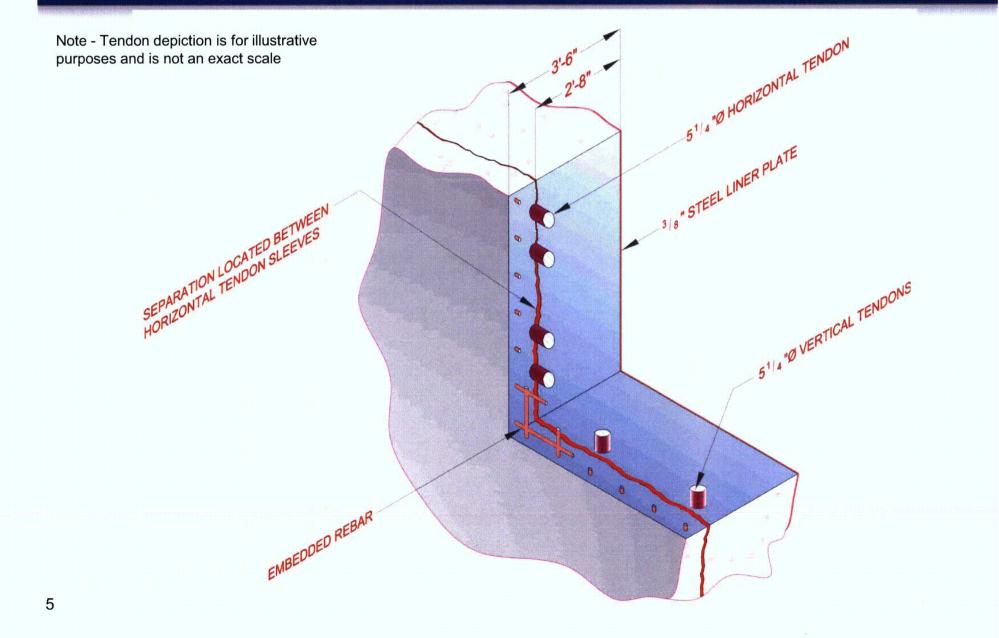
Location of the Delamination

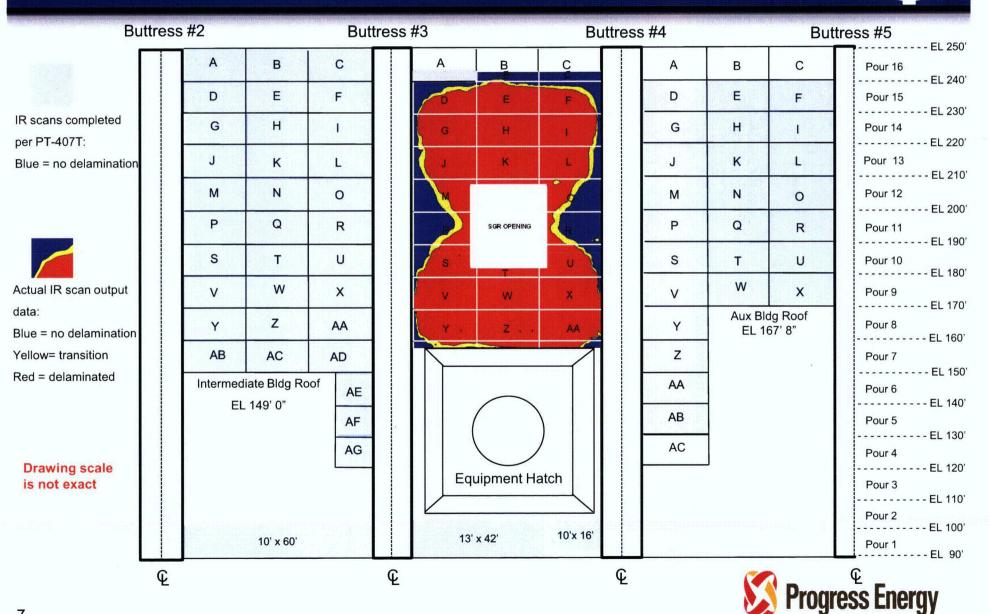
Containment "Unfolded" – Buttress 2 to 5 Updated Nov 16th, Mosaic IR Overlay scale is approximate

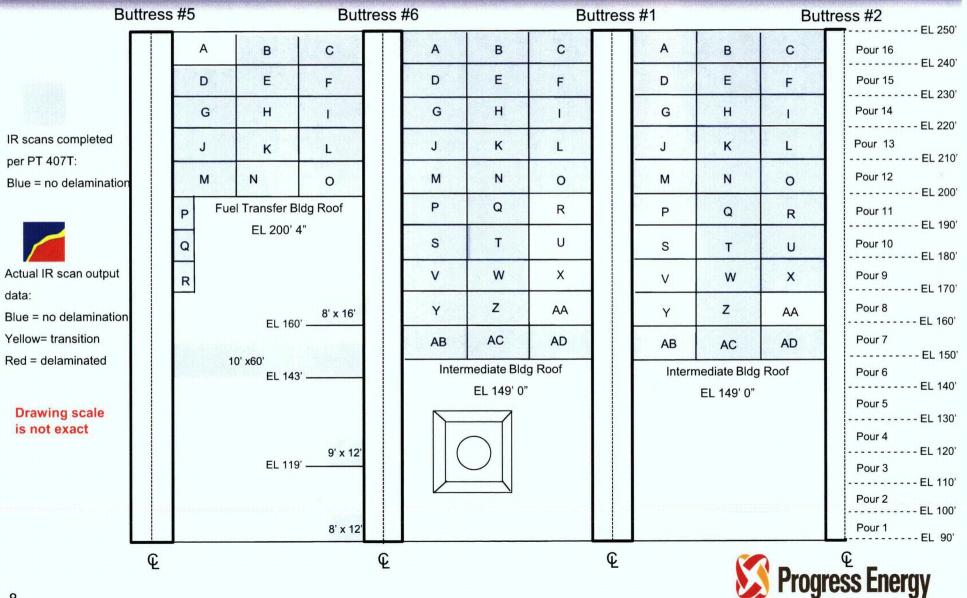
Containment "Unfolded" – Buttress 5 to 2

Updated Nov 16th 2009

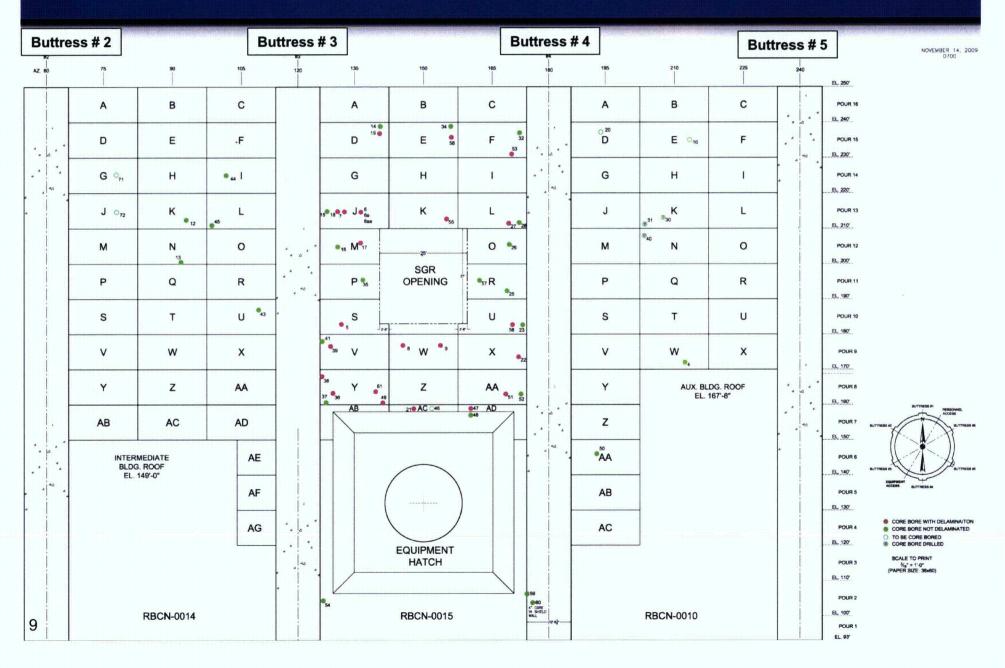
Core Bores

Buttress spans 2- 3- 4- 5 (as of Nov 14th 2009)

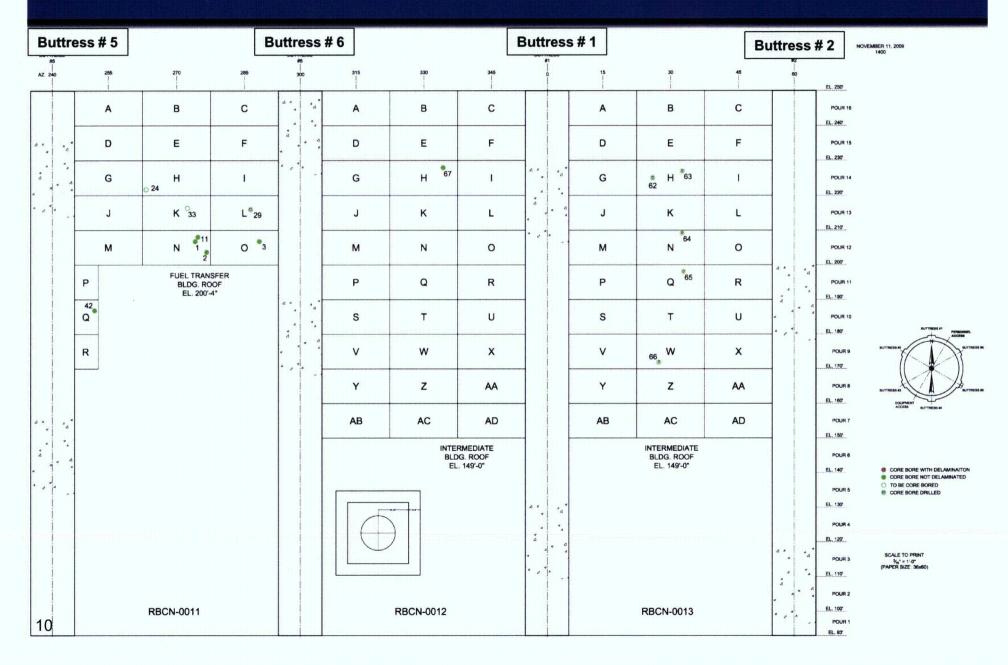
Core Bores Buttress Spans 5 - 6 - 1 – 2 (as of Nov 14th 2009)

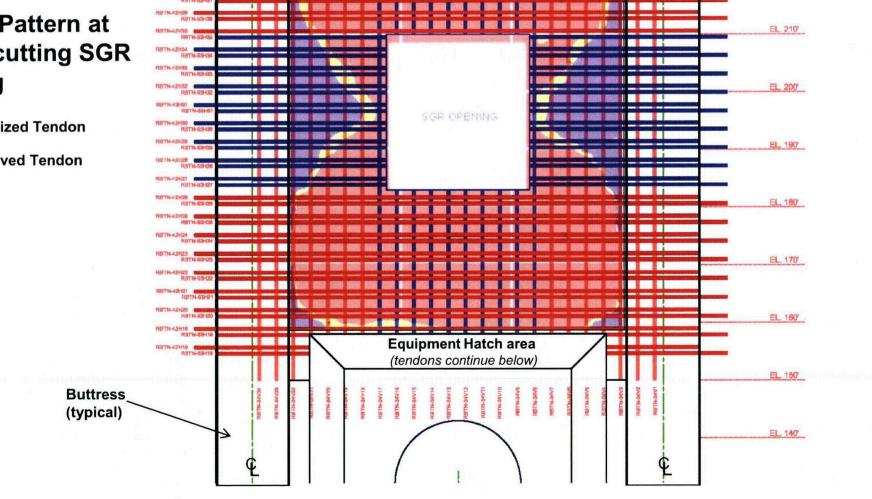
Tendon Pattern at time of cutting SGR Opening

Energized Tendon

Removed Tendon

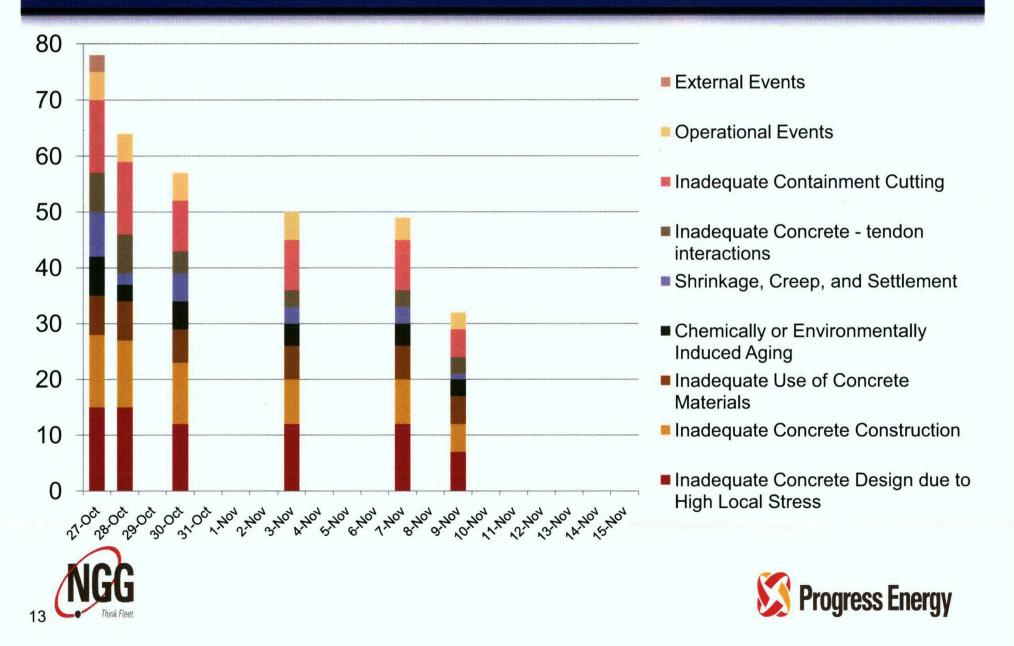
Root Cause Analysis – PII Metrics Un-refuted Failure Modes as of Nov 9th 2009

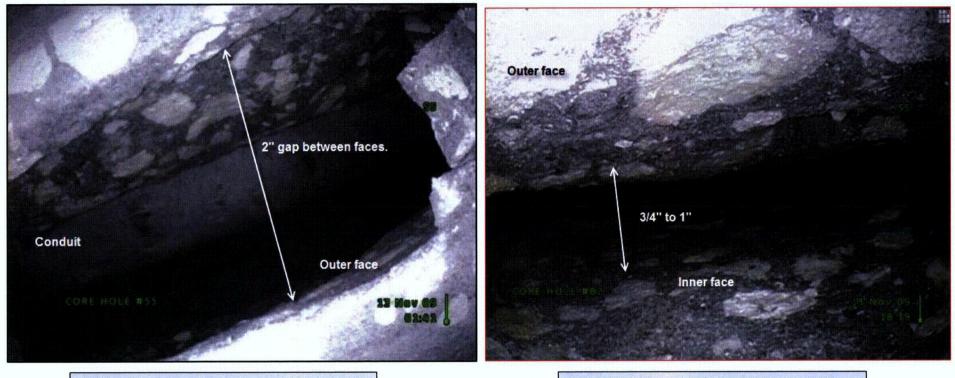
Boroscopic Photos *Delamination Gap Dimensions*

Buttress 3-4, Cell K, Core #55

Buttress 3-4, Cell H, Core #82

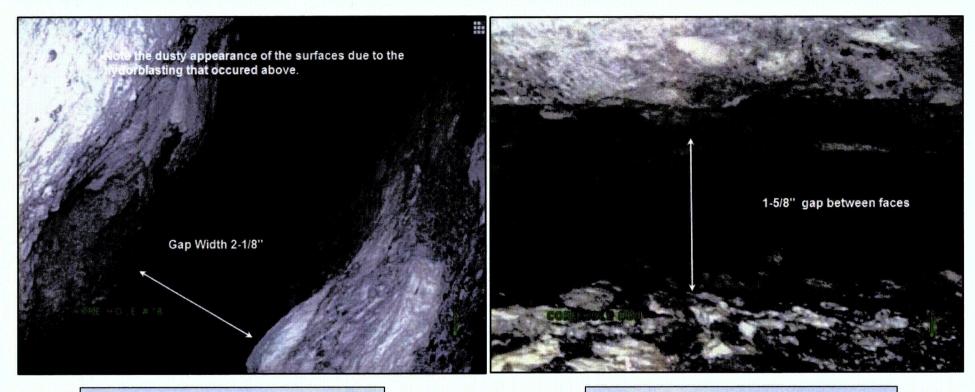
Boroscopic Photos *Delamination Gap Dimensions*

Buttress 3-4, Cell Z, Core #78

Buttress 3-4, Cell X, Core # 80

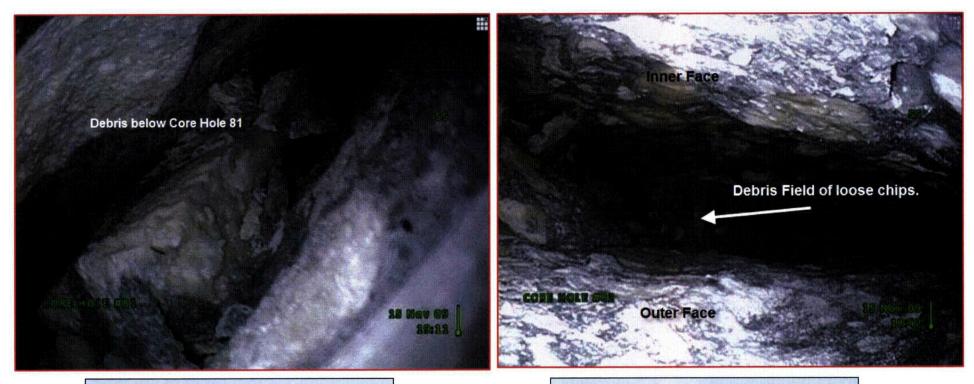
Boroscopic Photos *Debris in the Delamination Gap*

Buttress 3-4, Cell H, Core #81

Buttress 3-4, Cell H, Core #82

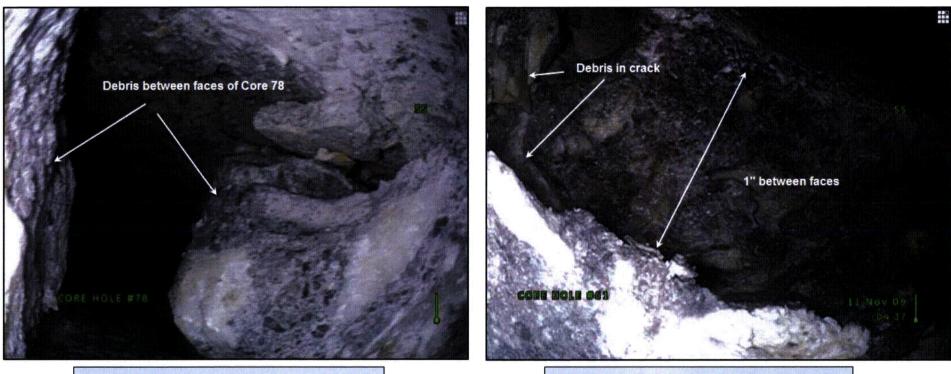
Boroscopic Photos *Debris in the Delamination Gap*

Buttress 3-4, Cell Z, Core # 78

Buttress 3-4, Cell Y, Core # 61

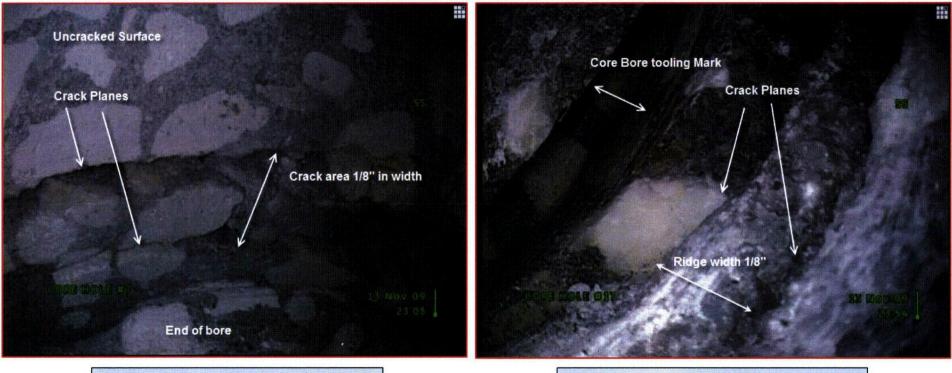
Boroscopic Photos *Fissures in the Delamination Gap*

Buttress 3-4, Cell J, Core #7

Buttress 3-4, Cell M, Core #17

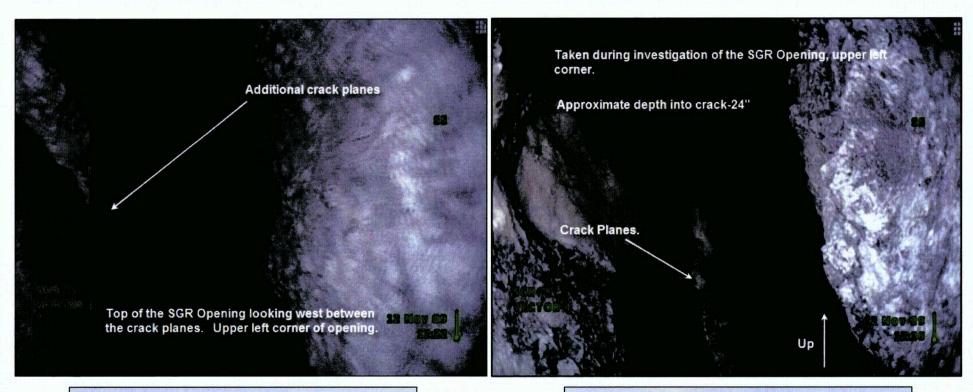
Boroscopic Photos Fissures in the Delamination Gap

Buttress 3-4, Top of SGR Opening Upper Left Corner, Looking West

Buttress 3-4, Top of SGR Opening **Upper Left Corner**
