November 11 2009

Subject: **Report of Petrographic Observations  
Crystal River Containment Wall  
Steam Generator Replacement Project  
Crystal River Nuclear Generating Facility, Florida  
MACTEC Project No. 6468-09-2535**

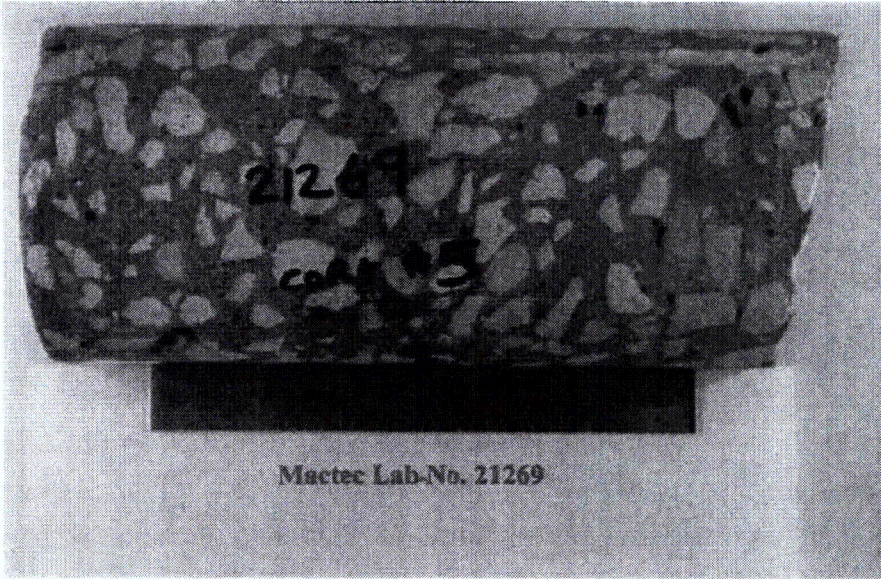
Photograph #1	Remarks

<p data-bbox="526 889 797 917">Mactec Lab-No. 21269</p>	<p data-bbox="1154 406 1419 527">Core 21269 as received. The exterior surface is to the left. The fracture surface is to the right.</p>

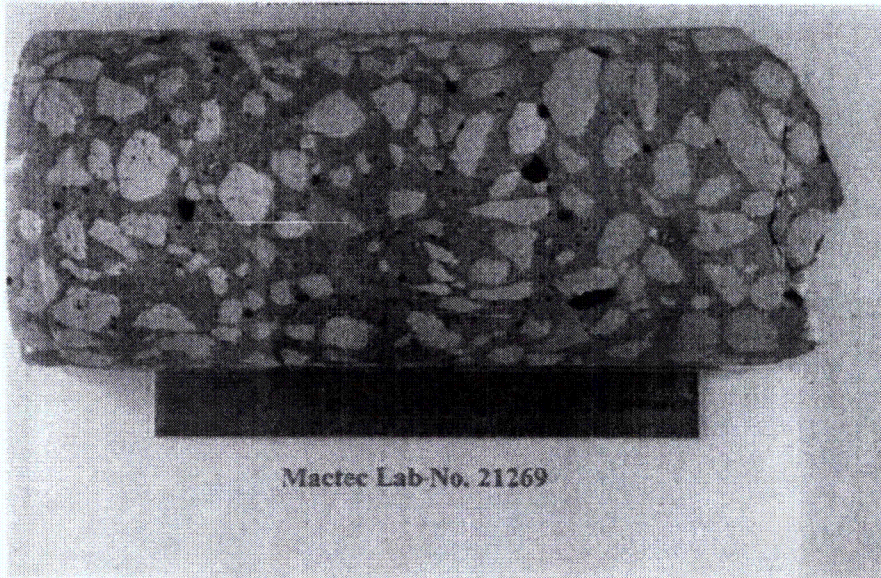
Photograph #2	Remarks

<p data-bbox="526 1687 797 1715">Mactec Lab-No. 21269</p>	<p data-bbox="1154 1202 1409 1357">Core 21269 as received. The exterior surface is to the left. The fracture surface is to the right.</p>

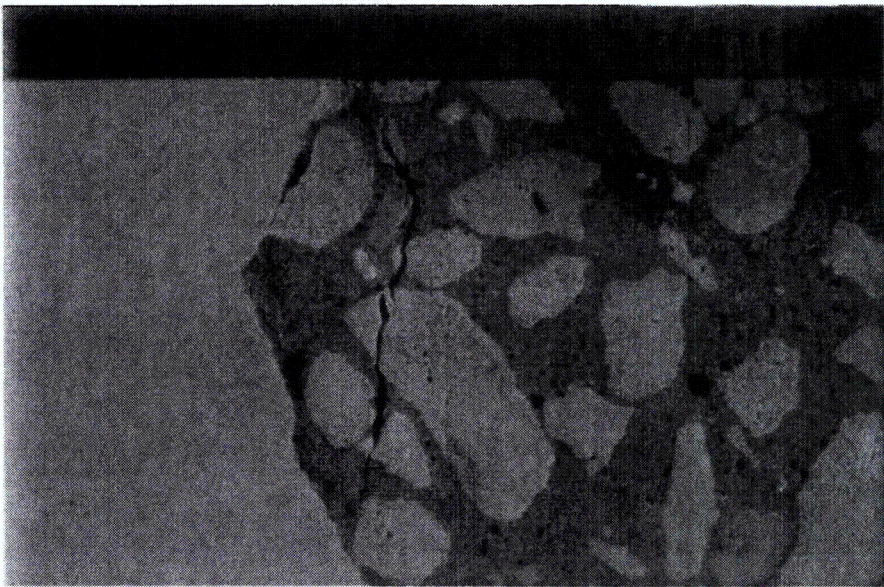
Photograph #3	Remarks

Close-up of the side of the core at the fractured surface end.

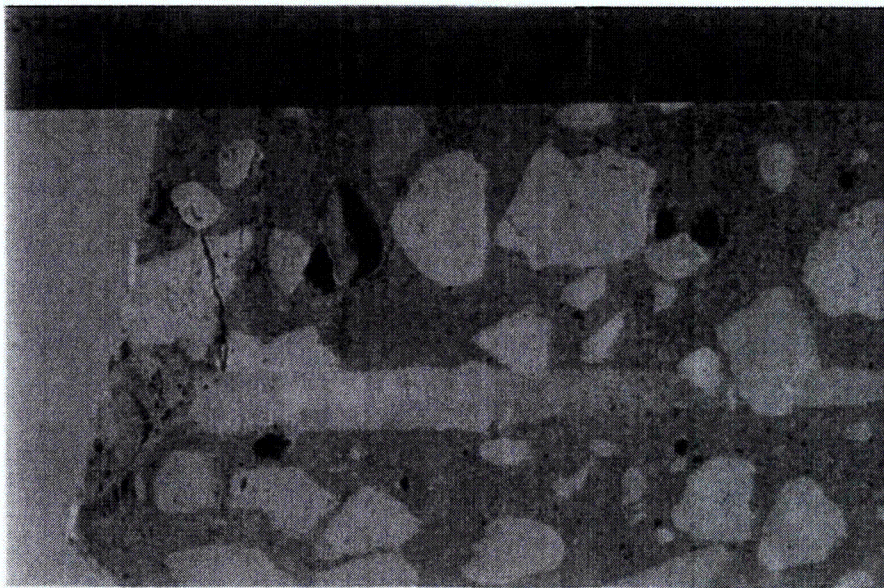
Photograph #4	Remarks

Close-up of the side of the core at the fractured surface end.

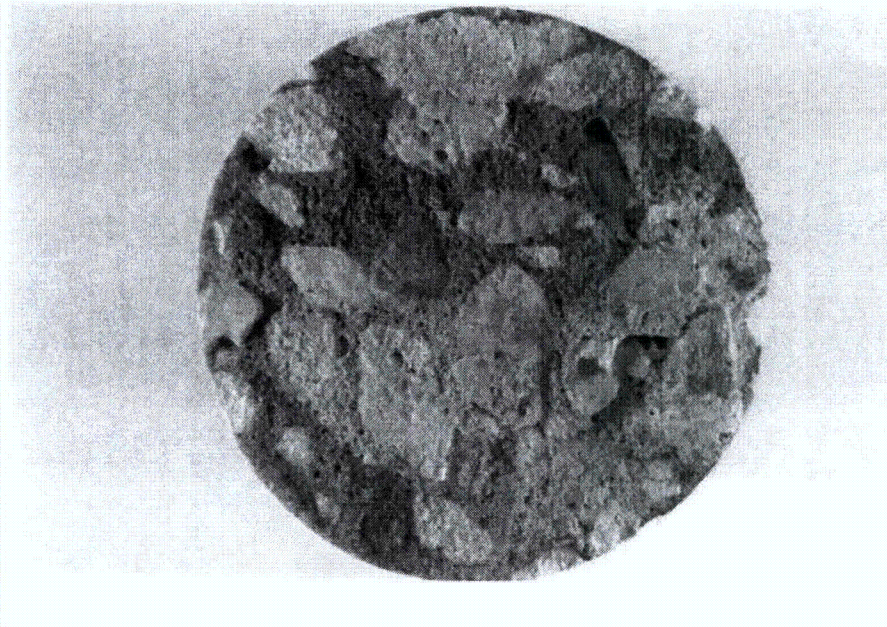
Photograph #6	Remarks

- The edge of the fractured surface had sharp distinct edges.
- Generally the coarse aggregate (predominately limestone) fractured as opposed to being pulled out of the cement paste matrix.

- The paste portion of the fractured surface did not appear carbonated and produced a pink color when phenolphthalein was applied.
- Some of the air voids that were exposed on the fractured surface had some mineral grown in them. We did not observe the mineral growth on the fractured surface around these subject voids.

The fractured surface of core 21269.

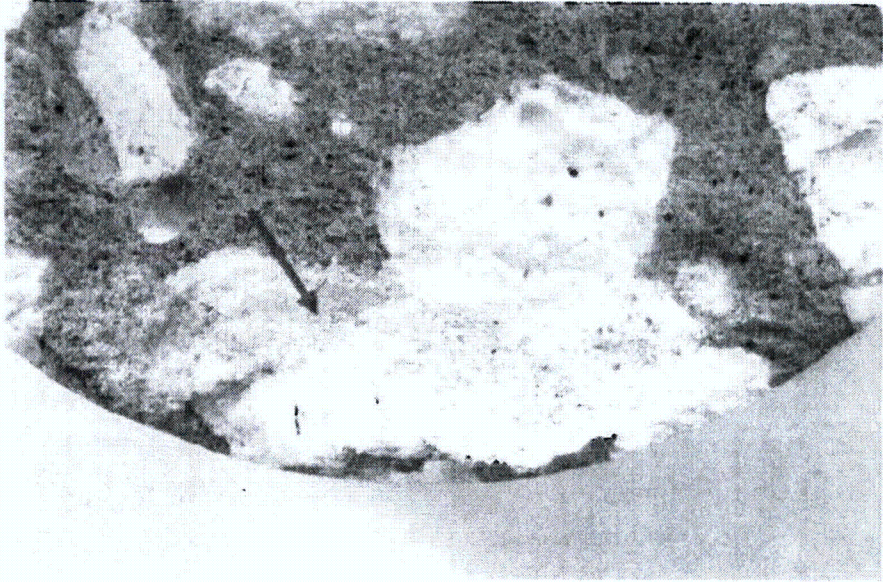
Photograph #7	Remarks

- There was a white colored deposit on a few areas of the fractured surface. The deposit was easily scratched off and contained desiccation cracking. Based on our observations of immersion mounts viewed under a petrographic microscope the deposit appeared to contain very fine material and small sharp angular pieces of quartz. These observations are consistent with what we would expect from core drilling slurry.

Close up of the fractured surface of core 21269. Note the desiccation cracking where the white deposit is thicker (shown by red arrow).

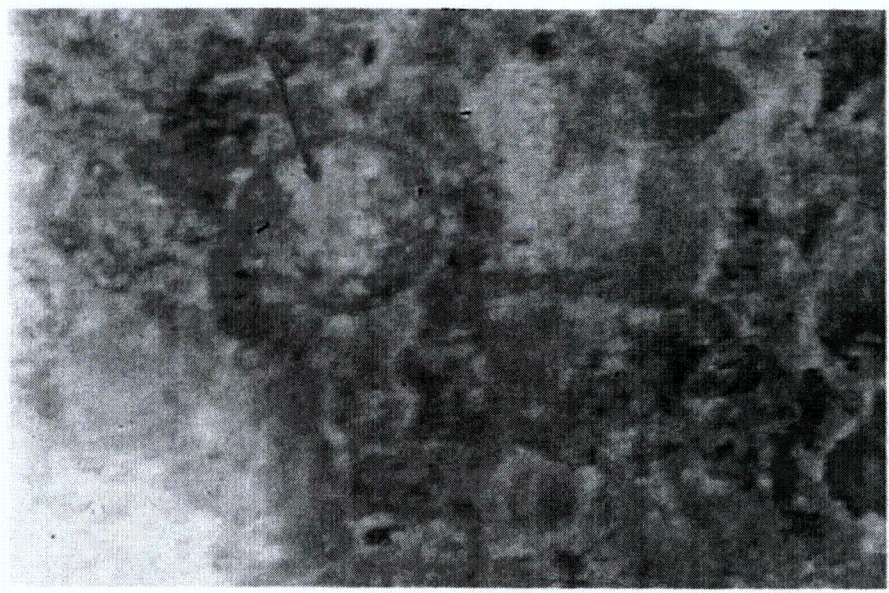
Photograph #11	Remarks

A significant observation on the fractured surfaces of the samples is the mineral growth that was observed in some of the air voids exposed at the fractured surface, but mineral growth was not observed on the fractured surface. There was not an extensive amount of mineral growth observed in the voids indicating the concrete was relatively dry in service (possibly due to the elevated temperature inside the containment area). Had the crack been in existence for a long period of time, we would have expected to see some mineral growth on the fractured surface.

<p>Photomicrograph of the fracture surface. Red arrow points to an air void with some mineral growth. Due to the uneven surface and limited depth of field at this magnification, some areas are out of focus.</p>

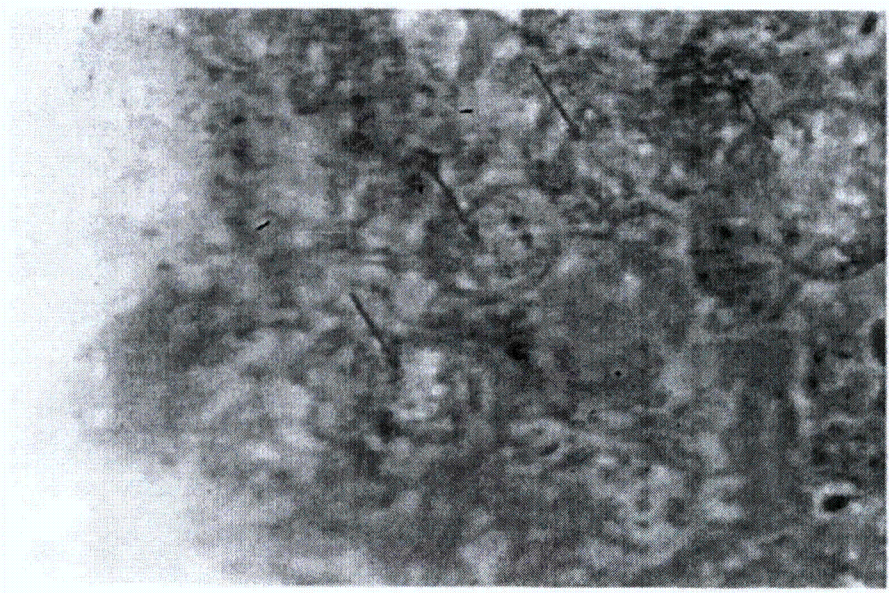
Photograph #12	Remarks

<p>Photomicrograph of the fracture surface. Red arrows point to air voids with some mineral growth. Due to the uneven surface and limited depth of field at this magnification, some areas are out of focus.</p>

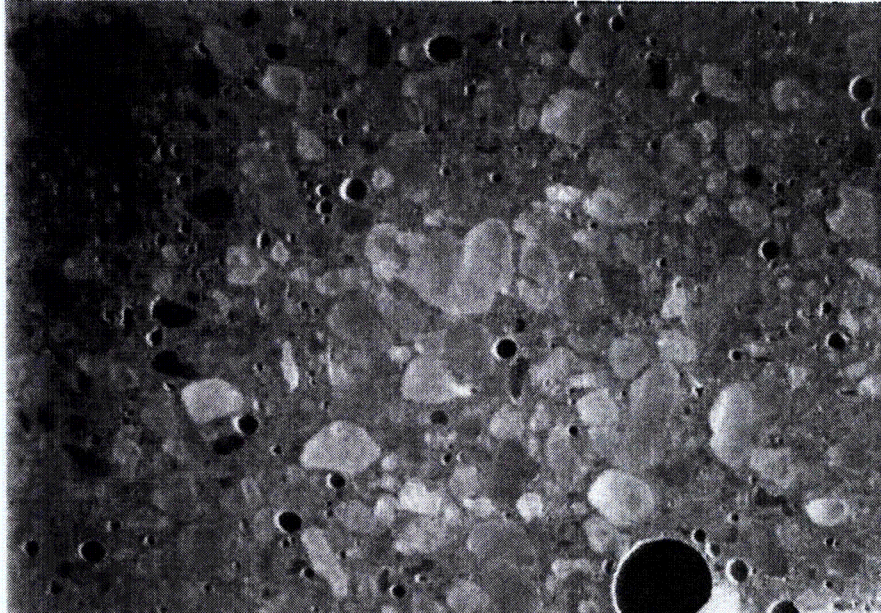
Photograph #17	Remarks

<p>Photomicrograph of the polished section. Note the un-even distribution of air voids. Width of view is approximately 0.5 inch.</p>

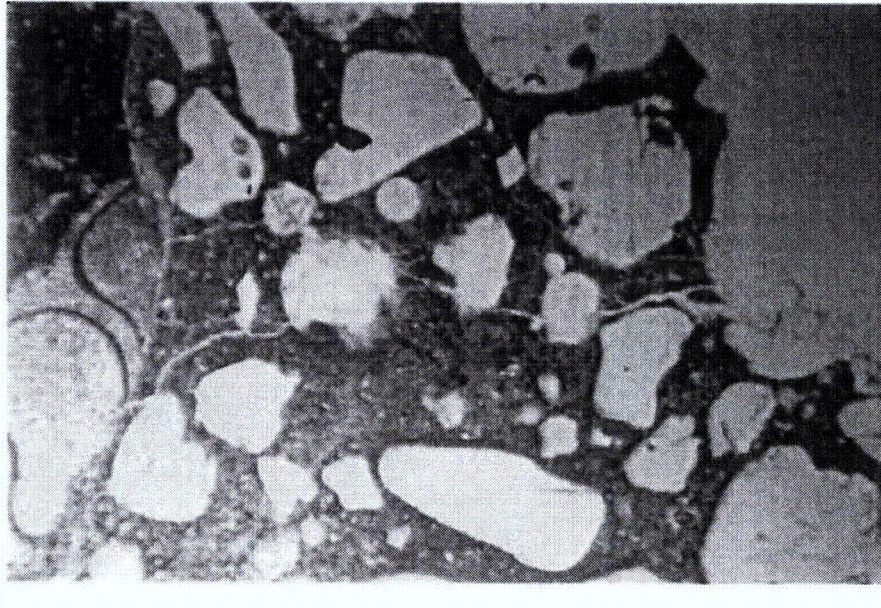
Photograph #18	Remarks

<p>Photomicrograph of thin section using plane polarized light. The fractured surface is to the left. Note fractures (red arrow). Width of view is approximately 0.5 inch.</p>

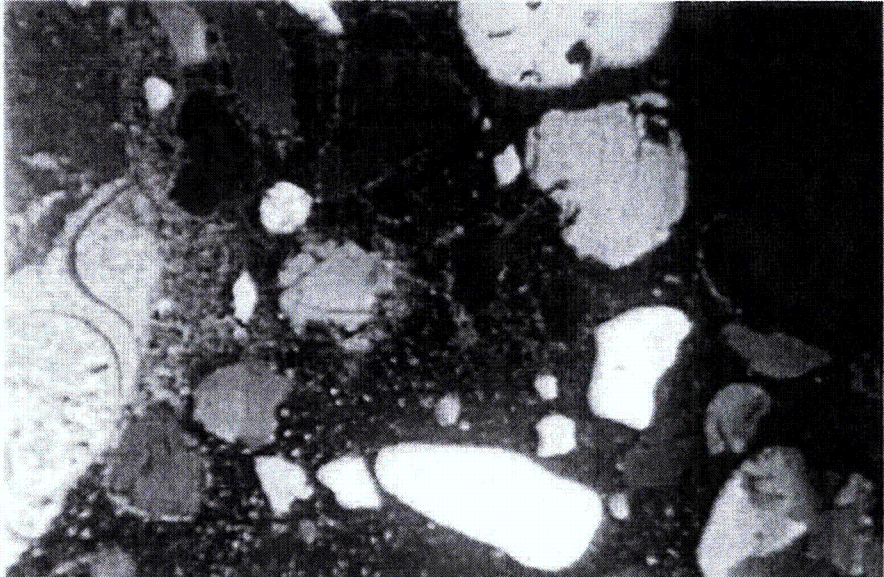
Photograph #19	Remarks

<p>Same view as in photograph #18 taken with cross polarized light. Red arrow points to an air void. Width of view is approximately 0.5 inch.</p>

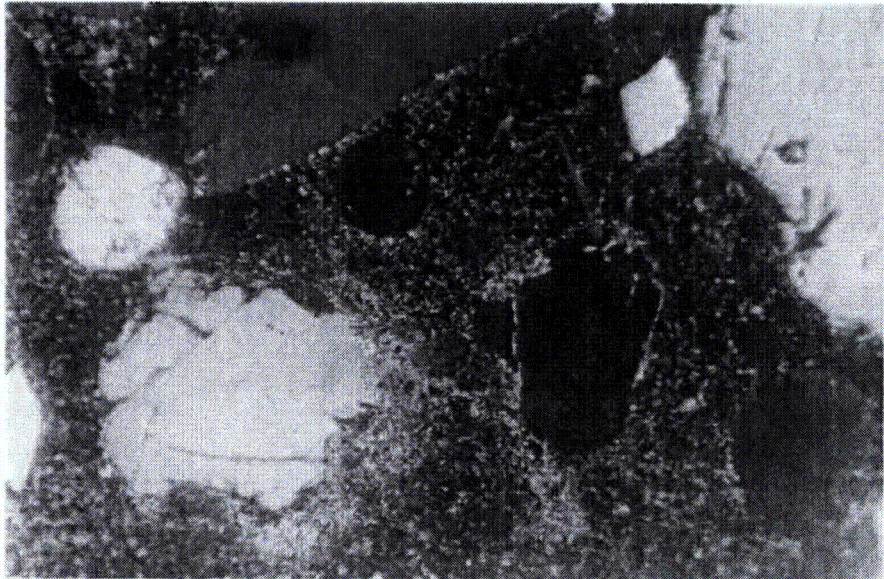
Photograph #20	Remarks

<p>Close up of the air void identified in photograph #19. Note the small mineral growth (red arrow). Width of view is approximately 0.5 inch.</p>

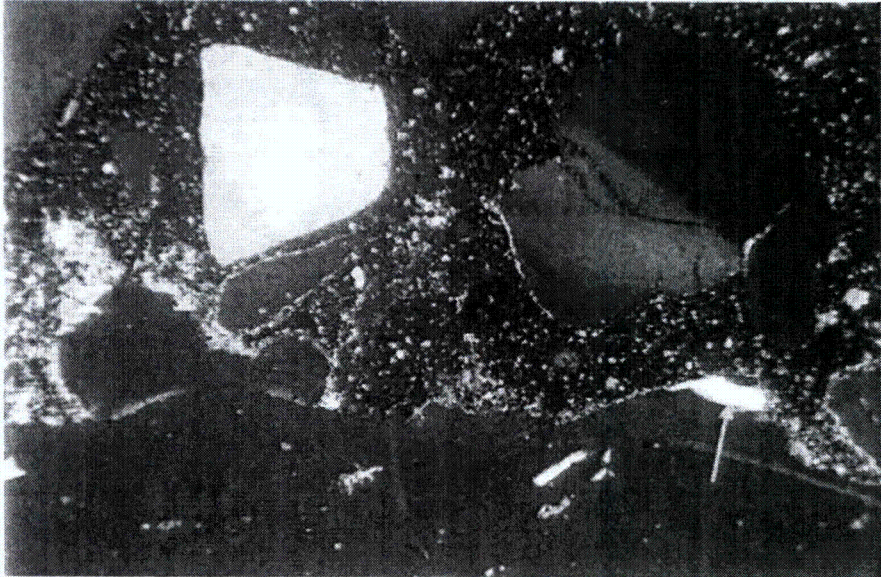
Photograph #22	Remarks

<p>Same view as photograph #21 taken with cross polarized light. The red arrow points to an air void with mineral growth (white area around void). The blue arrow points to a fractured surface (note lack of mineral deposits). The yellow arrow points to a fractured piece of quartz. Width of view is approximately 0.5 inch.</p>

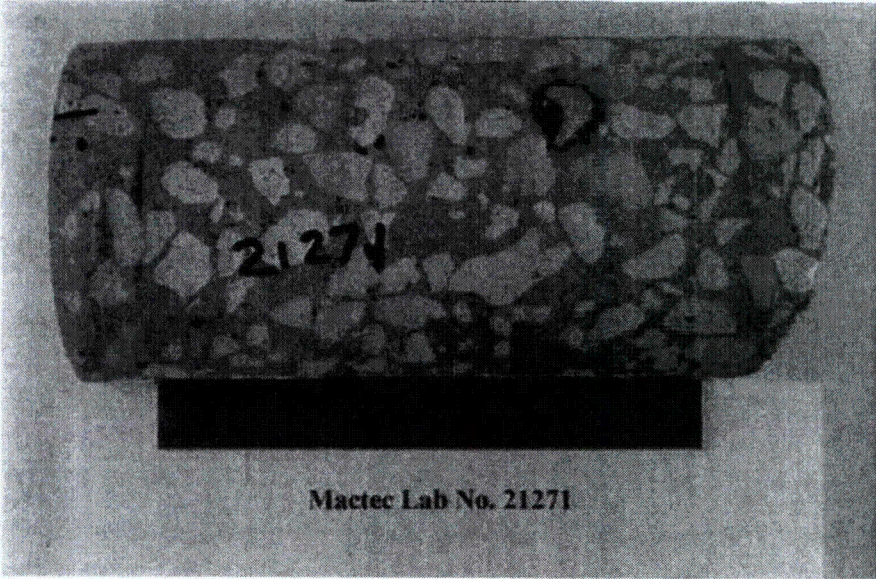
Photograph #1	Remarks

<p data-bbox="553 911 818 940">Mactec Lab No. 21271</p>	<p data-bbox="1149 407 1416 527">Core 21271 as received. The exterior surface is to the left. The fracture surface is to the right.</p>

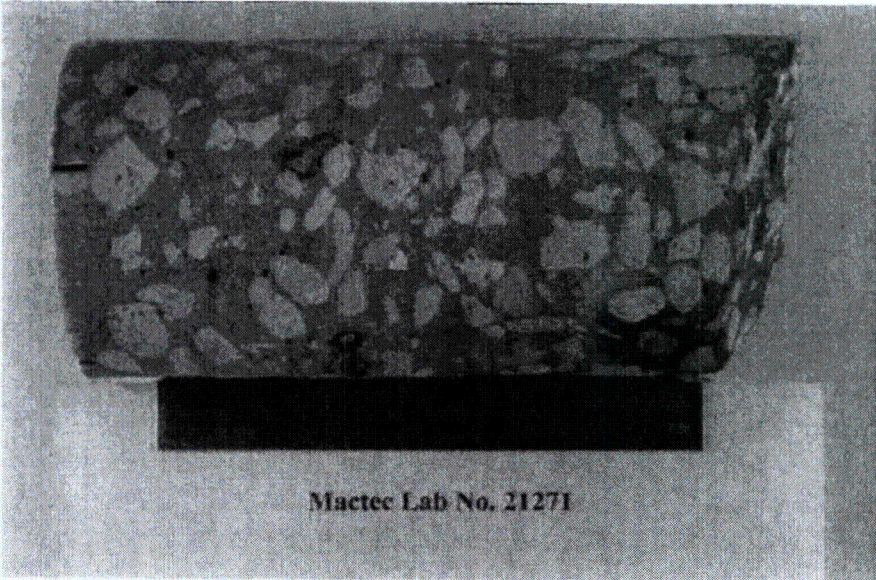
Photograph #2	Remarks

<p data-bbox="553 1703 818 1732">Mactec Lab No. 21271</p>	<p data-bbox="1149 1194 1403 1346">Core 21271 as received. The exterior surface is to the left. The fracture surface is to the right.</p>

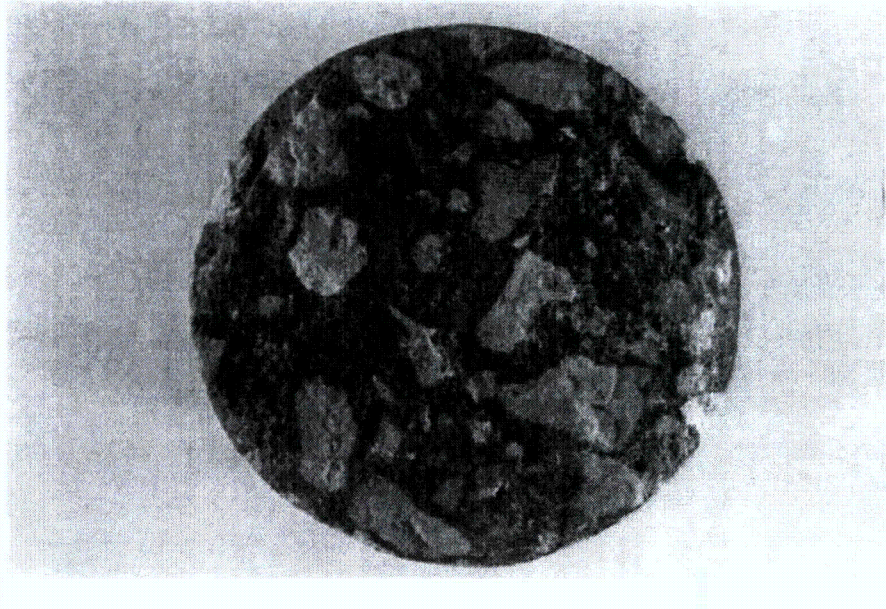
Photograph #3	Remarks

- The edge of the fractured surface had sharp distinct edges.
- Generally the coarse aggregate (predominately limestone) fractured as opposed to being pulled out of the cement paste matrix.
- The fine aggregate (predominately quartz) generally was pulled out of the cement paste although it appeared that a few pieces of the quartz did fracture.
- The paste portion of the fractured surface did not appear carbonated and produced a pink color when phenolphthalein was applied.
- Some of the air voids that were exposed on the fractured surface had some mineral grown in them. We did not observe the mineral growth on the fractured surface around these subject voids.
- Pieces of this sample were purposely fractured in our laboratory and the purposely fractured surfaces had similar observations to the submitted fractured surface.

The fracture surface of core 21271.

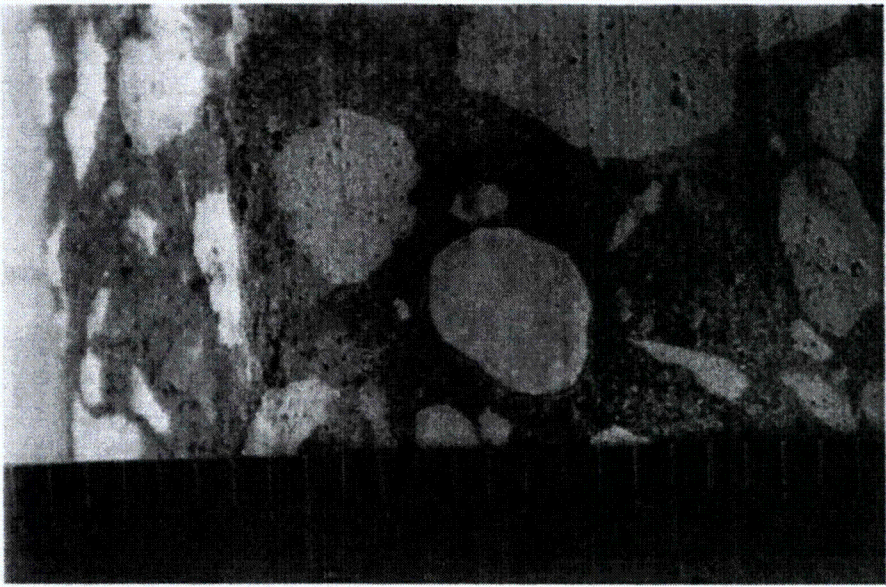
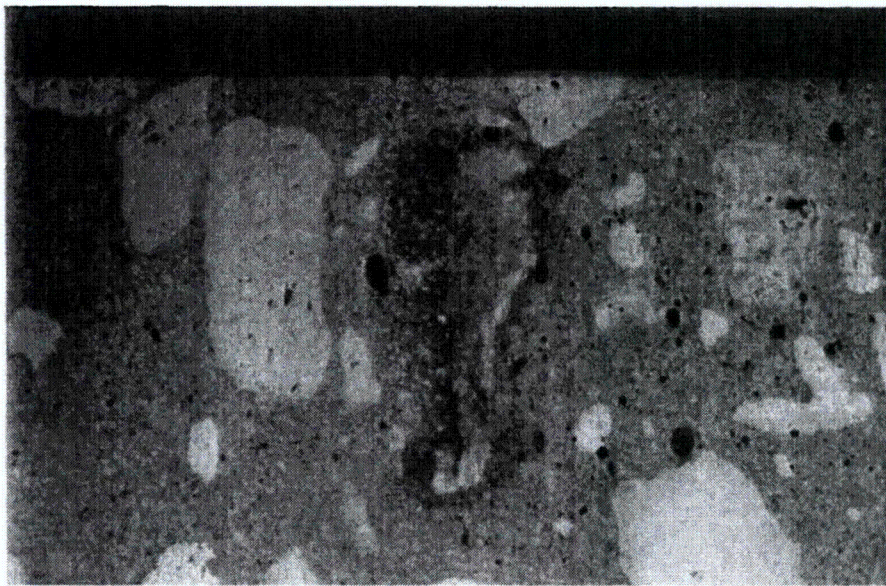
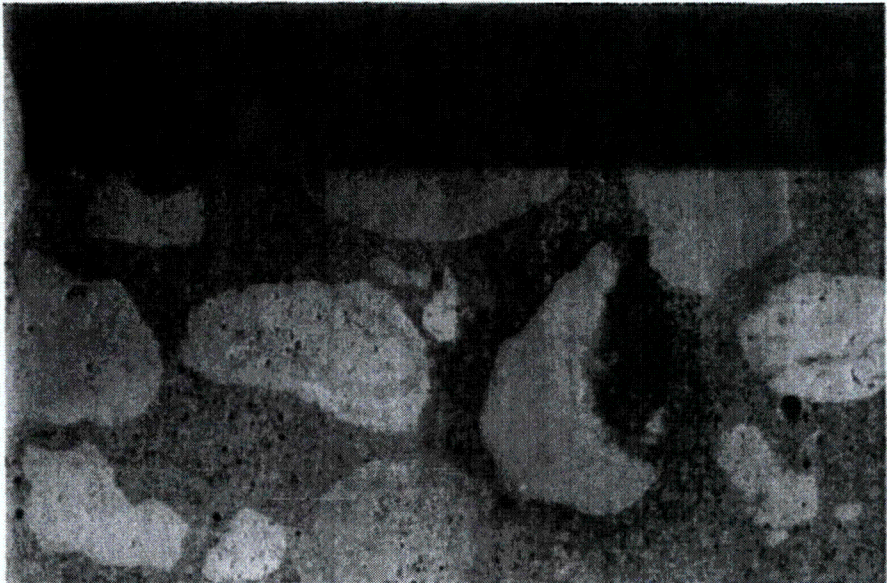
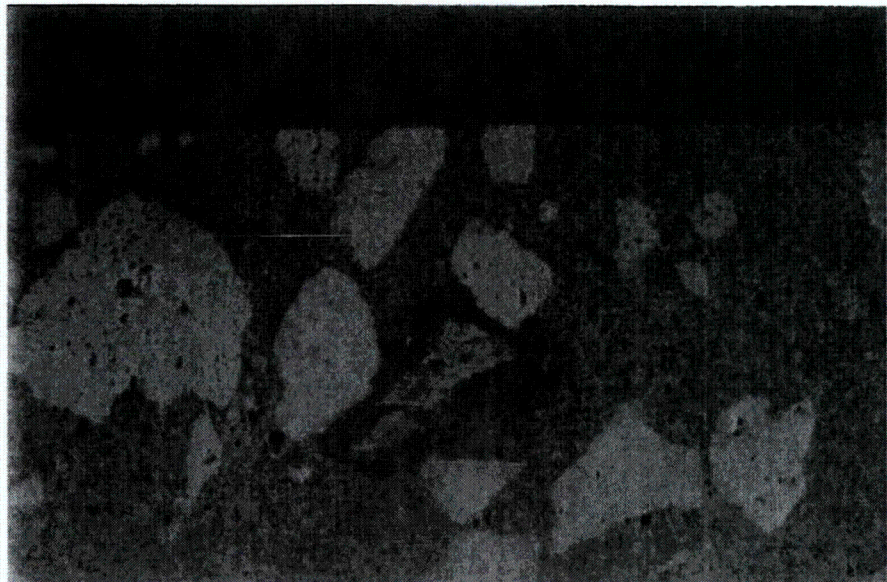
On sample 21271, there were 4 coarse aggregate pieces on the cut surface of the core that retained moisture (and moisture in the surrounding paste) longer than other portions of the sample. These pieces are shown in Photographs 5, 6, 7, and 8. One of the pieces (Photograph 5 for core 21271) had a darkened rim. A thin section was prepared from the piece in photograph 7 and this piece contained microcrystalline quartz and radial silica and exhibited localized evidence of alkali silica reaction.

<p>An aggregate particle on the cored surface. This particle has a darkened rim and the area around the particle appeared to retain moisture longer than the rest of the core. Marks on the ruler are 0.1 inch.</p>

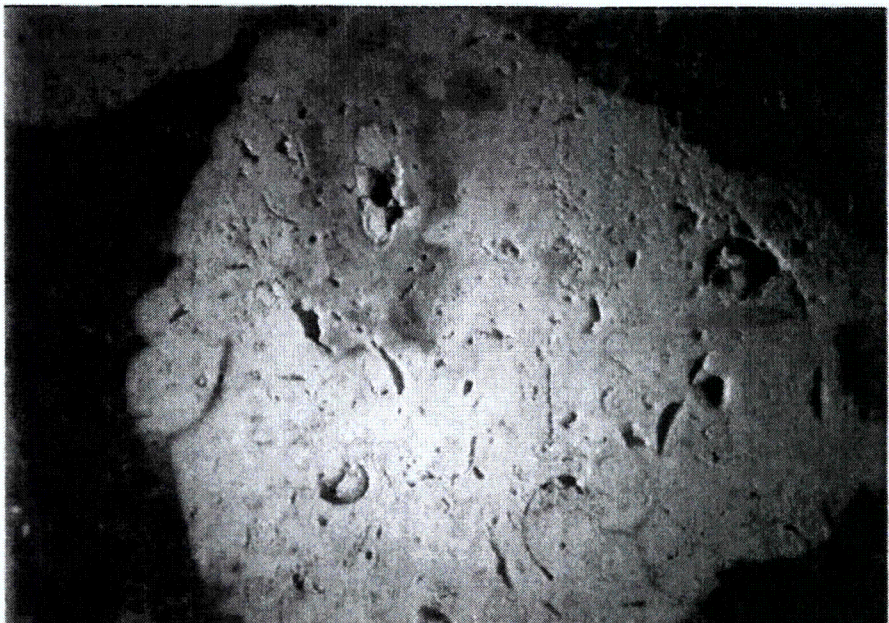
Photograph #9	Remarks

<p>Close up of the polished sections showing voids in the coarse aggregate. Width of view is approximately 0.8 inch.</p>

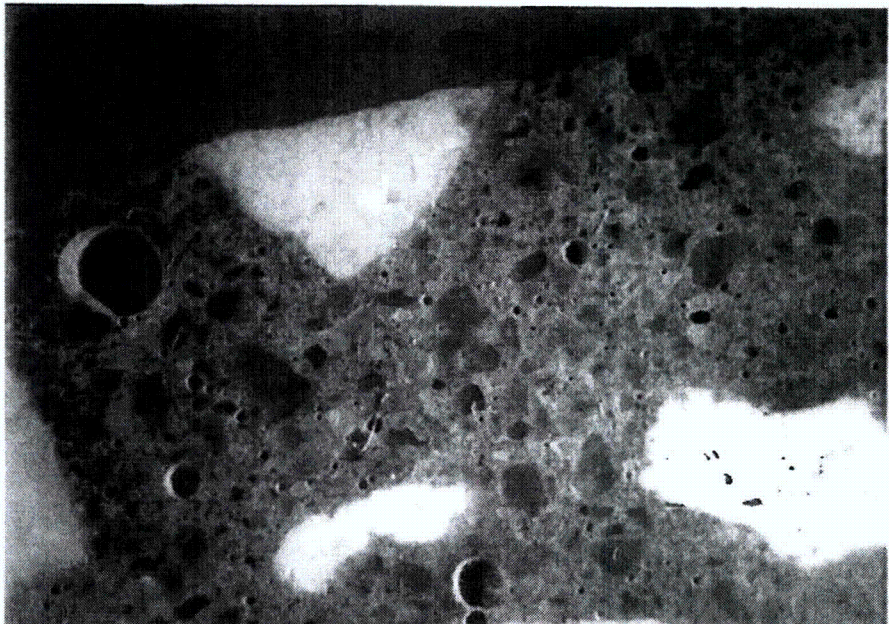
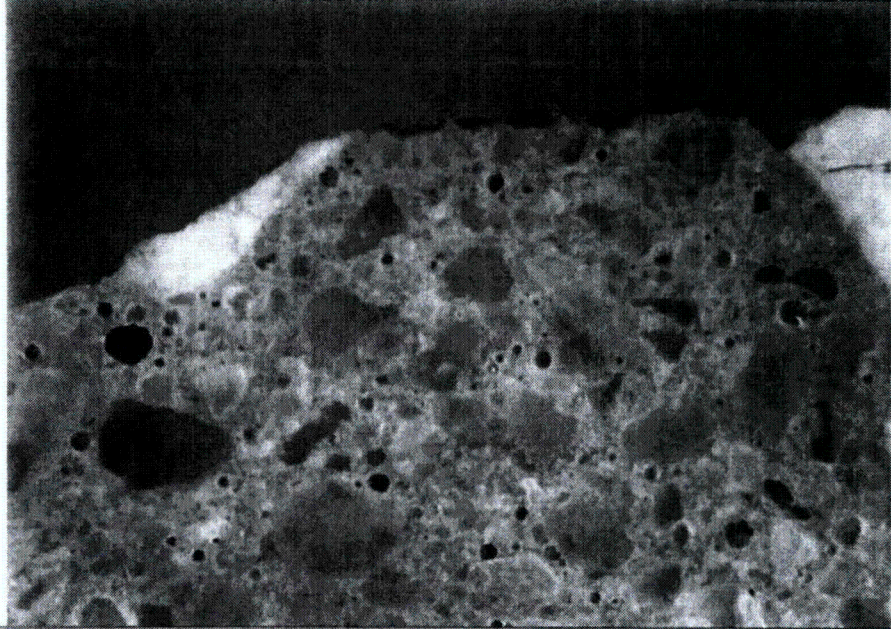
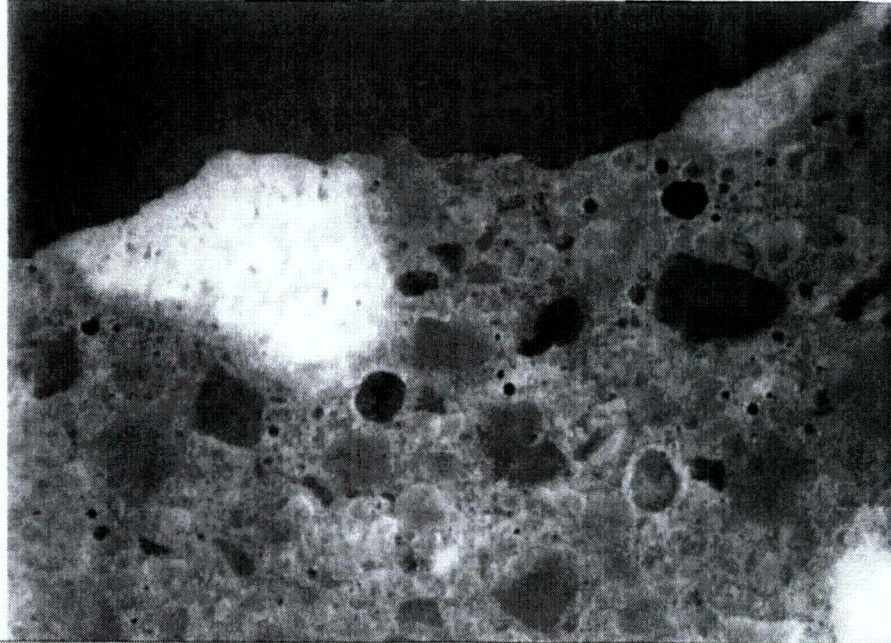
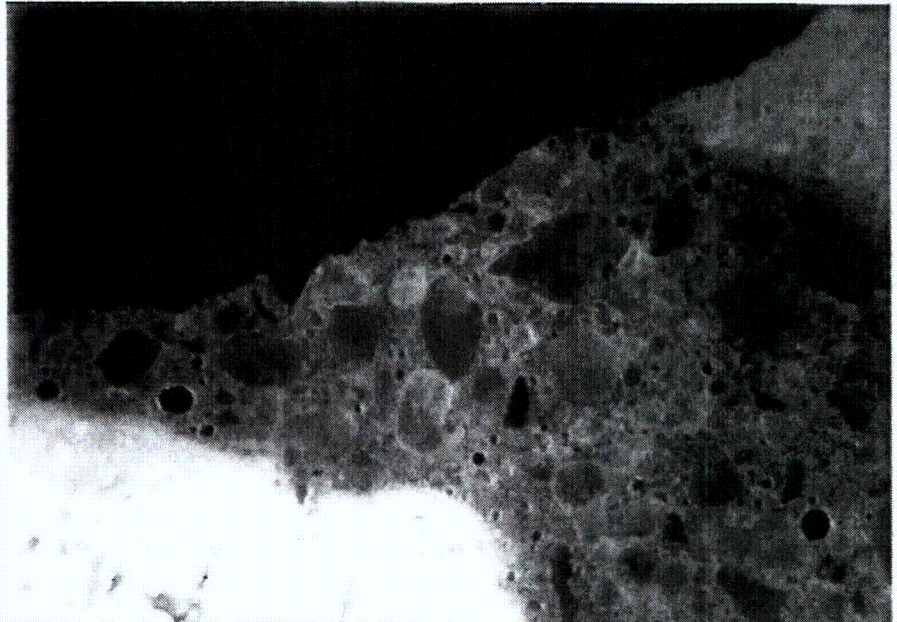
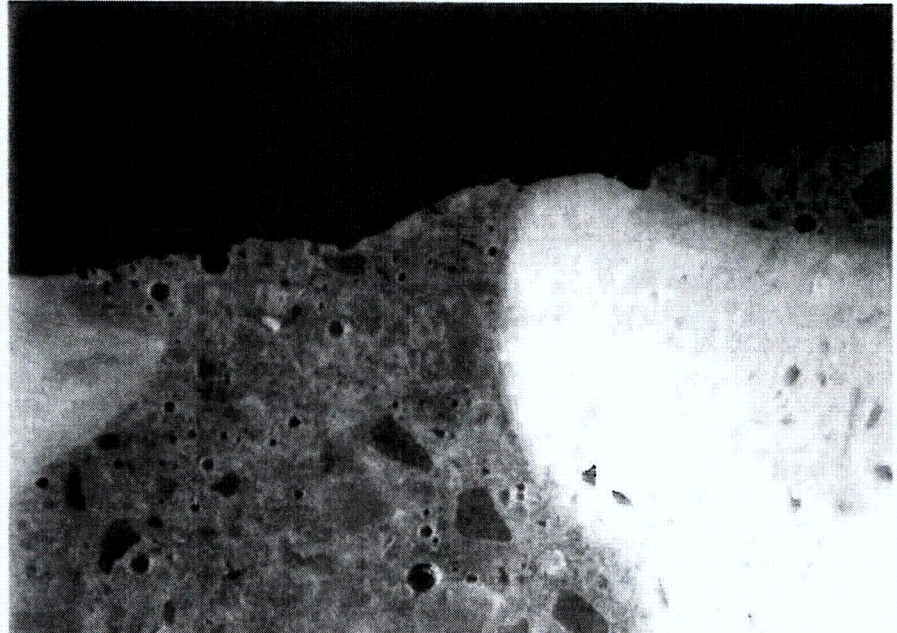
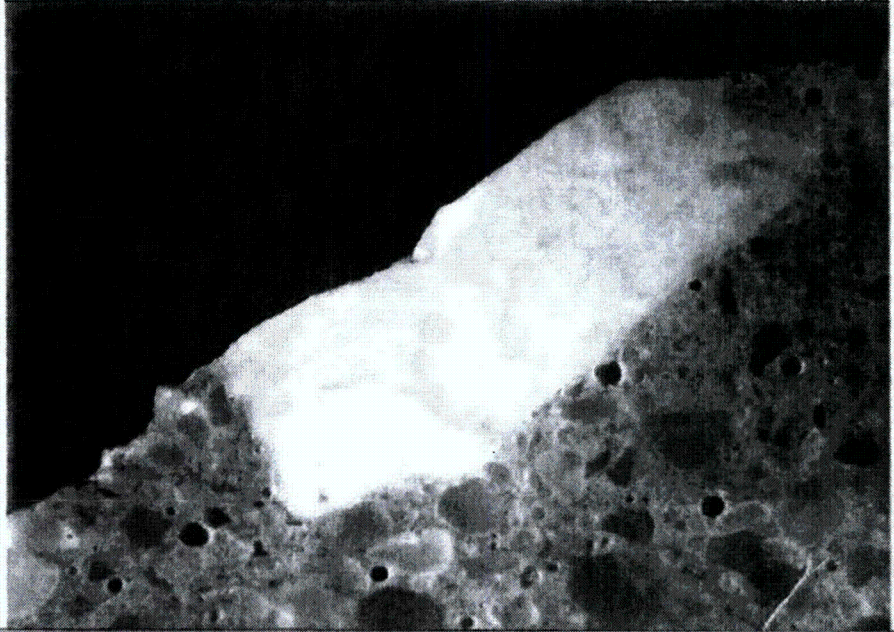
<p>Close up of the polished sections showing the fracture surface (top of photograph). Note uneven distribution of air voids. Width of view is approximately 0.4 inch.</p>

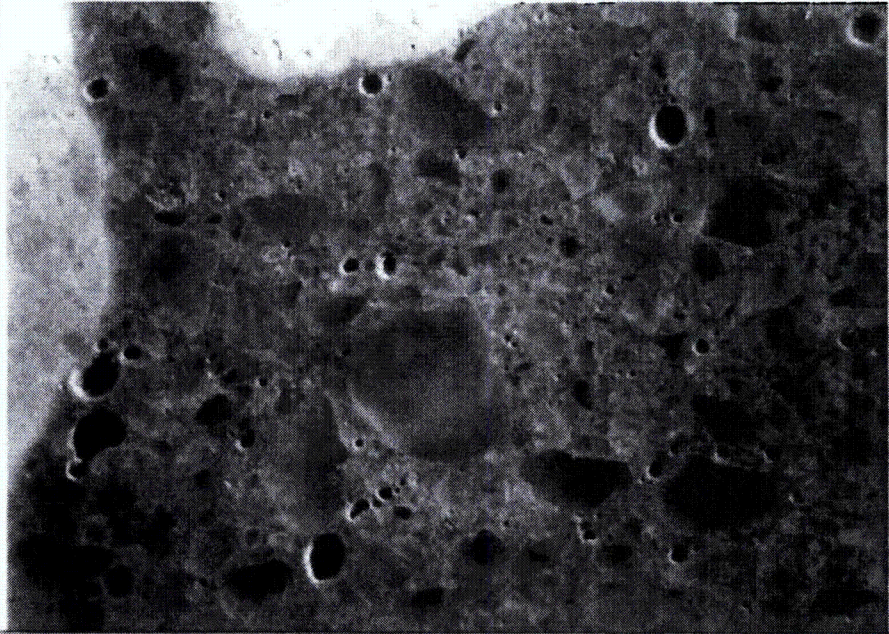
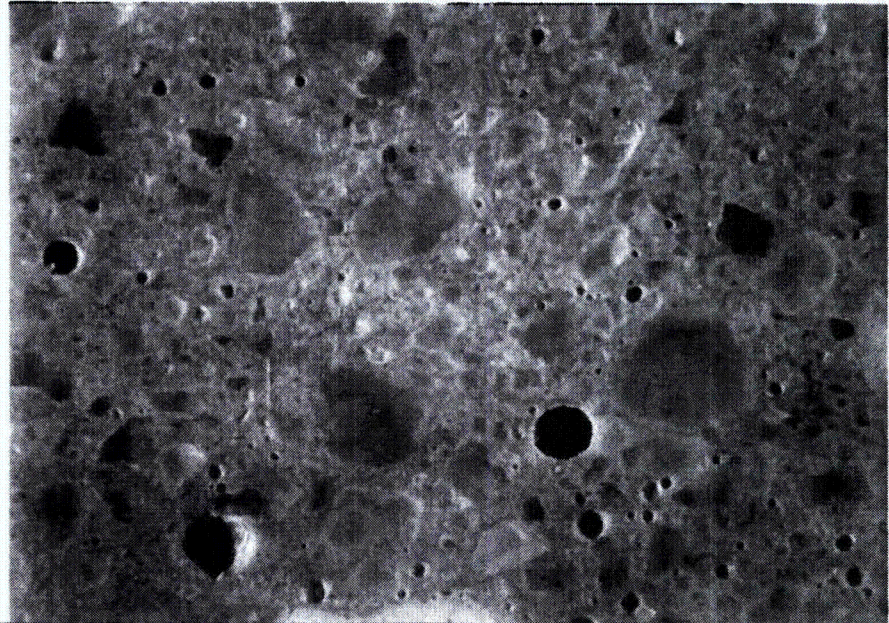
Close up of the polished sections showing the fracture surface (top of photograph). Note uneven distribution of air voids. Width of view is approximately 0.2 inch.

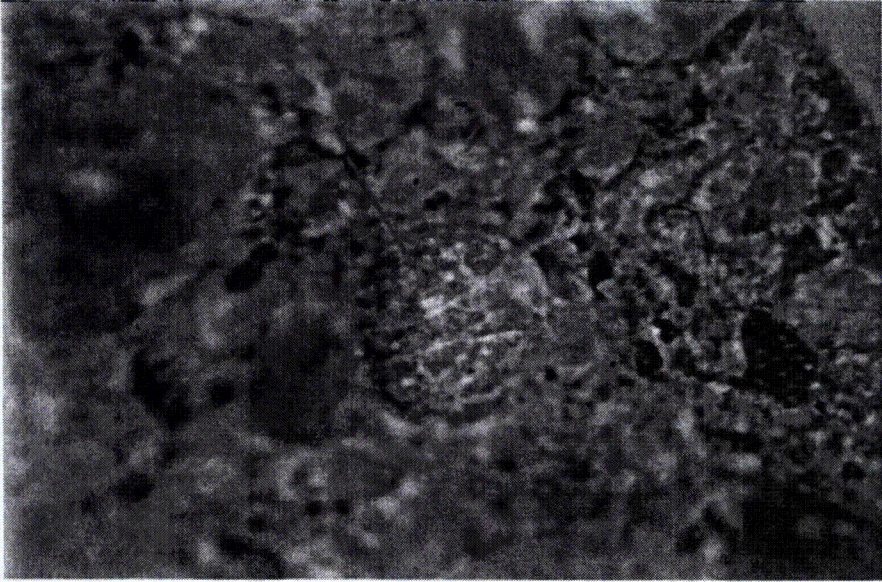
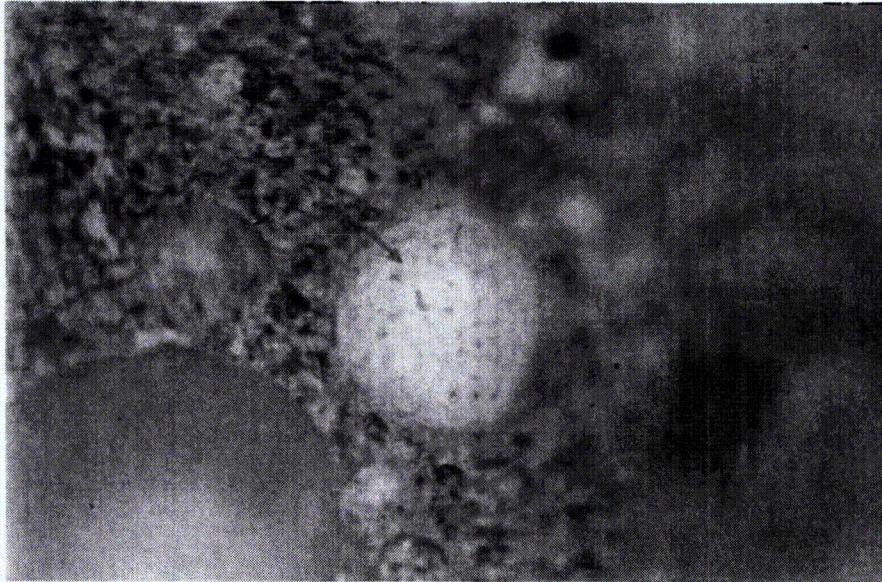
<p>Photomicrograph of the fractured surface showing an air void with some mineral growth (red arrow). Because of the un-even surface and the magnification the focal depth is limited and some areas of the photomicrograph are not in focus. Width of view is approximately 0.06 inch.</p>

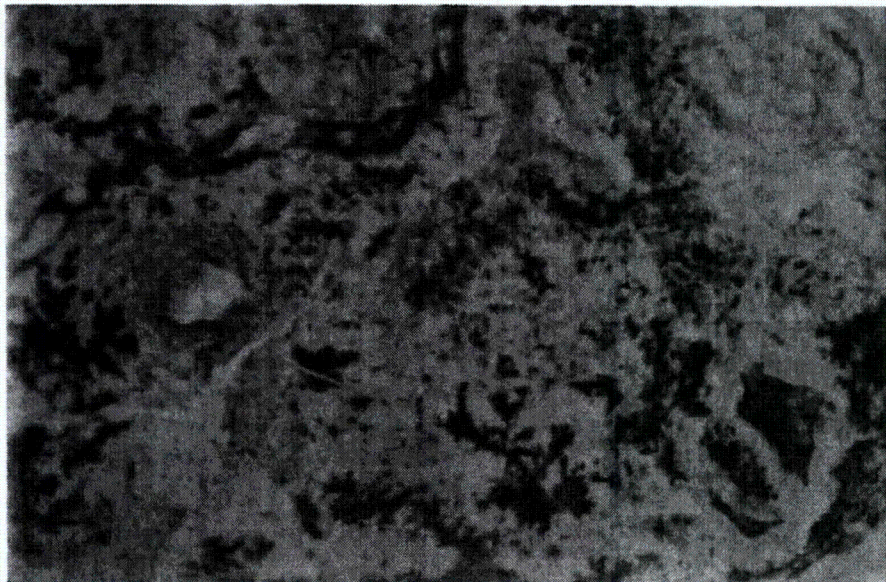
Photograph #26	Remarks

radial silica (essentially chert) with the limestone, several cracks were observed going through the portion which was predominately chert. There appeared to be minor amounts of ASR gel but a positive identification could not be made due to the small amounts present.
Contamination	Not observed.
<b>FINE AGGREGATE:</b>	
Shape	Generally sub-rounded to sub-angular
Grading	#4 and smaller
Distribution	Even
Texture	Fine
Composition	Siliceous
Rock Types	Quartz
Alteration:	Not Observed
- Degree	
- Products	
Coatings	Not Observed
Rims	Not Observed
Internal Cracking	A few internal fractures were observed
Contamination	Not observed.

<p>Cracking in a chert deposit in a limestone particle (red arrows). Width of view is approximately 0.5 inch.</p>
