From: Schroeder, Daniel *DS*
Sent: Thursday, April 15, 2010 10:18 AM
To: Conte, Richard; OHara, Timothy
Cc: Burritt, Arthur; Cline, Leonard; Wilson, Peter; Kaufman, Paul
Subject: RE: draft problem summary on SL 1 AFW
Attachments: SL1 AFW Degradation Coating Failure rev1.doc

From: Conte, Richard *DS*
Sent: Wednesday, April 14, 2010 4:22 PM
To: OHara, Timothy; Schroeder, Daniel
Cc: Burritt, Arthur; Cline, Leonard; Wilson, Peter; Kaufman, Paul
Subject: draft problem summary on SL 1 AFW

Problem Summary:

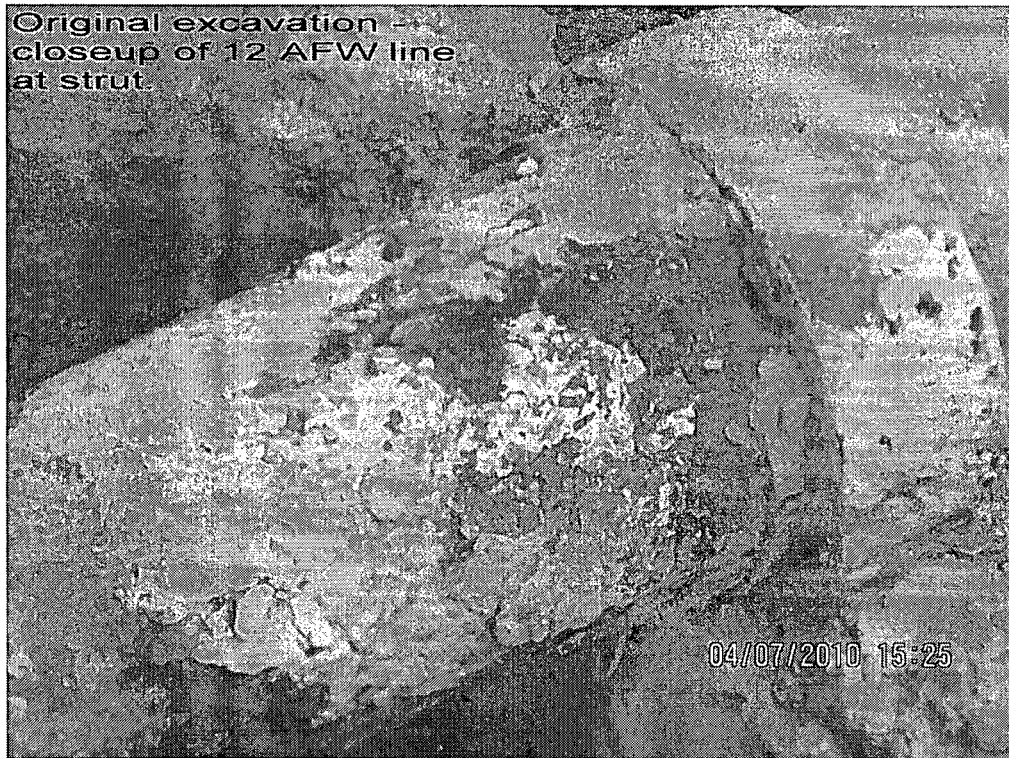
Example picture

Two of four AFW lines are buried on each Salem Unit. On Unit 1, approximately 150' of piping between the pumps in the Auxiliary building to SG #12 and to SG #14 are buried. Only the buried portions are in question here because they are inaccessible for inspection per the Code. The remainder of the non-buried piping in the AFW system is included in the ISI Program and is inspected via code qualified UT. The 150' is an estimate from several prints and several of the PSEG engineers - 2 runs of 4", schedule 80, carbon steel pipe of about 150' each - total of about 300'.

Regarding the min wall situation, not all of the limited Code UT are below calculated min wall of 0.278" (nominal is .337") for a rated pressure of 1950 psi.

PSEG had ordered replacement pipe.
