UNITED STATES
NUCLEAR REGULATORY COMMISSION
REGION I
475 ALLENDALE ROAD
KING OF PRUSSIA, PA 19406-1415

August 10, 2010

SUBJECT: SALEM NUCLEAR GENERATING STATION, UNIT NOS. 1 AND 2 –
NRC INTEGRATED INSPECTION REPORT 05000272/2010003 and
05000311/2010003

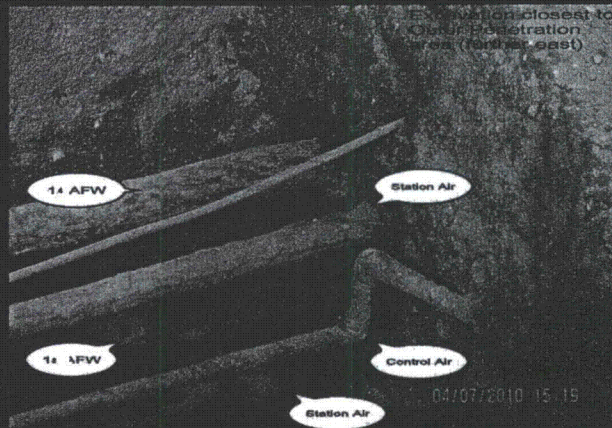
Salem Excavation

AFW System Piping, Control Air & Station Air: The inspectors reviewed PSEG's discovery, reporting, evaluation and the repair/replacement of Unit 1 AFW piping that was excavated for inspection during the April 2010 Unit 1 refueling outage (1R20). PSEG conducted this inspection in accordance with PSEG's Buried Piping Inspection Program. Additionally, the inspectors reviewed the UT testing results performed to characterize the condition of the degraded Unit 1 buried AFW piping.

Analysis. Visual inspections and UT measurements completed by PSEG on Unit 1 AFW buried piping in April 2010 identified degraded pipe coating and wall thinning on a portion of the excavated pipe. Considering the effect of this identified degradation, not performing the ASME Code, Section XI, paragraph IWA-5244 required pressure test at the required frequency for this normally inaccessible buried piping would result in an undetected loss of structural integrity for buried Unit 1 AFW discharge piping. The inspectors determined this was a performance deficiency.
