Summary of Telecon Internal to NRC staff 4/28/10

Problem Summary:

As a result of implementation the PSEG buried pipe program, significant degradation of the No. 14 and 12 Auxiliary Feedwater Piping was identified - the yard section was replaced and the FHB section was abandoned in place with new piping routed above grade inside the FHB with code compliant pressure testing in each of the sections. Based on inspector questioning, PSEG wrote an internal notification reporting that the ASME code required pressure drop test for buried Class 3 piping (an inservice inspection) had never been done (IWA-5244 test). PSEG then entered a number of TS LCO for AFW and structural integrity (????) and the section 4.0 of the TS and starting developing operability determination for Unit 2 current operations and Unit from an historical viewpoint. See attachment 5 for development of facts on the issue.

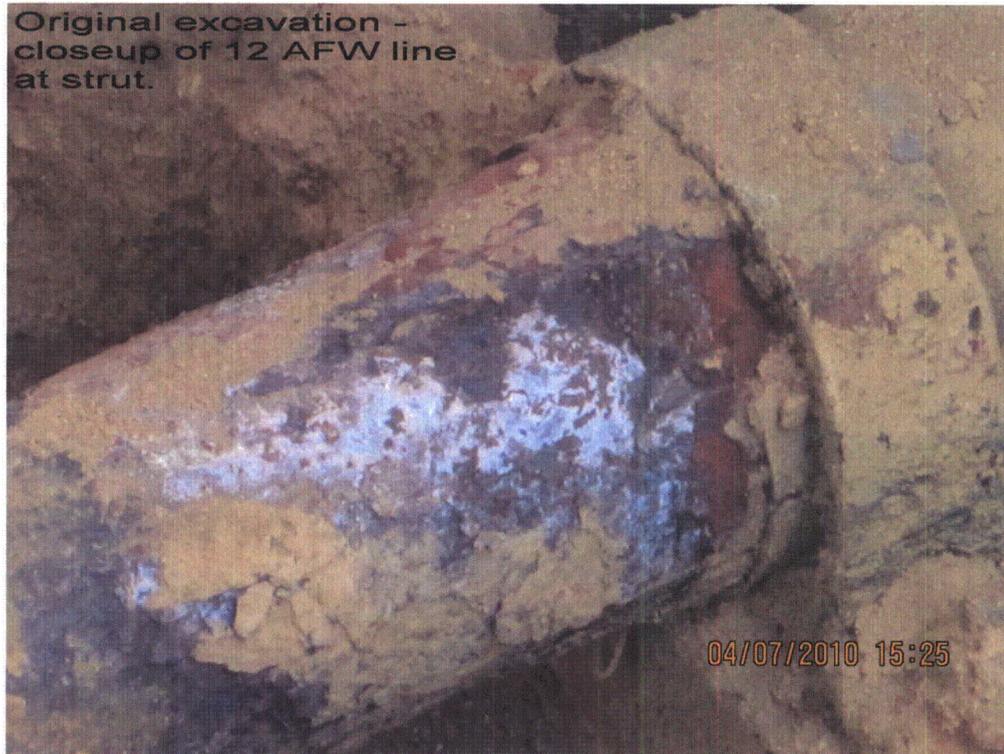
Example picture

On the deep section of piping for headers 12 and 14, the licensee has excavated a small portion of the down comer that leads to the deeper piping. They performed ultrasonic testing (UT) around the elbow at the top of this down comer (depth of approx 4 ft), which was completely submerged in groundwater. The minimum wall thickness measured in this area was ~0.226",

which was greater than the minimum required wall thickness of 0.200". In addition the licensee performed a guided wave pipe inspection on a portion of the straight run of the deep section of piping (approximately 20 ft in length at a depth of approx. 17 ft). The results indicated less wall thinning on this section of piping than the guided wave results indicated for the shallow section of piping. The licensee has also confirmed that the deep section of AFW piping was coated similar to the shallow section of piping.

Based on the results of the UT around the elbow and the results of the guided wave in the 20-ft section of deep piping, the licensee plans no further excavation of the deep section of piping. The licensee's current plans are to recoat all of the piping exposed during excavation that will not be replaced, in both the shallow and deep sections, and then following the completion of pipe replacements for the significantly degraded exposed pipe sections, hydro the entire line, both the shallow and deep sections. The licensee will use these hydro results to support operability of the deep section of piping for the next operating cycle.
