**UNITED STATES  
NUCLEAR REGULATORY COMMISSION**  
REGION II  
245 PEACHTREE CENTER AVENUE NE, SUITE 1200  
ATLANTA, GEORGIA 30303-1257

**SUBJECT: WATTS BAR NUCLEAR PLANT UNIT 2 CONSTRUCTION - NRC INTEGRATED  
INSPECTION REPORT 05000391/2010604**

Enclosure: Inspection Report 05000391/2010604 w/attachment

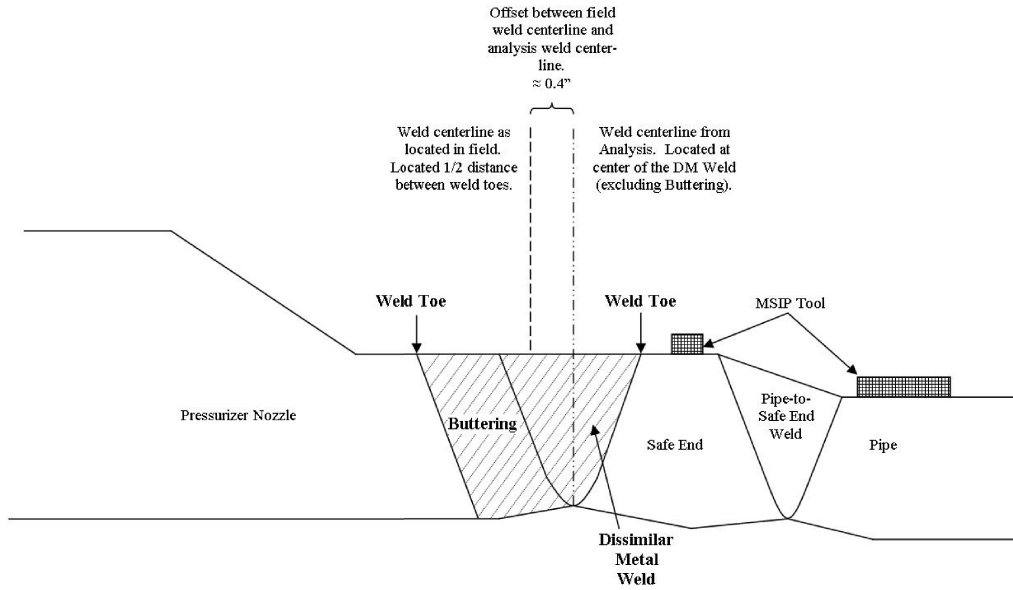
**FIGURE 1**

On July 22, 2010, the inspectors observed the process of identifying the weld centerline for the pressurizer surge line nozzle DM weld (2-WP-10- SE) using the same procedures described above. However, in this instance NuVision Engineering (contractor) personnel performed the process in conjunction with TVA personnel. Weld toe markings had previously been applied at the safe end weld toe (see Weld Toe B on Figure 1), but the carbon steel nozzle weld toe had not been marked (see Weld Toe A on Figure 1). The inspectors observed TVA personnel apply a low-stress "V" stamp to the carbon steel nozzle weld toe. This location was easily identifiable with the naked eye and, therefore, ET examination was not required. The inspectors then questioned NuVision Engineering personnel on the method to be used to locate the weld centerline and observed the identification of the weld centerline using a process of measuring the distance between the previously located toes of the weld and marking one half the distance between them. This process was consistent with procedure N-GP-8. The centerline mark was confirmed as correct by PCI QC personnel. However, the joint configuration of the surge line nozzle included a layer of weld butter on the carbon steel nozzle side (see Battering on Figure 1), which resulted in an offset between the field marked centerline and the centerline required by the stress analysis (4387-4-001-01, NuVision Engineering, "Analytical Verification of MSIP for Pressurizer Surge Nozzle to Safe End Weld Watts Bar Units 1&2," Revision 1) that was approximately 0.40", and outside the allowable tolerance of  $\pm 0.25$ " provided by the stress analysis calculation. The licensee did not apply MSIP to the pressurizer surge line, and began development of a detailed procedure specifically created to mark the correct weld centerline for the pressurizer surge line nozzle.

The inspectors determined that the licensee's incorrect marking of weld centerlines for the six pressurizer nozzles resulted from the licensee's failure to meet 10 CFR Part 50 Appendix B, Criterion IX, "Control of Special Processes." Specifically, the licensee did not provide a procedure with adequate guidance on how to establish the appropriate weld centerline, and QC checks were not documented with specific criteria or tolerances. The inspectors determined this finding was more than minor in accordance with Inspection Manual Chapter 2517, because it represented an uncontrolled work practice that could impact the quality of safety-related SSCs. This finding has a cross-cutting aspect in the area of Human Performance, H.2(c), because the licensee did not ensure complete procedures were available.

Inaccurate placement of the MSIP clamp based on incorrect marking of the weld centerline could result in inadequate compressive stresses at the DM weld inner diameter, which could increase susceptibility of the weld to PWSCC. The licensee captured this violation in their corrective action program in PER 241073.

Pressurizer Surge Line Nozzle Dissimilar Metal Weld Centerlines.
