Subject: September 2010 Inspection Report, Cameco Resources, Permits 603 & 633

**SEPTEMBER 2010 INSPECTION REPORT
DISTRICT 1/LAND QUALITY DIVISION**

COMPANY: Cameco Resources (CR), Highland Ranch, Permit #603
& Smith Ranch, Permit 633

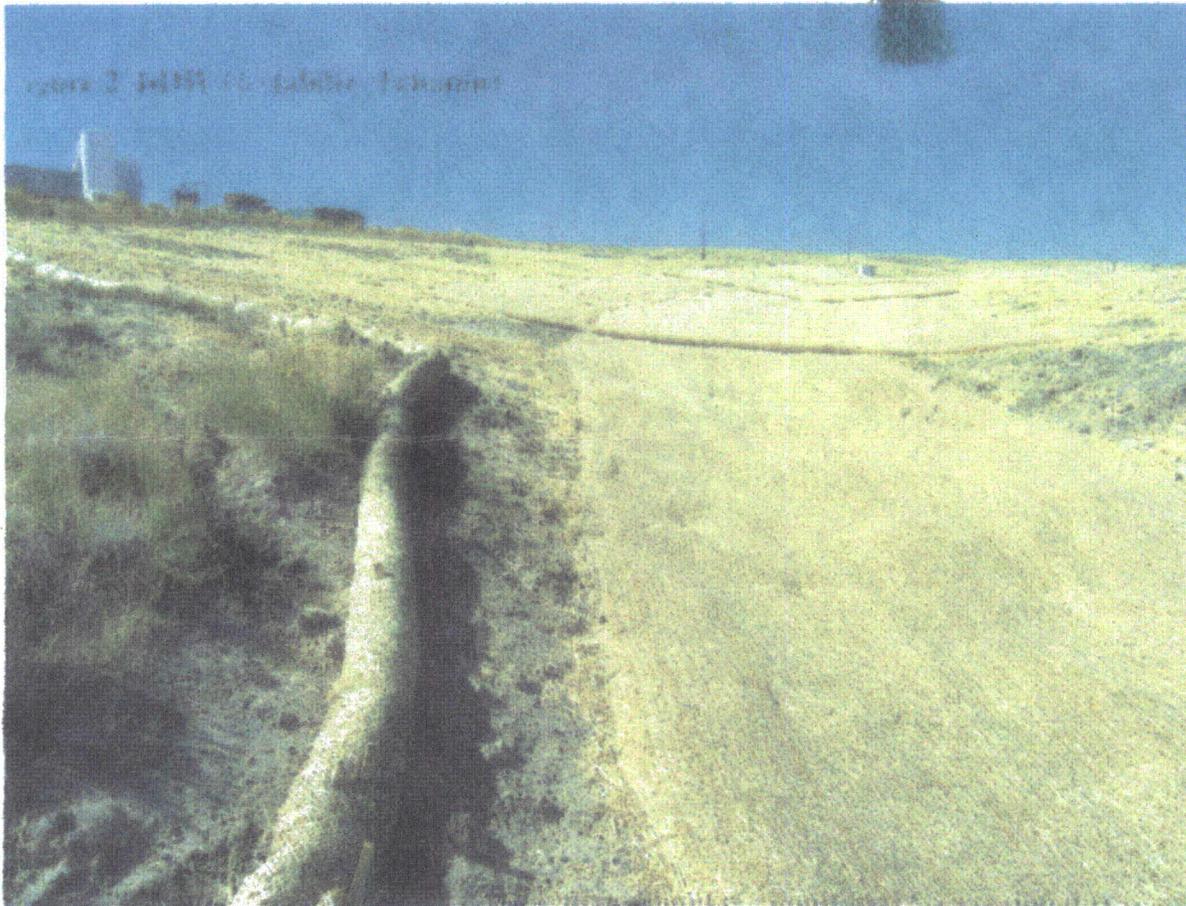
The well pad has been reclaimed in addition to the drainage west of the embankment which had failed and caused significant sediment in the drainage (Figure 1). A wellhouse now encloses the well. Topsoil was applied and seeded. A mesh fabric was used to stabilize the drainage until vegetation could stabilize the soil (Figure 2). Straw waddles were used at the top of the embankments along the drainage as well as across the drainage (spaced approximately 30- 40 feet) with stakes placed approximately 4 feet apart. There was new grass emerging in places.

Figure 1 Reclaimed DDW #6

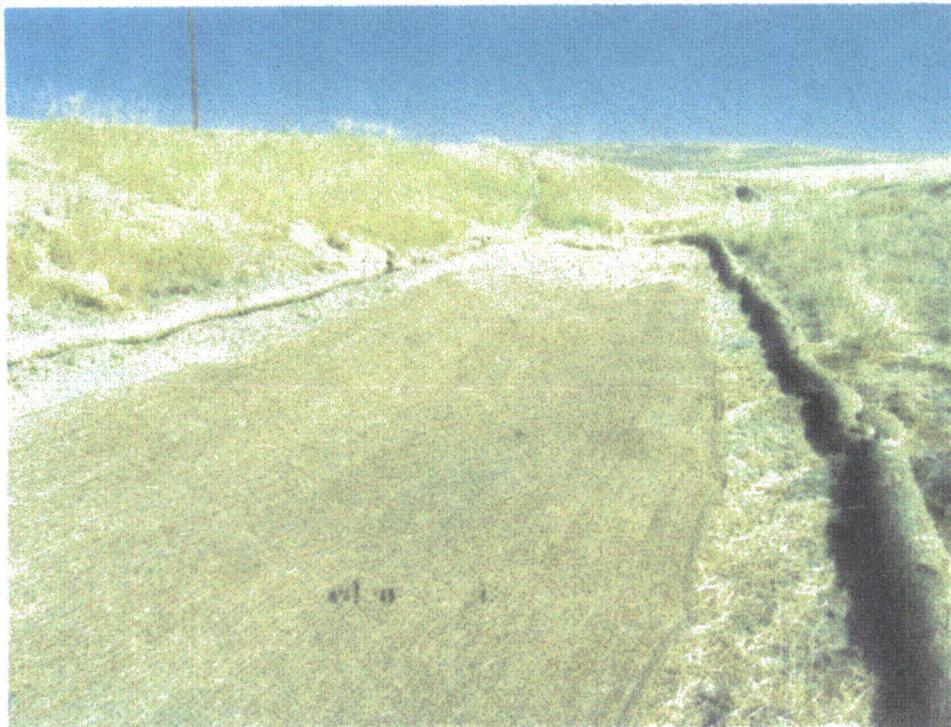
Figure 2 DDW #6 stabilized channel

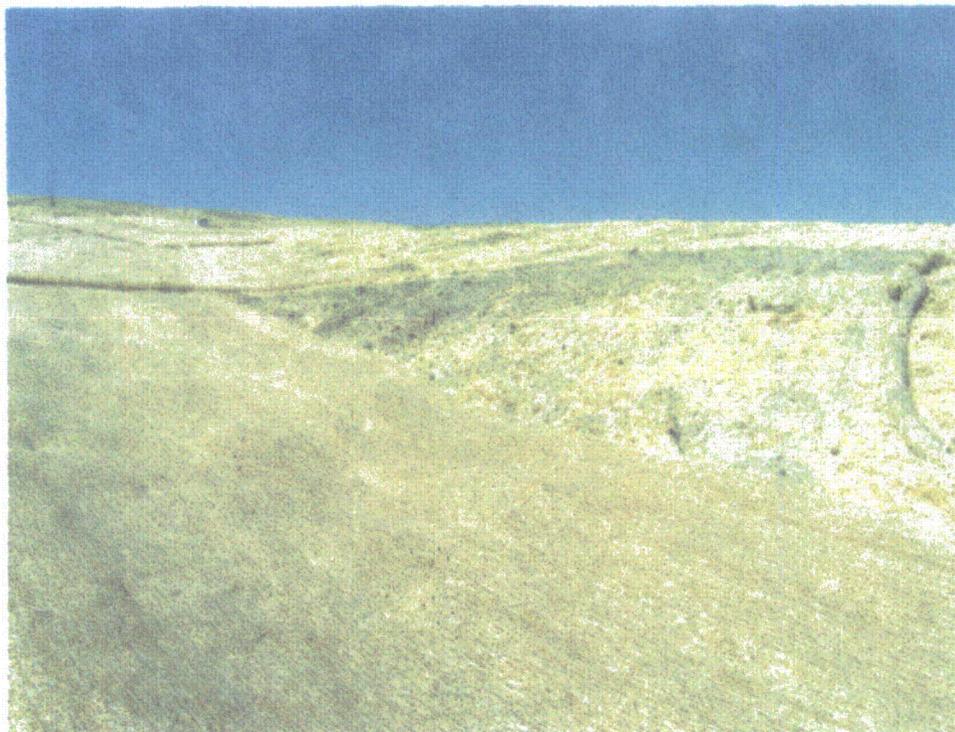
The reclamation appeared adequate. An area of the slope break from the top of the reclaimed pad should be monitored for erosion where there is limited mulch/fabric protection (Figure 3). There is potential for rilling which could undercut the fabric below.

- 1 The reclaimed slopes at DDW#6 should be monitored for rill development which could undercut the erosion control fabric. The reclamation appears adequate; however, until vegetation is re-established, the slopes are not stable.
- 2 The re-vegetation in Mine Unit 9 has not been successful. LQD understands that CR is developing a plan to revegetate. LQD encourages the effort to complete the temporary reclamation of this wellfield. According to Noncoal Rules and Regulations, Chapter 3,

Figure 3 Reclaimed slope above channel that should be monitored for erosional rilling

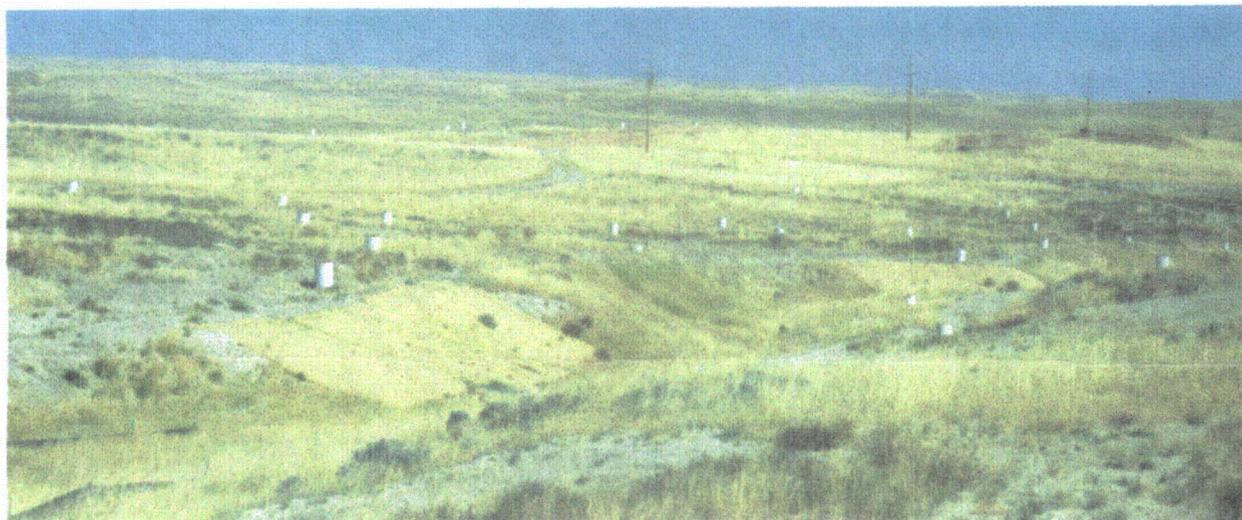
The ephemeral drainage through MU-9 was examined for slope stability. LQD inspectors had previously identified potential for erosion on the slopes following the apparent unsuccessful revegetation. CR has used biomats in locations along the drainage to provide stability and to help revegetate the slopes (Figure 4). The re-vegetation was not obviously successful since the installation of the biomats, however, no further erosion was noted on the slopes. The northeast end of the MU-9 reclamation was noted to be unsuccessful. CR is evaluating their seeding methods used for this area and developing a plan for re-application of seed. Noxious weeds were not noted in the reclamation. The south end of the wellfield had new mulch installed but it did not appear crimped into the soil.

Figure 4 Biomats installed in MU9 drainage
