**UNITED STATES  
NUCLEAR REGULATORY COMMISSION**  
REGION II  
245 PEACHTREE CENTER AVE., NE, SUITE 1200  
ATLANTA, GEORGIA 30303-1257

**SUBJECT: NRC INSPECTION REPORT NO. 70-27/2010-003 AND NOTICE OF VIOLATION**

Report No.: 70-27/2010-003

Babcock and Wilcox  
NRC Integrated Inspection Report 70-27/2010-003  
July 1 – September 30, 2010

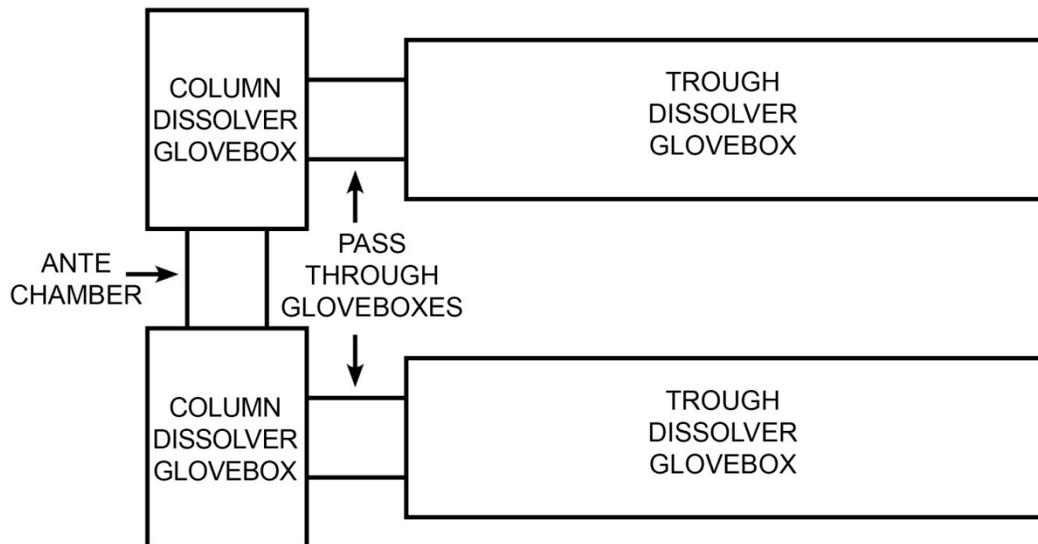
**Figure 1 – High-Level Dissolver Enclosure Top View**

The licensee dissolves high-enriched uranium in two trough dissolvers in the uranium recovery area. The trough dissolvers are part of a large enclosure consisting of six gloveboxes and an ante-chamber. The enclosure arrangement (shown in Figure 1) consists of two column dissolver gloveboxes, two trough dissolver gloveboxes, two pass-through gloveboxes each connecting a column dissolver glovebox with a trough dissolver glovebox and an ante-chamber connecting the two column dissolver gloveboxes. The column dissolver and trough dissolver gloveboxes have multiple drains but the pass-through gloveboxes did not have drains.

Following glovebox flushing operations on June 11, 2010, UR area operators observed approximately one-liter of solution at the bottom of one of the pass-through gloveboxes in the high-level dissolver enclosure. The concentration of the solution was determined to be 26 grams U-235/liter. After the event the licensee cleaned both pass-through gloveboxes to remove any residual material that was in the pass-through gloveboxes. The licensee measurements indicated that a total of 111.65 grams of solid U-235 was

removed. The licensee determined that presence of fissile solution in the pass-through glovebox represented an unanalyzed condition that failed to meet the performance requirements of 10 CFR 70.61 for NCS.

The inspectors reviewed the criticality safety analysis for the process and interviewed the responsible criticality engineer. The original analysis for the process did not anticipate or analyze for the presence of solution or material being left in the pass-through glovebox. The inspectors determined that the 26 grams U-235/liter solution that was found in the pass-through glovebox was below the license limit of 573 grams of U-235 for a fully reflective system ( $k$ -effective = 0.95). The solution was more than a minor safety concern because the licensee had failed to analyze the accident sequence and therefore the licensee had failed to establish IROFS to prevent a nuclear criticality accident in the pass-through glovebox.
