**RE: 2010 Partial Inspection Report, DN 236, Cameco Resources**

## 2010 REPORT OF PARTIAL INSPECTION

**COMPANY:** Cameco Resources (CR), DN236

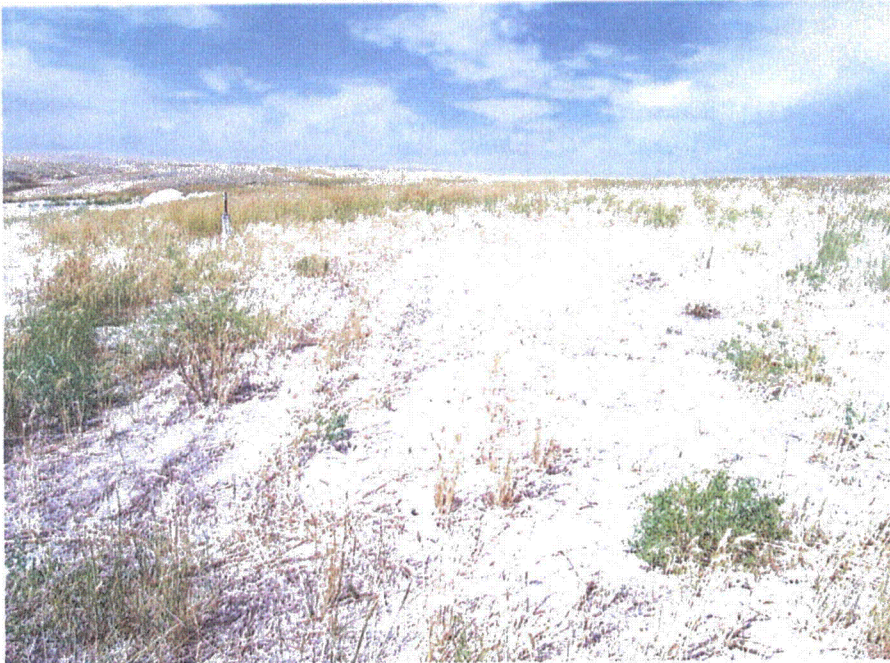
**Figure 1 View of plugged and reseeded drill hole site**

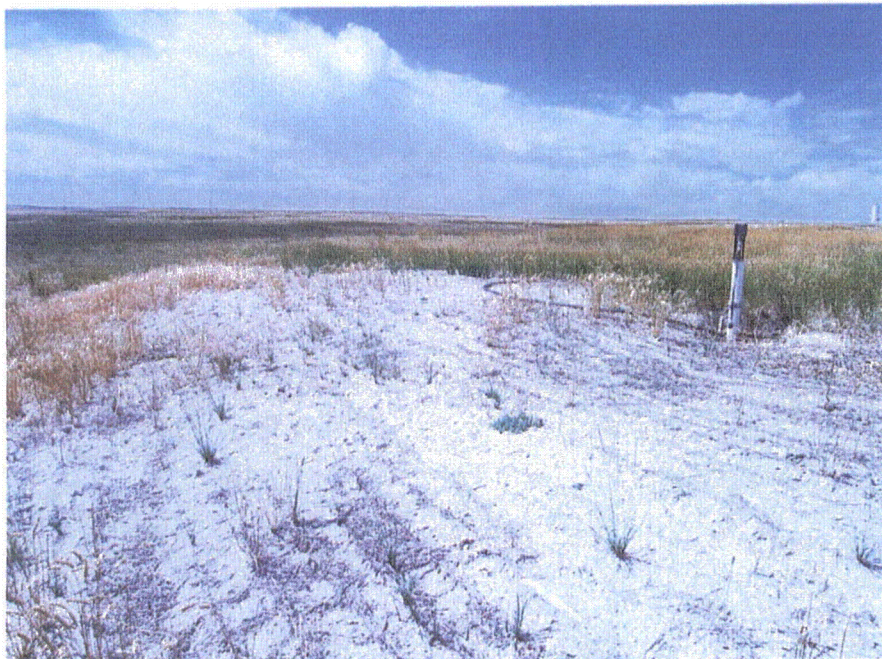
**Figure 2 View of plugged and reseeded drill hole site**

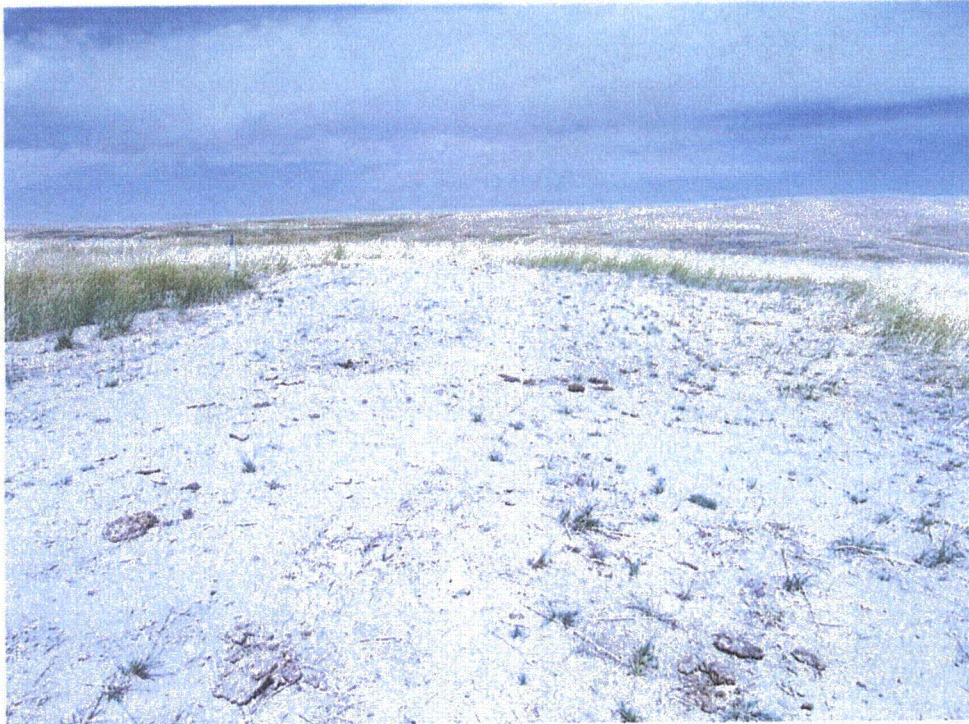
**Figure 3 View of graded site with no evidence of seeding**

- 1 CR should reseed the sites where vegetation is not evident or very poor.
- 2 CR must address the potential open hole with proper abandonment practices and regrade the open pit.
- 3 The inspection resulted in a determination that the reclamation bond remains a requirement for the eight drill sites until LQD better understands the work completed at these sites. CR will need to describe the reclamation completed, i.e., grading and seeding dates for the drill holes listed in the report. If wells were subsequently installed that carry a separate reclamation bond for the same disturbance area, CR should explain this as a double bonded site and show it on a map and in the surety. LQD will consider reviewing a request to release the bond for the drill holes if it is bonded separately for a well. The descriptions should be as detailed as possible for LQD to review the overlapping sites.

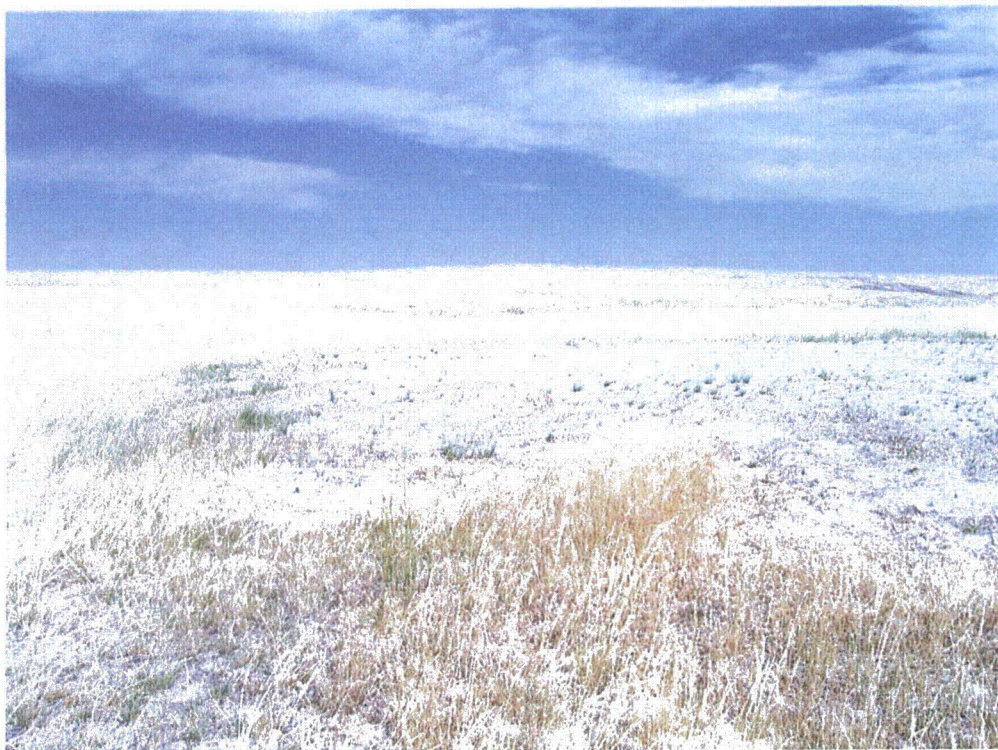
**Figure 4 View of graded site with no evidence of seeding**

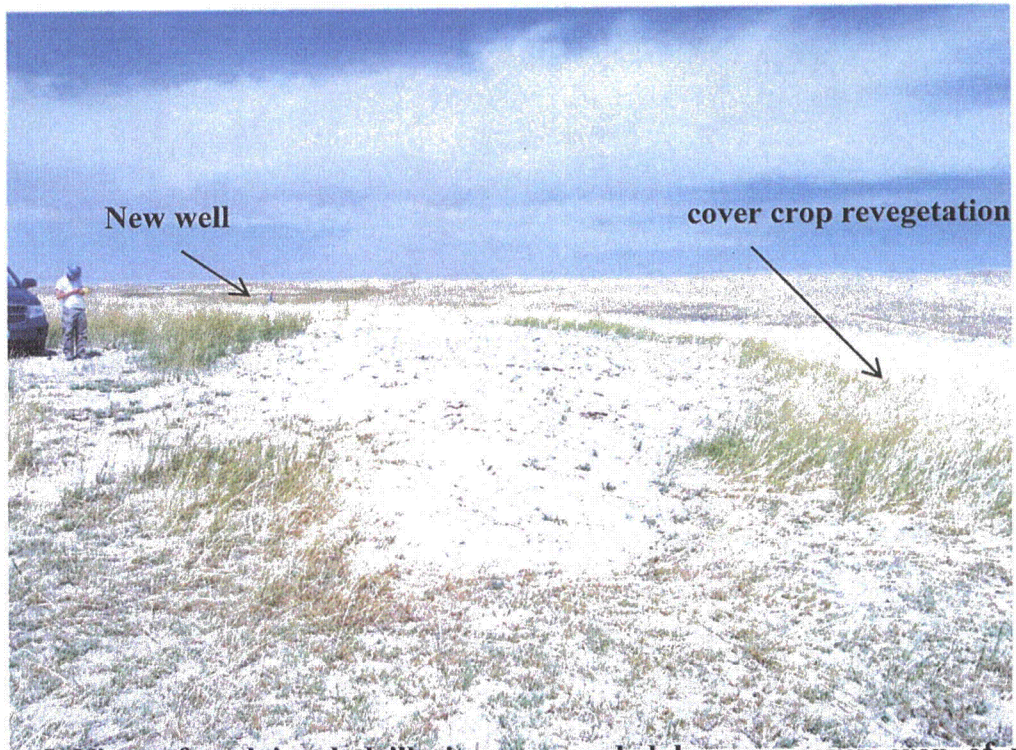
**Figure 5** View of reclaimed drill site surrounded by new cover crop of recent reclamation, also showing a new well

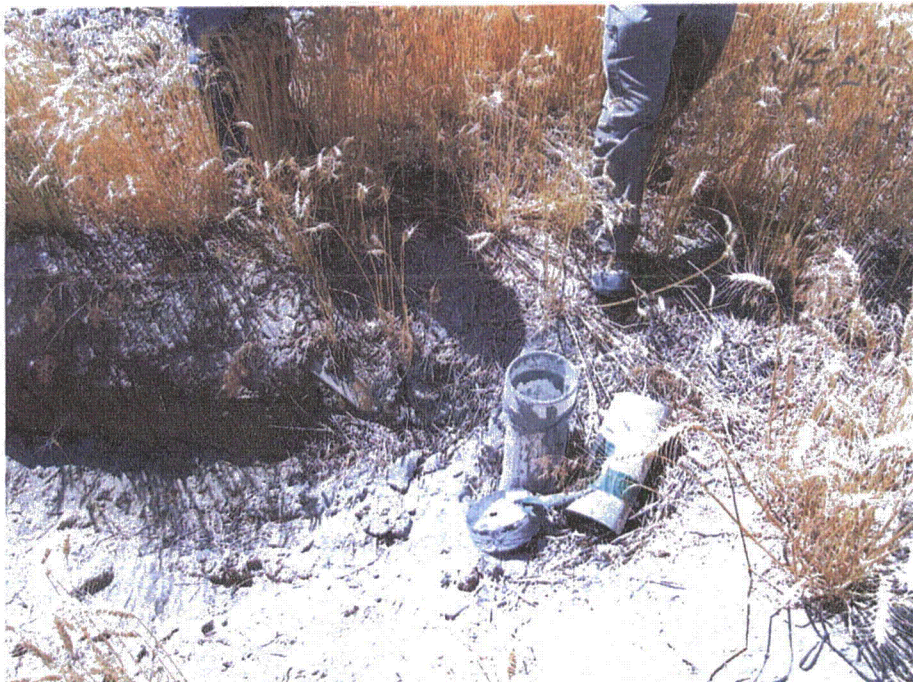
CR will need to provide additional information to explain the disturbances found at these sites. In addition, an uncapped, broken pipe from a well and an unreclaimed open pit will need to be explained to LQD. Please provide this information at your earliest convenience.

**Figure 6** View of possible open hole, broken pipe

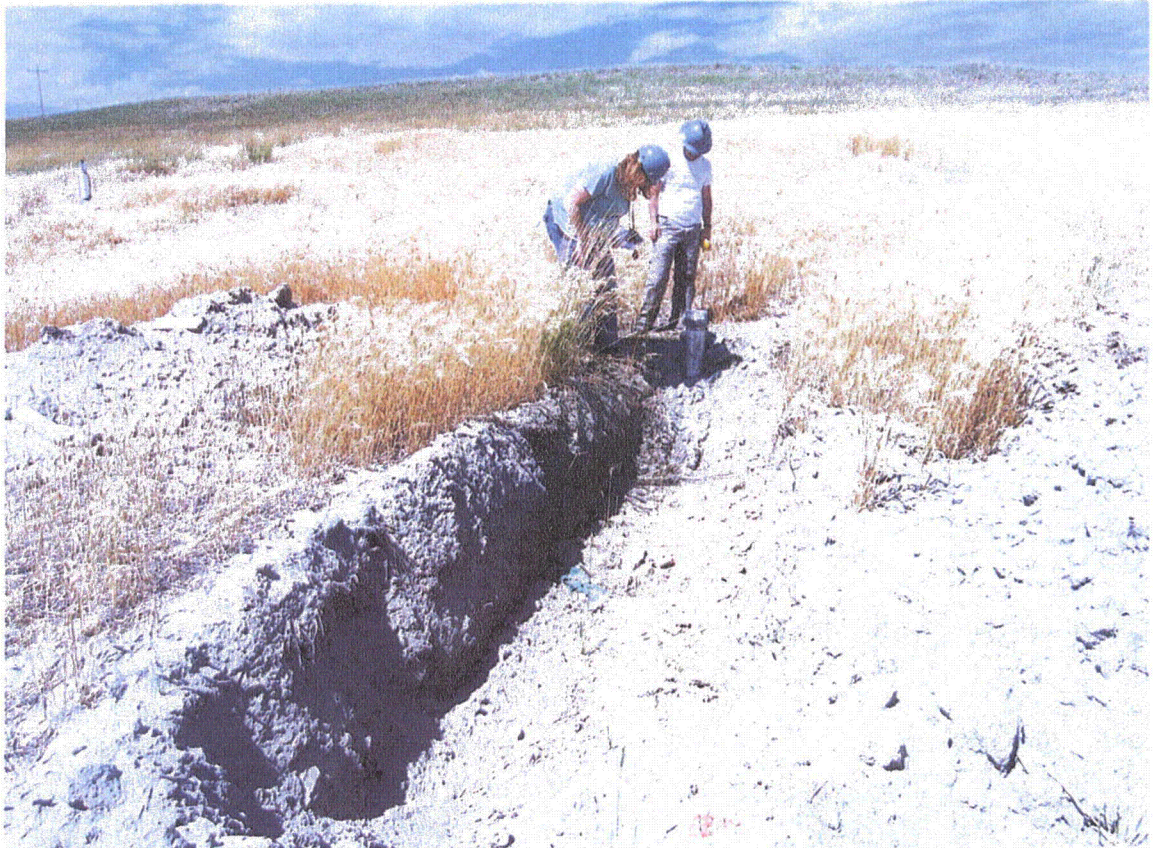
**Figure 7 View of un-reclaimed mud**
