Subject: 2010 Annual Site Inspection and Monitoring Report for Uranium Mill Tailings
Radiation Control Act Title II Disposal Sites

U.S. DEPARTMENT OF
ENERGY

2010 Annual Site Inspection and Monitoring Report for Uranium Mill Tailings Radiation Control Act Title II Disposal Sites

November 2010

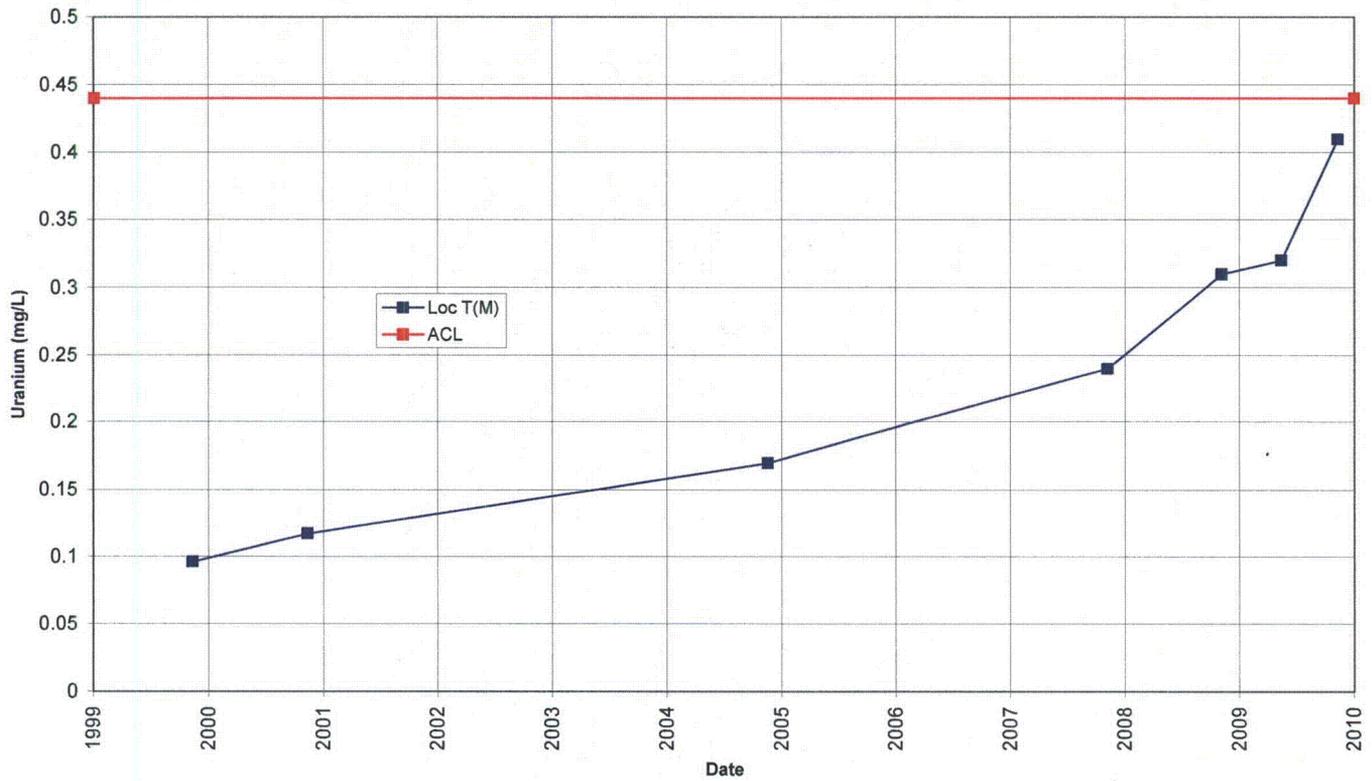
Figure 1-3. Uranium Concentration in Alluvium Well MW-T(M)

Groundwater monitoring results indicate that all compliance requirements continue to be met; however, the uranium concentration in an alluvium well downgradient of the disposal cells is increasing and approaching the alternate concentration limit (ACL). The U.S. Department of Energy (DOE) is cooperating with the State of New Mexico regarding the investigation of regional groundwater contamination associated with historical Grants Mineral Belt uranium activities. An evaluation of the groundwater conditions at the Bluewater site is part of that investigation.

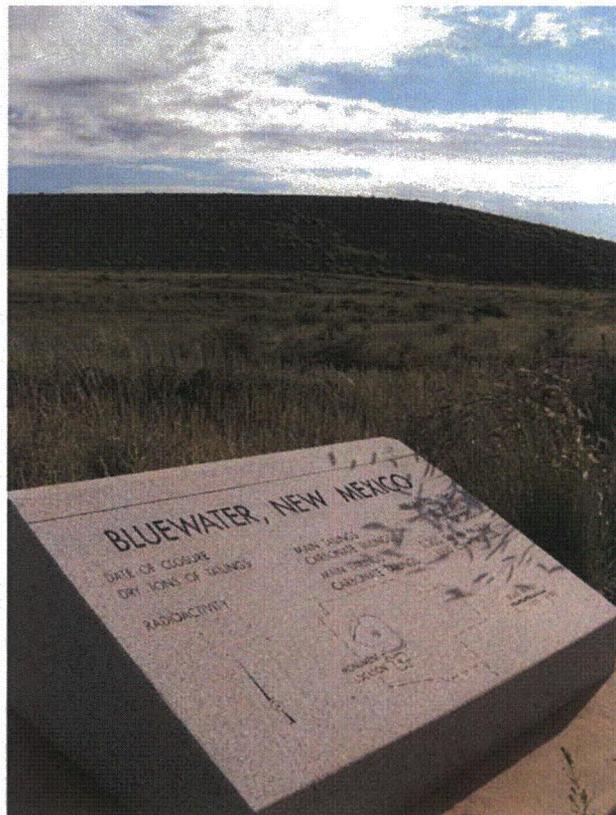
BLU 8/2010. PL-1. Site marker.

Site Marker and Boundary Monuments—A granite site marker is between the southwest corner of the main tailings disposal cell and the northwest corner of the carbonate tailings disposal cell. The marker was in excellent condition (PL-1).

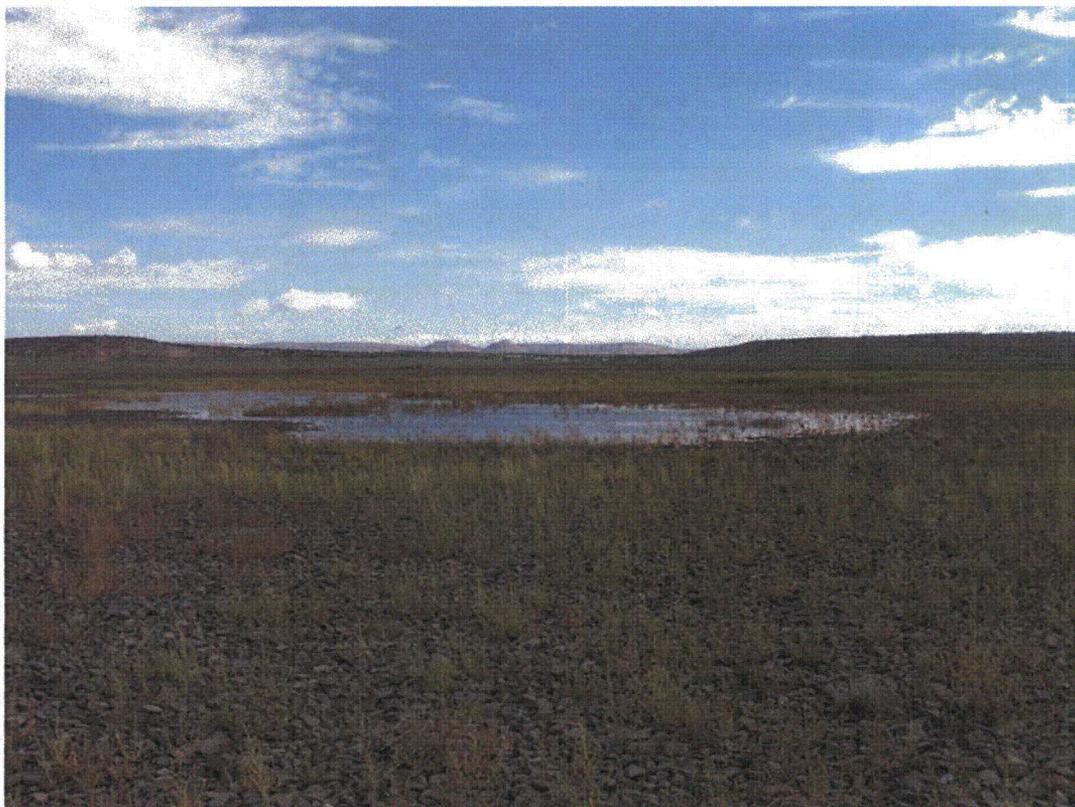
BLU 8/2010. PL-5. Standing water in shallow depressions on the main tailings cell.

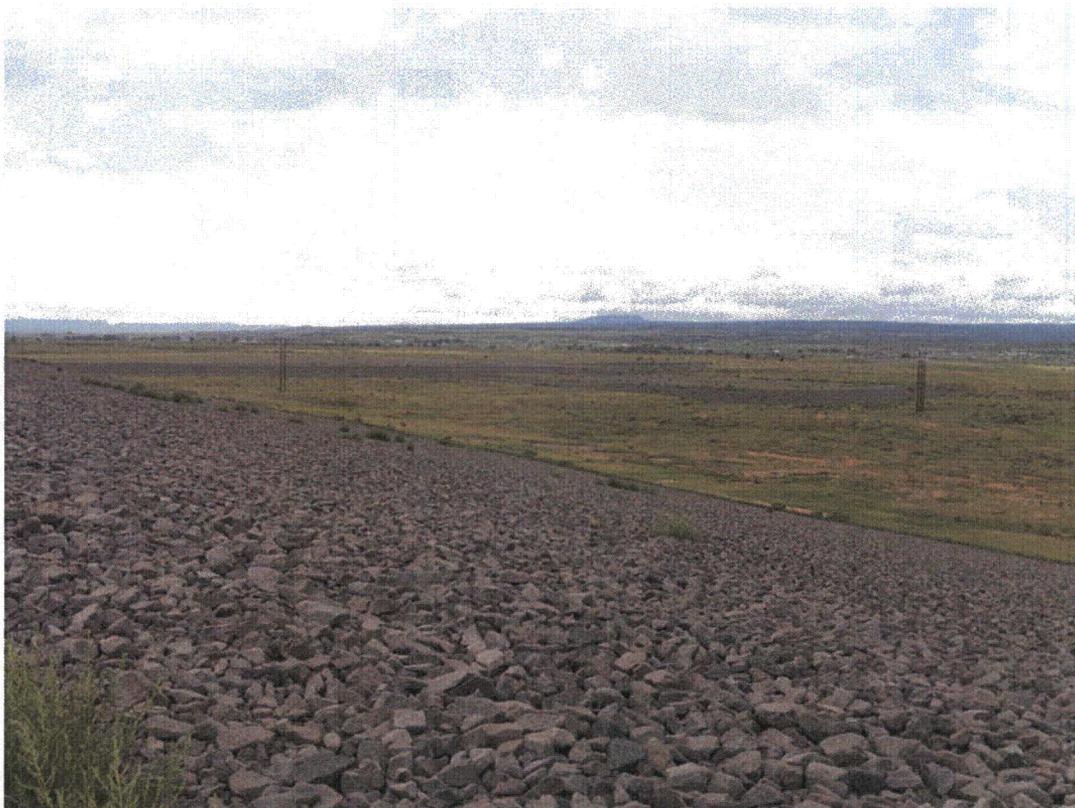
Carbonate Tailings Disposal Cell, Asbestos and PCB Disposal Areas, and Landfills—Basalt riprap covers the top and side slopes of the 54-acre carbonate tailings disposal cell (PL-6). The top, for the most part, slopes gently eastward. The small northwest and southeast extensions slope in their respective directions. Annual weeds and scattered perennial shrubs were present on the cell and its extensions. The carbonate tailings disposal cell was in excellent condition.

BLU 8/2010. PL-6. Carbonate tailings cell viewed from the main tailings cell.

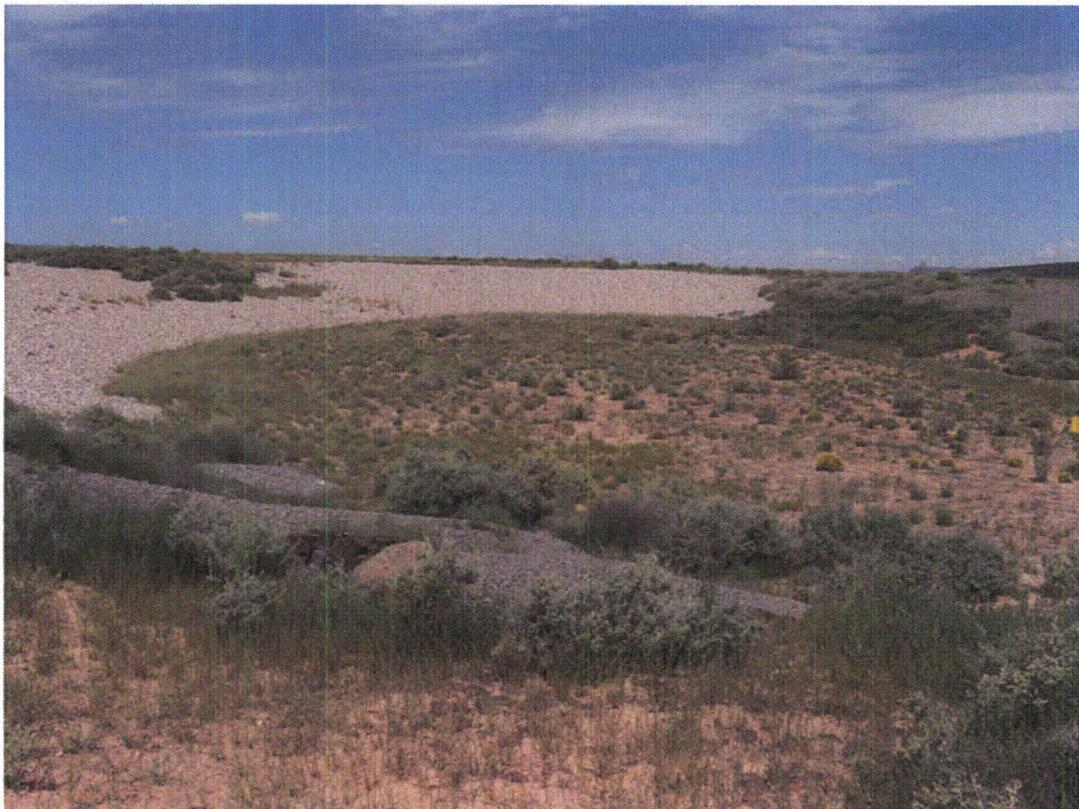
The 2-acre asbestos disposal area is a bowl-like feature just south of the carbonate pile (PL-7). The north, west, and south side slopes of this feature are covered by limestone riprap; the bottom of the bowl (the asbestos cell cover) is grass-covered. The asbestos disposal area was in excellent condition.

BLU 8/2010. PL-7. Asbestos disposal area.

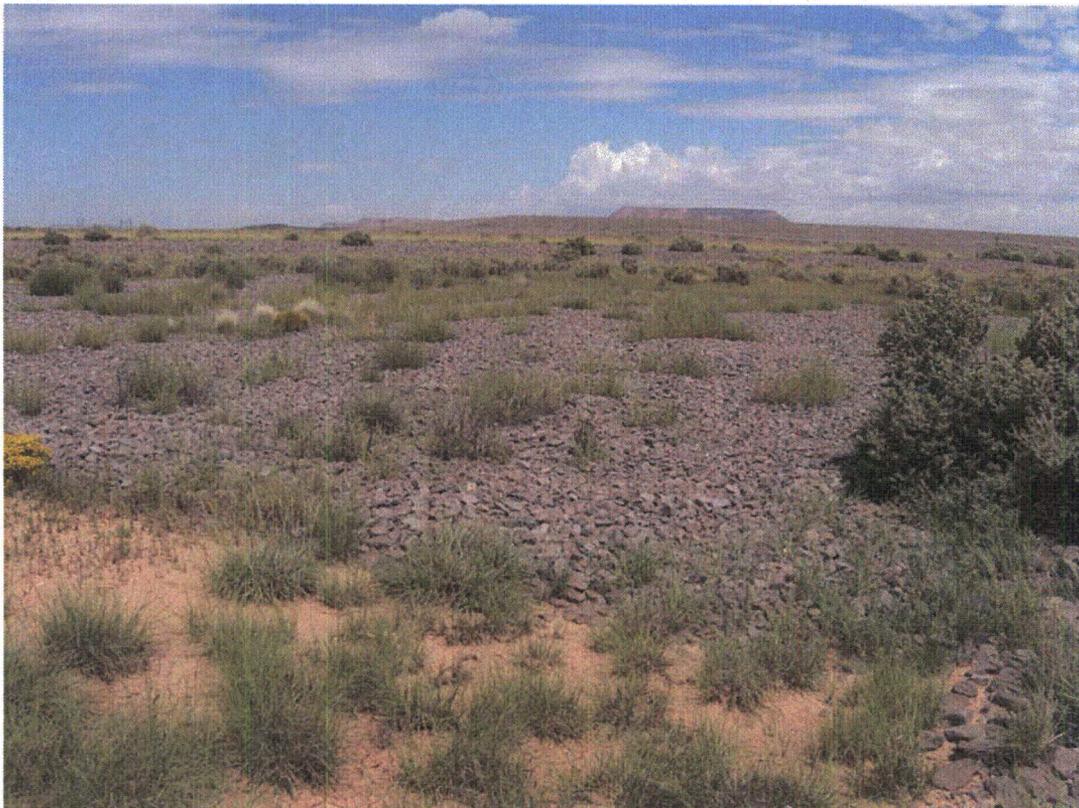
The 11-acre grass-covered disposal area south of the asbestos disposal area was in excellent condition, as was the small riprap-covered PCB disposal area located within the disposal area (PL-8). The two grass-covered landfills east of the carbonate tailings disposal cell, totaling about 2 acres, were in excellent condition. The stockpile area, another grass-covered landfill (southeast of the carbonate tailings disposal cell), was also in excellent condition.

BLU 8/2010. PL-8. Rock cover over PCB disposal area.

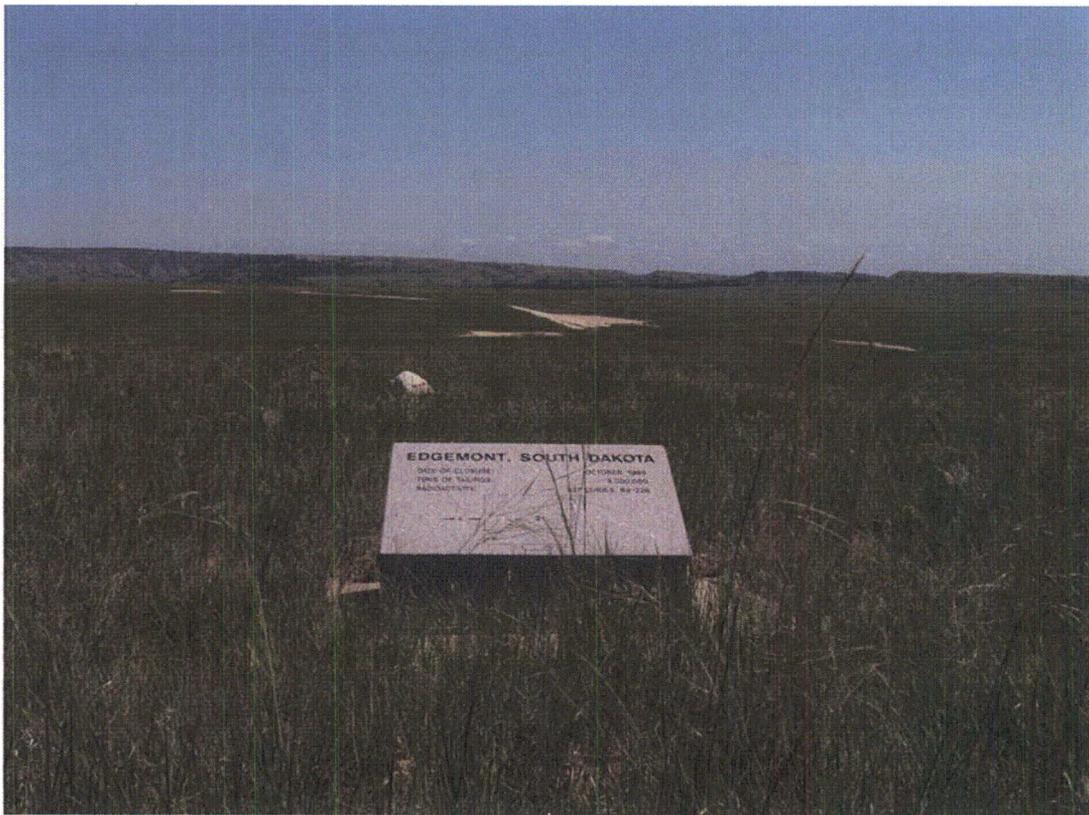
EDG 6/2010. PL-1. Site marker.

Site Marker and Monuments—One unpolished granite site marker identifying the site is just inside the entrance gate and was in excellent condition (PL-1). Four boundary monuments, one at each corner of the property, were in excellent condition.

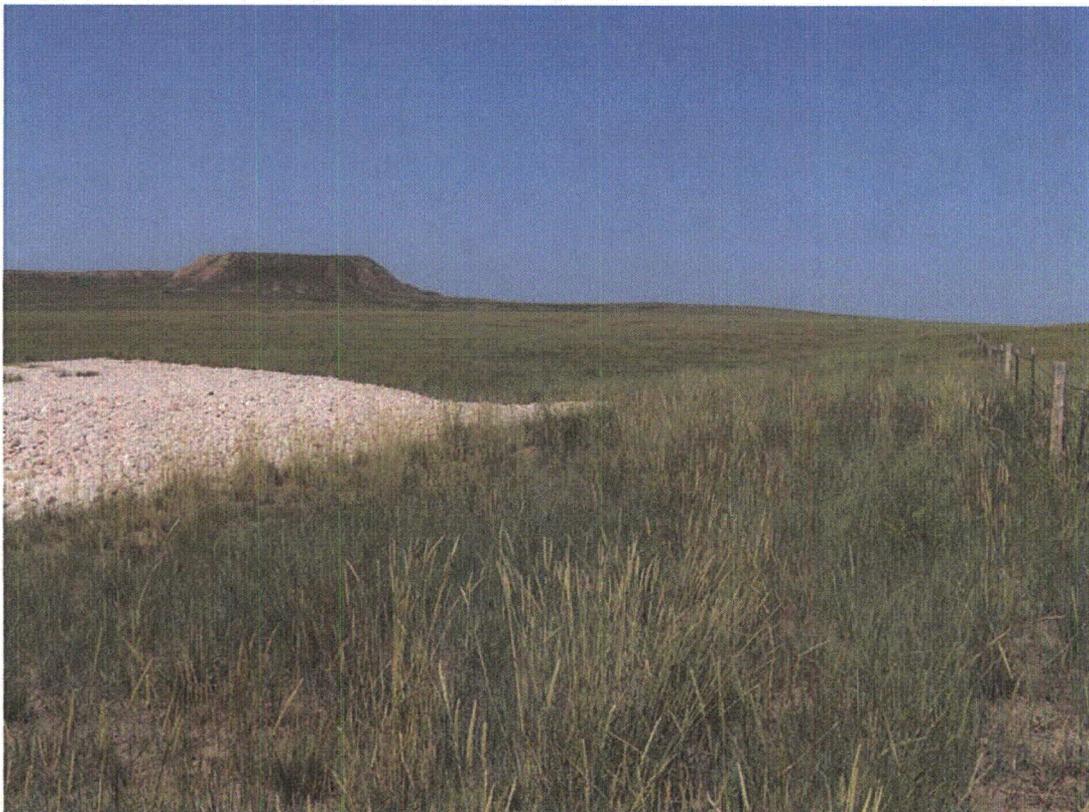
Top of the Disposal Cell—The 100-acre top of the disposal cell, completed in 1989, is grass-covered and in good condition. Although numerous cattle trails are present on the cell, no signs of erosion, settling, or other modifying processes that might affect the integrity of the cell were noted. The grass cover, which DOE manages through controlled grazing, was healthy due to substantial spring precipitation (PL-2).

EDG 6/2010. PL-2. Grass-covered disposal cell cover.

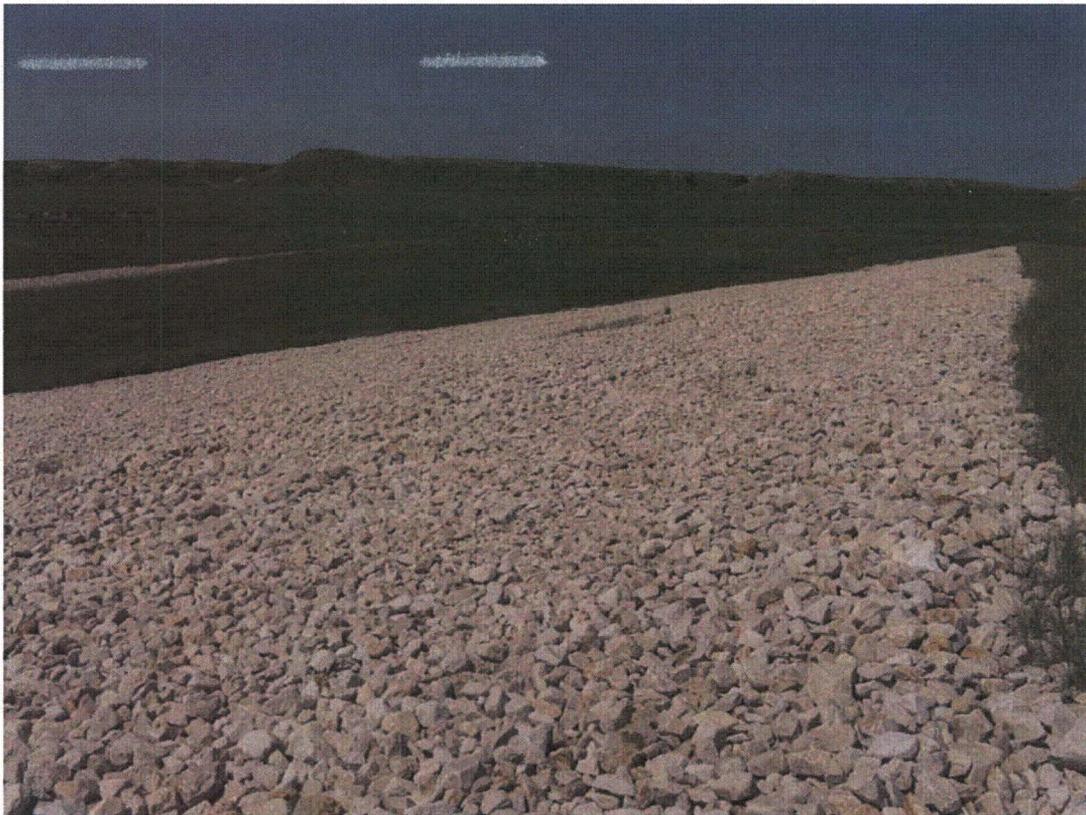
Embankment Face and Drainage and Diversion Channels—The embankment face, the steepest manmade slope on site, is covered with riprap. The slope is stable, and the riprap showed no signs of degradation (PL-3). Scattered plants, mostly grass and annual weeds, grow in the riprap. These plants do not threaten the stability or function of the embankment face.

EDG 6/2010. PL-3. West end of the tailings embankment.

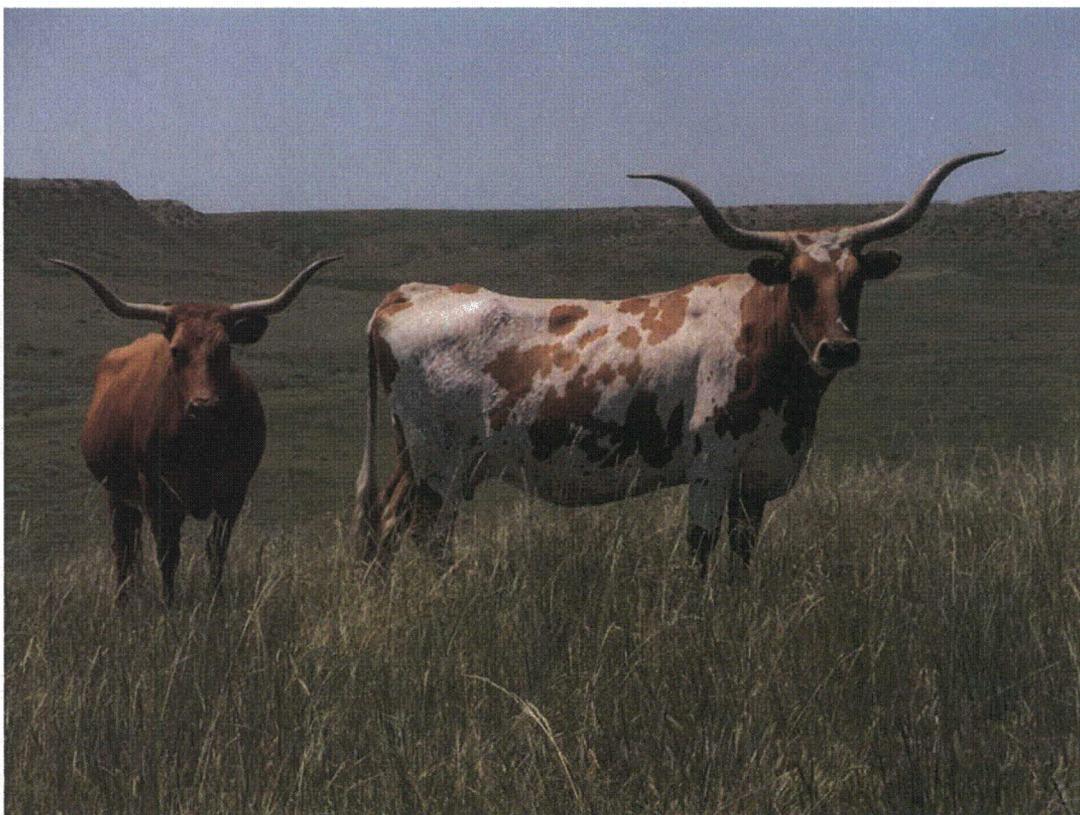
Cattle were grazing the site at the time of the inspection (PL-8). Cattle trails are common on the site and in a few places have concentrated storm runoff and created rills and gullies. The most significant erosion features, in the southeast portion of the site, do not have the potential to affect the disposal cell. Although minor natural erosion is occurring on the steep shale slopes in the east and northeast portions of the site, this undisturbed region of the site remains in good condition.

EDG 6/2010. PL-8. Cattle on site.

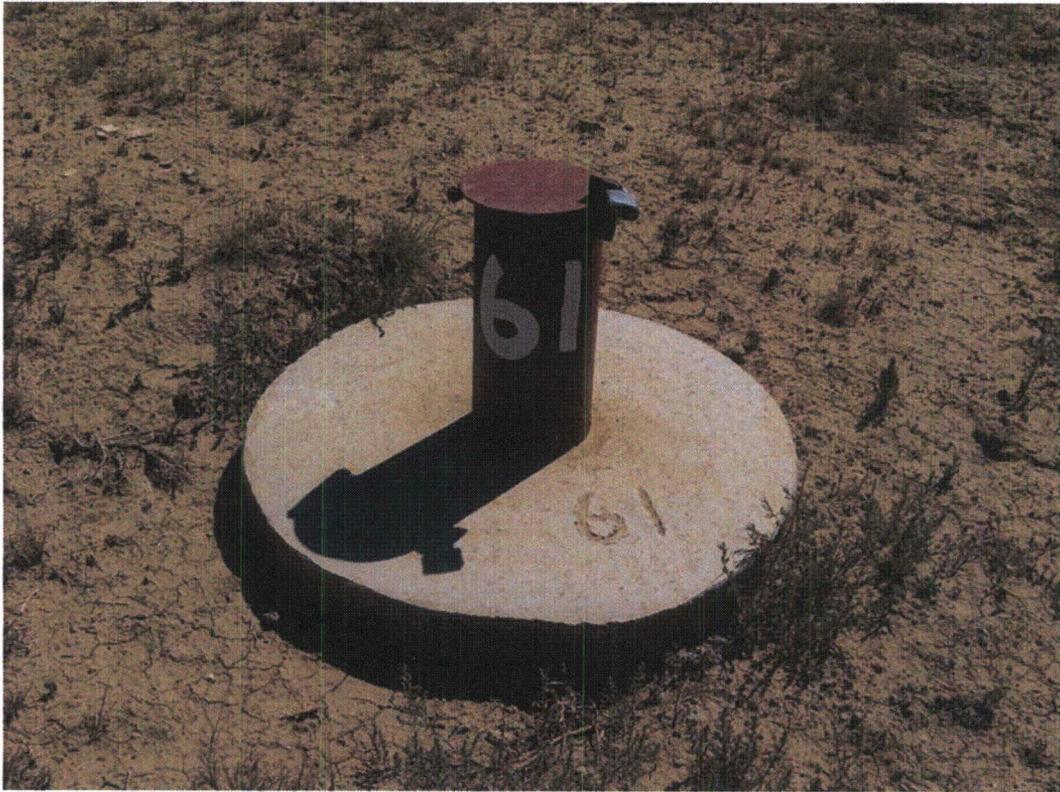
BAR 8/2010. PL-1. Monitoring well MW-61 with new concrete collar.

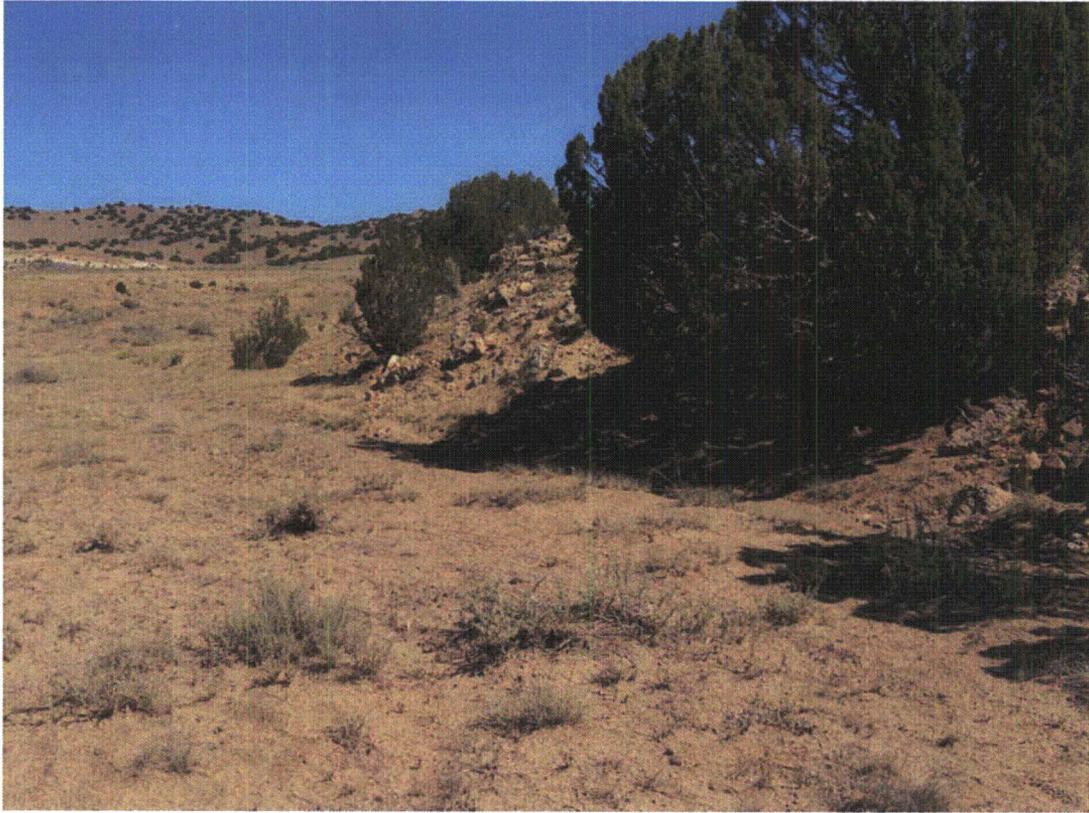
BAR 8/2010. PL-7. Tres Hermanos outcrop area; no seeps present.

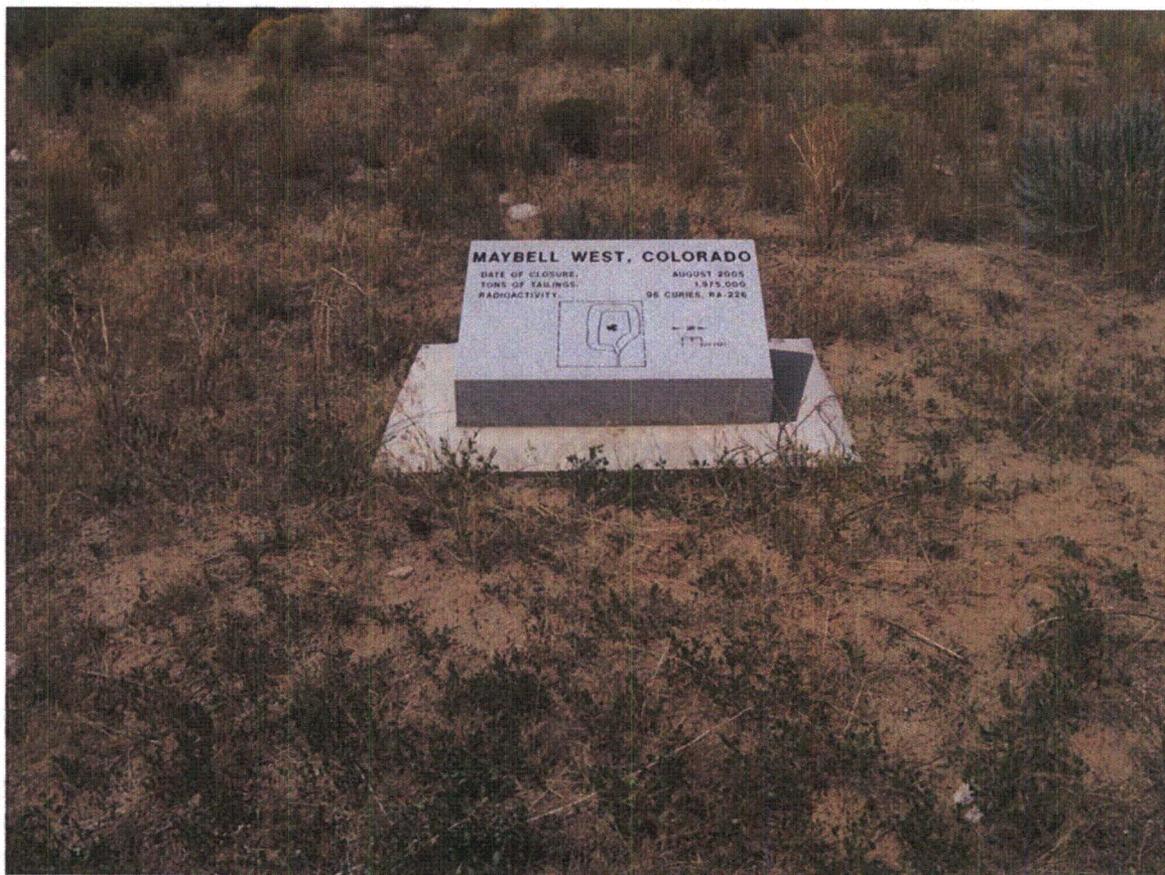
MAW 8/2010. PL-2. Site marker.

Site Marker—One standard granite site marker is located on the site just south of the entrance gate (PL-2). The site marker was in good condition.

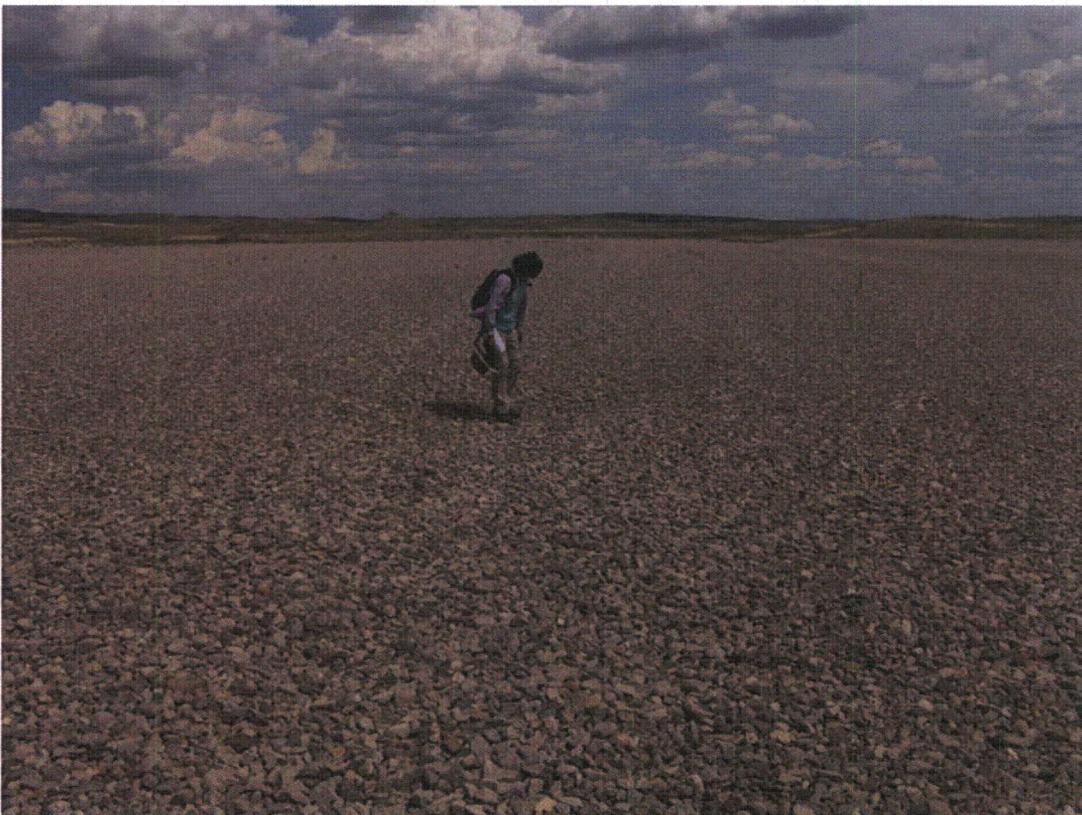
MAW 8/2010. PL-6. Shallow depression on the disposal cell top.

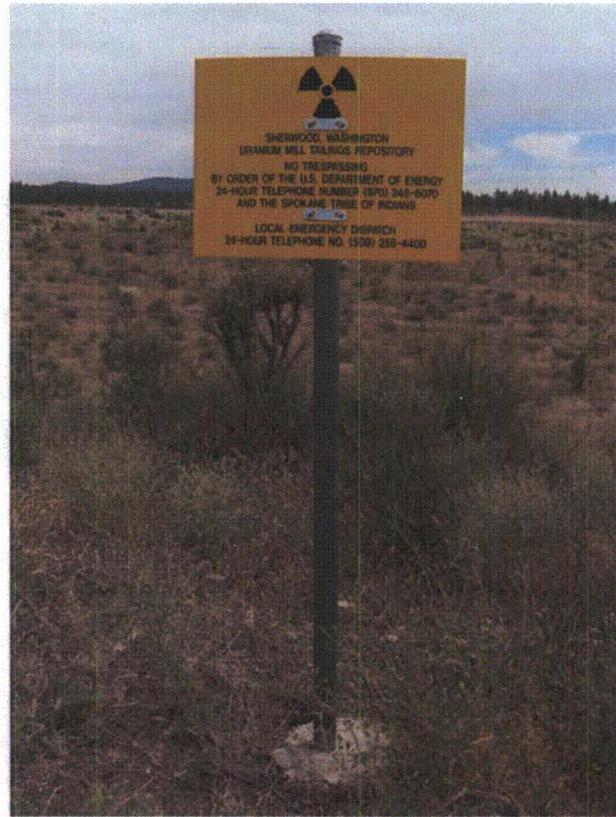
SHE 7/2010. PL-1. New perimeter sign P6.

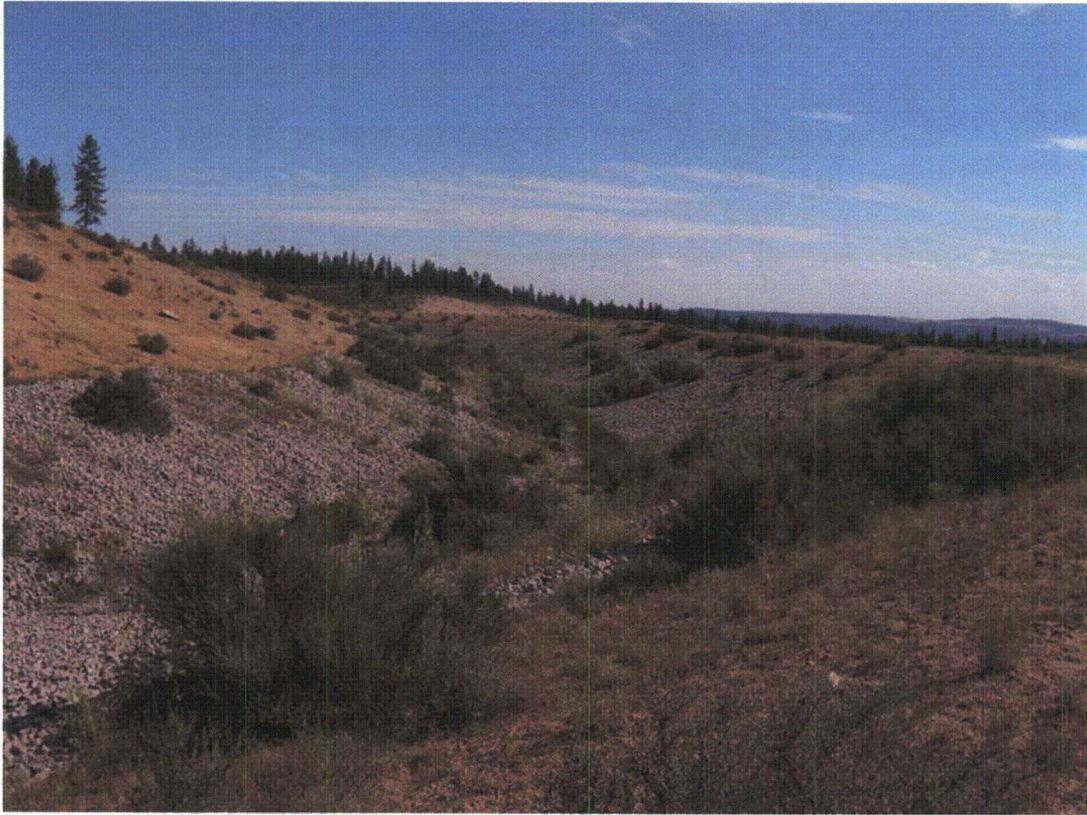
SHE 7/2010. PL-5. Wetland vegetation in the diversion channel.

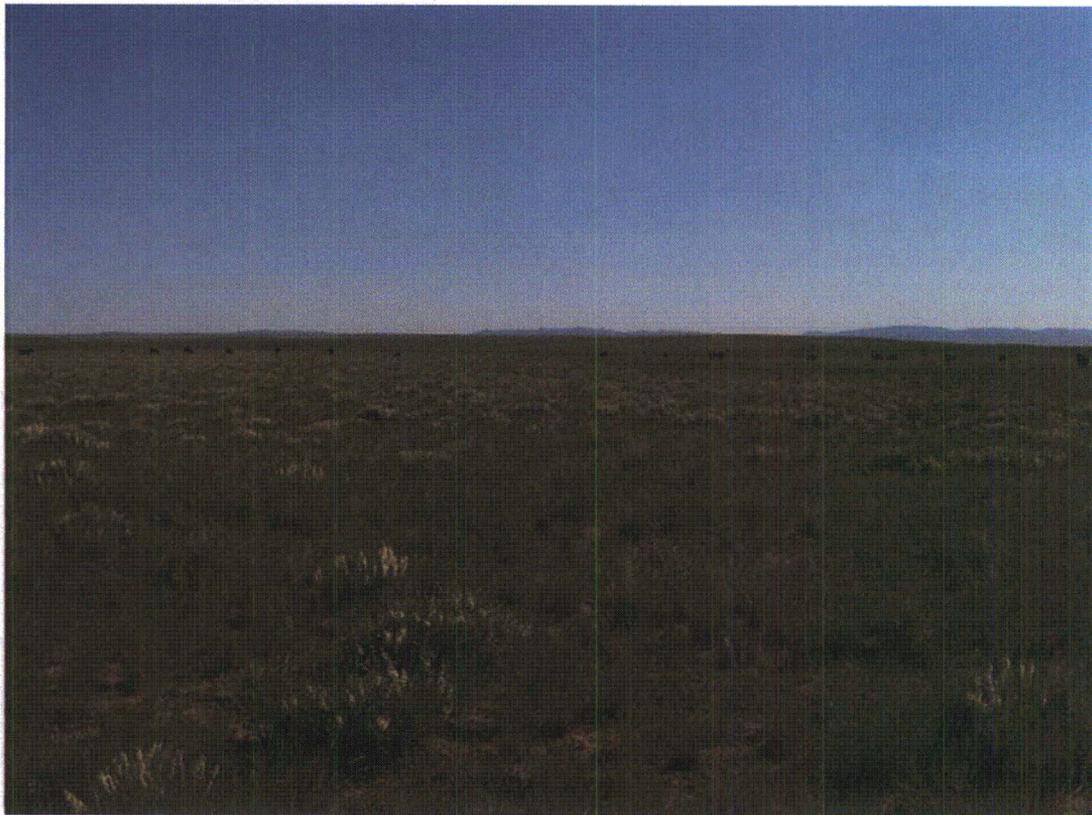
Cover of the Tailings Impoundment—The tailings impoundment, completed in 2000, occupies approximately 142 acres and has a grass cover (PL-4). The cell surface is constructed at two elevations separated by a riprap-armored slope (PL-5). The slope was in excellent condition.

SBS 6/2010. PL-4. Upper surface of the disposal cell.

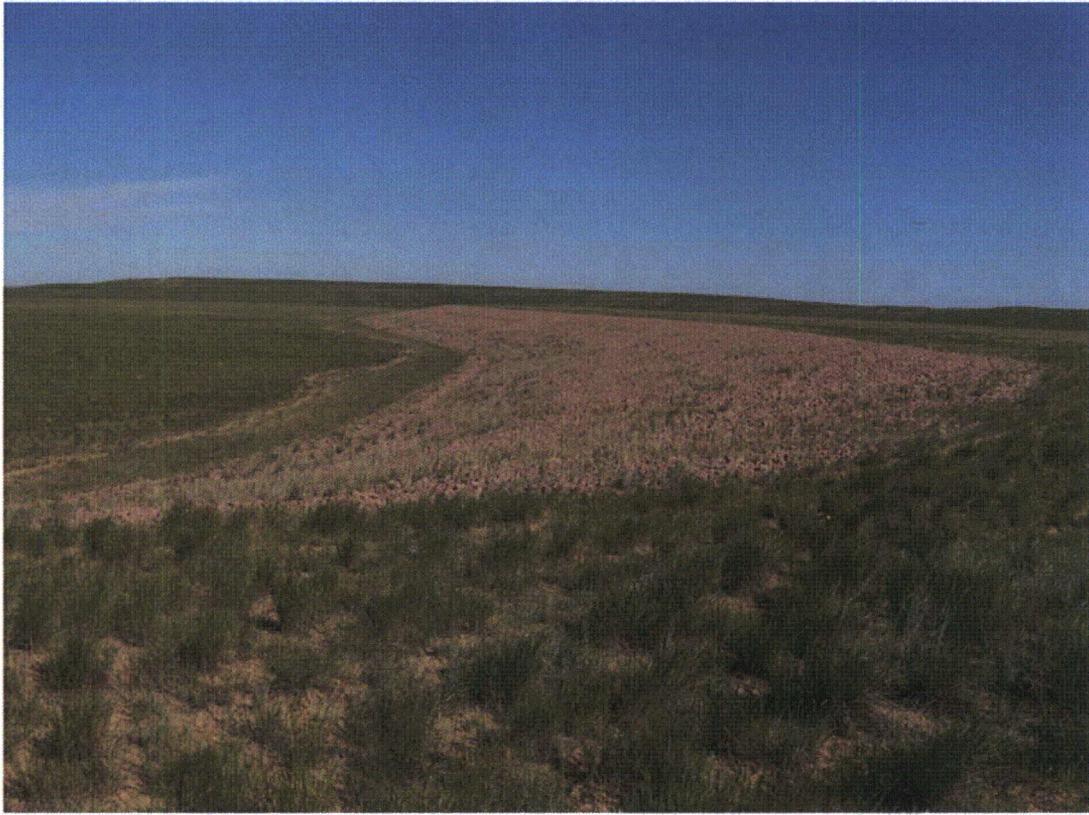
SBS 6/2010. PL-5. Riprap-armored slope between the upper and lower surfaces of the disposal cell.

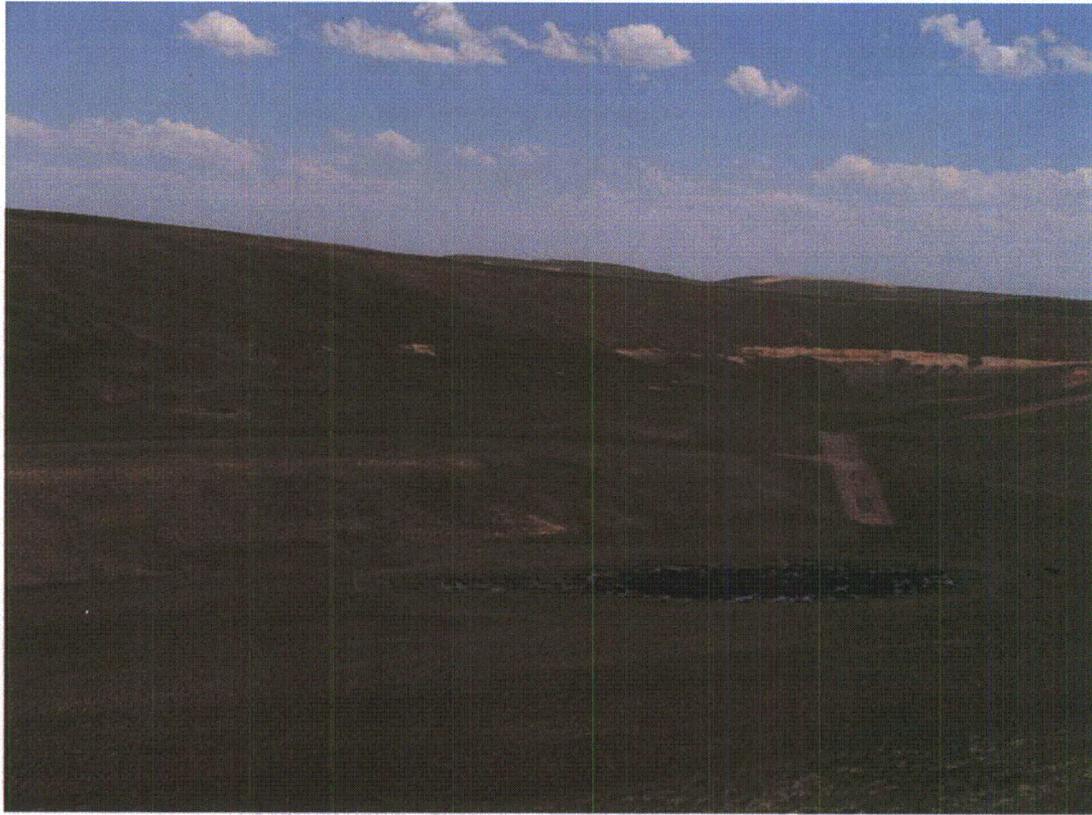
SBS 6/2010. PL-7. Vegetation on the east slope and standing water in Pit 4.
