Subject: 2010 Annual Pond Inspection Report  
Source Materials License SUA-1534  
Docket Number 40-8943

**CROW BUTTE MINE  
DAWES COUNTY, NEBRASKA**

**2010 POND INSPECTION REPORT**

By: David V. Coe, PE  
Nebraska Registration No. E - 4295

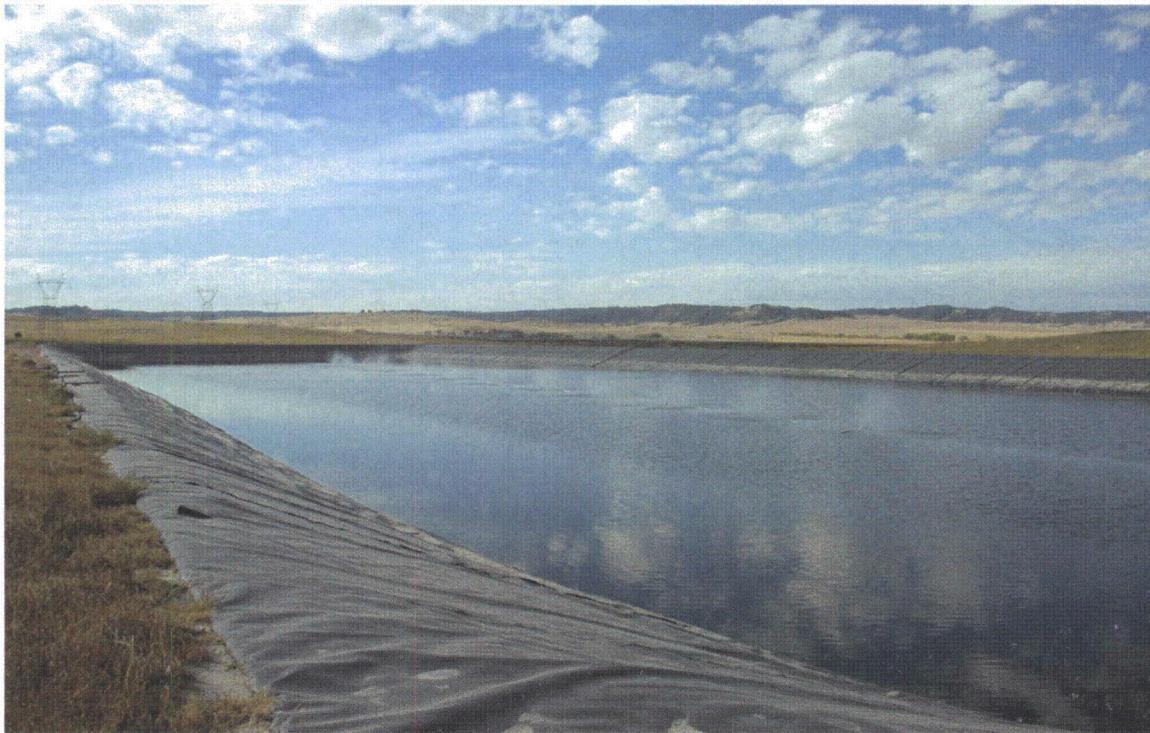
**#1 Southwest view of evaporation pond #1, date: 10/08/10**

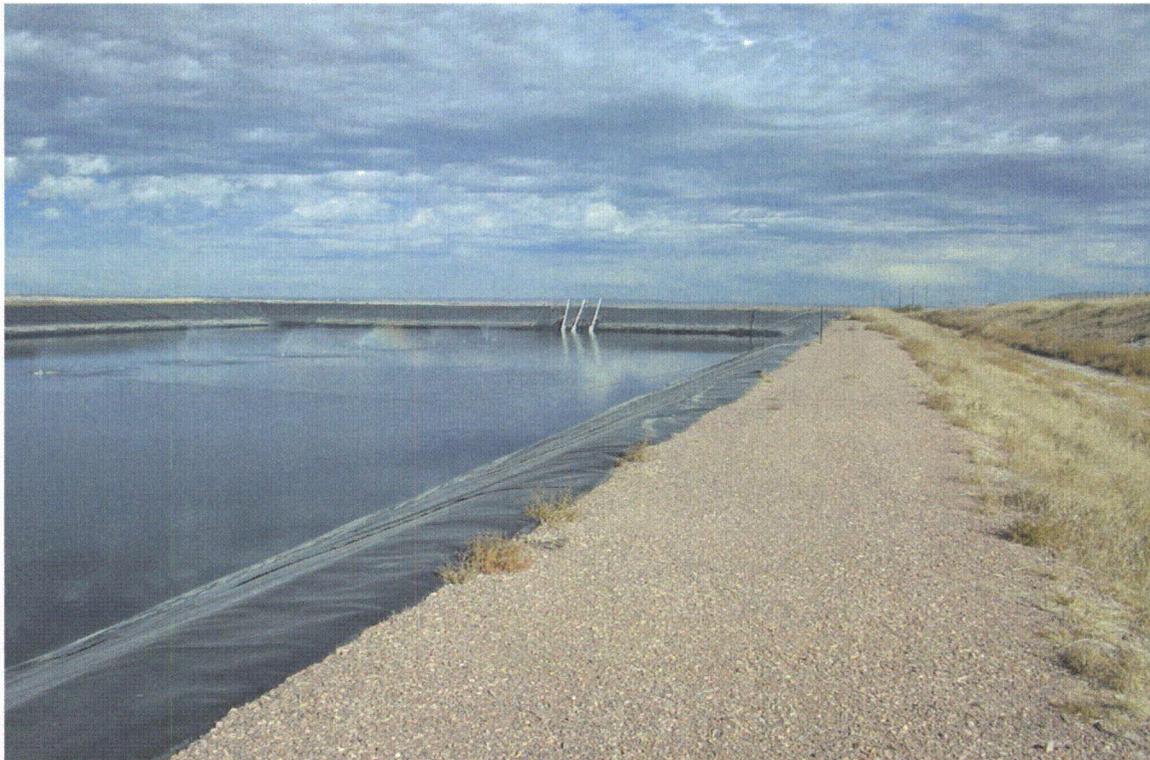
**#2 Northwest view of pond #1. Date: 10/08/10**

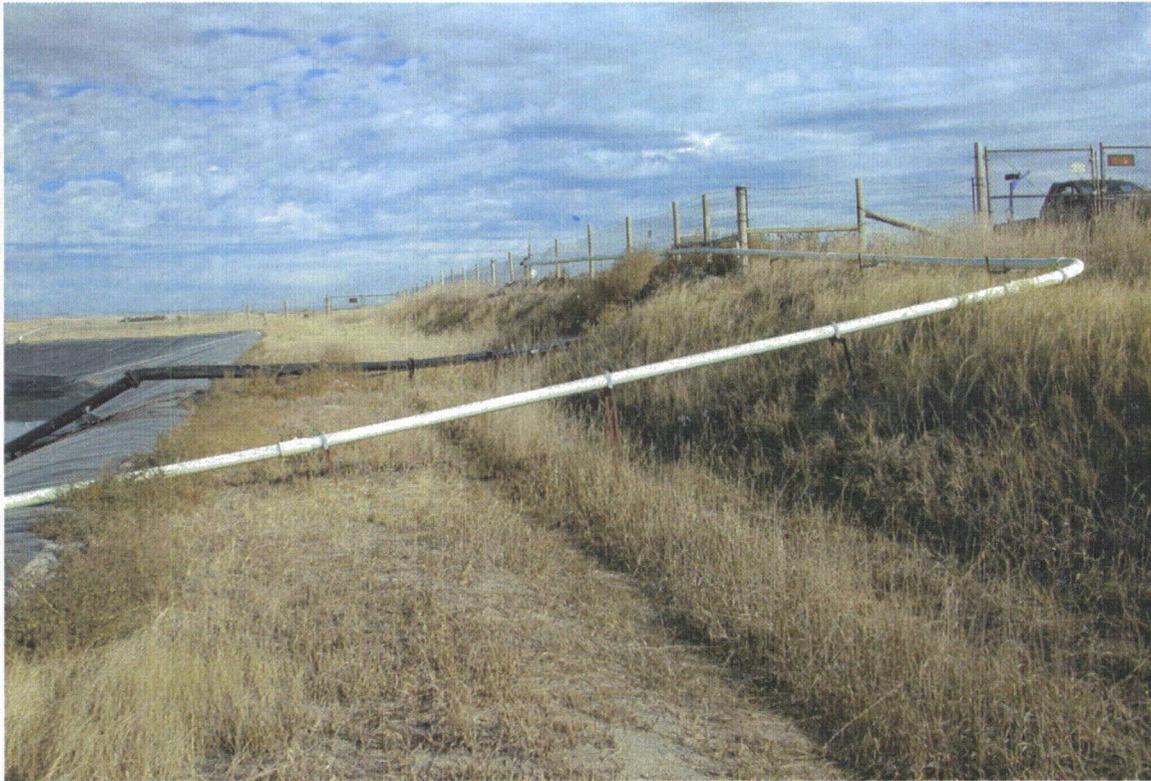
We completed our visual inspection of the commercial ponds walking up the east embankment of Pond #3. Crow Butte Resources have added a new point of truck delivery to the commercial ponds. The trucks deposit their loads at a pipeline near the entrance gate of the pond area. The old site was near the northeast corner of the fenced area of Pond #3. CBR have also added a new pipeline for extracting pond storage for re-processing (reclaiming uranium from the waste pond). The line going into the pond was an 8" diameter ductile iron pipe and transitioned to a 6" diameter size on the top of the embankment. There is a pump at the bottom of the pond inside the 8" pipe.

**New piping arrangements @ pond #3, white pipe is for truck dumping. Date: 10/08/10**

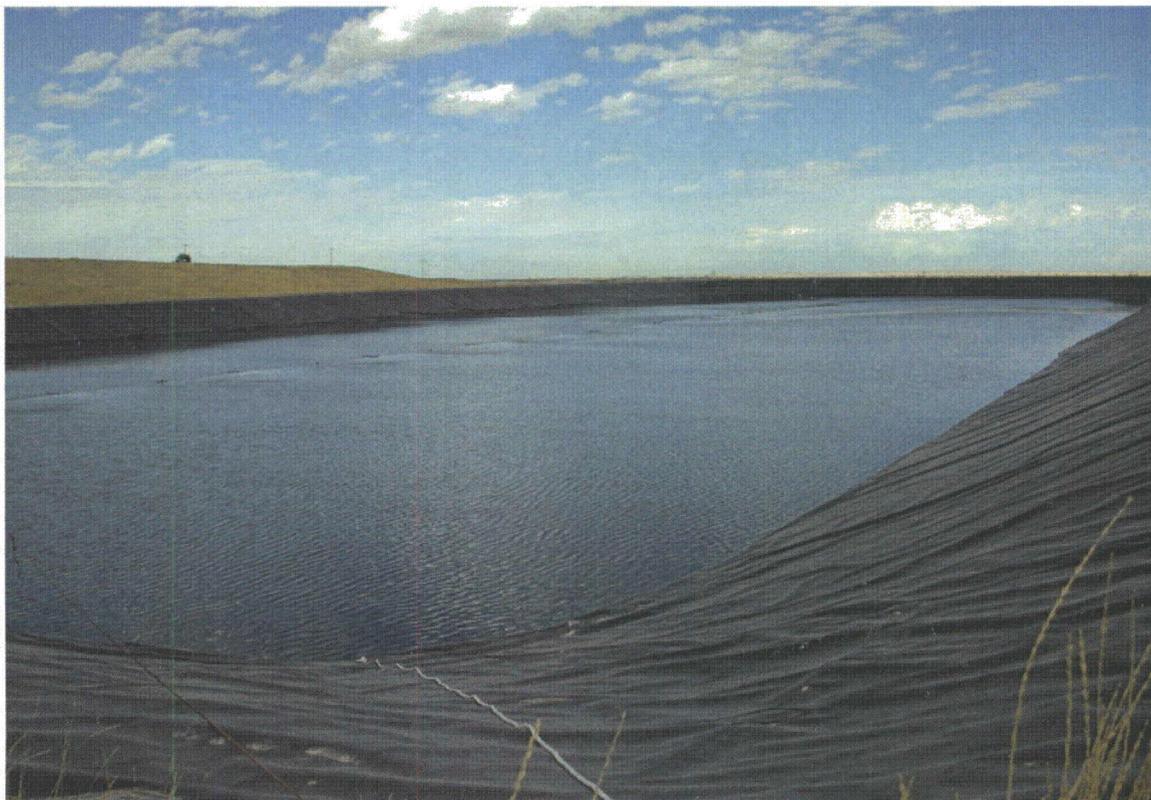
**#4 Northwest view of pond #4. Date: 10/08/10**

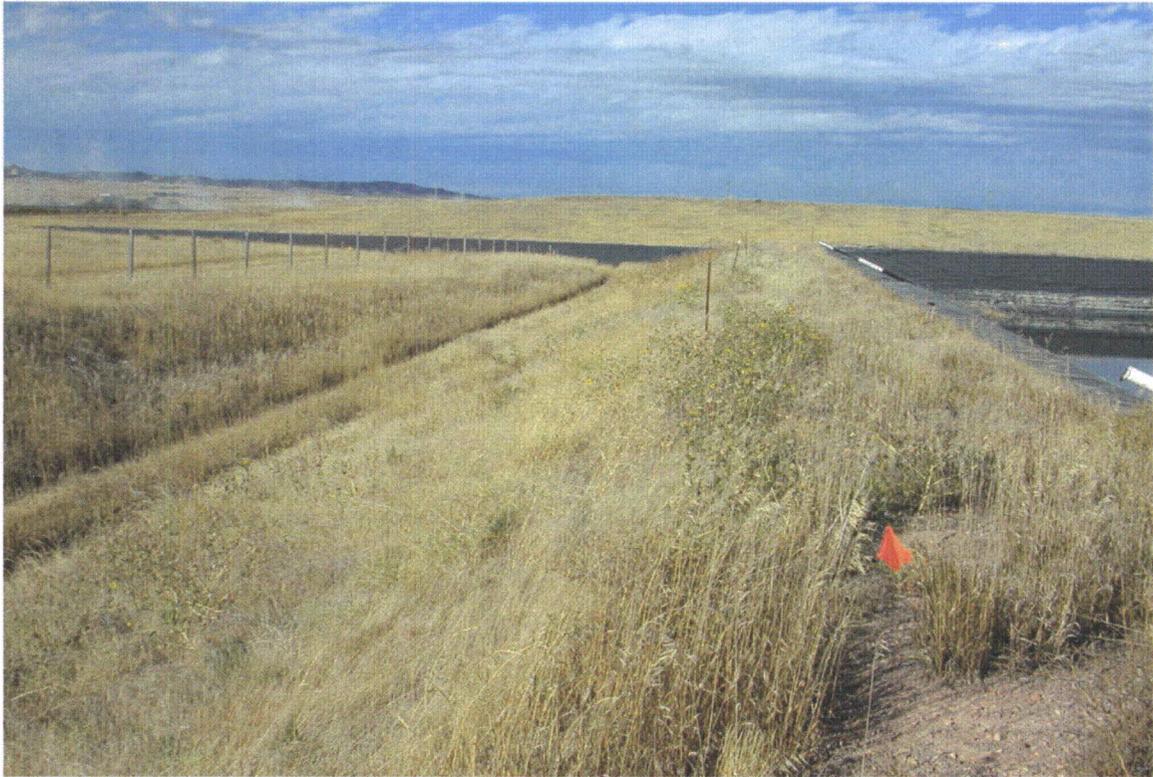
**Good vegetation along south embankment of Pond #1, Date: 10/08/10**

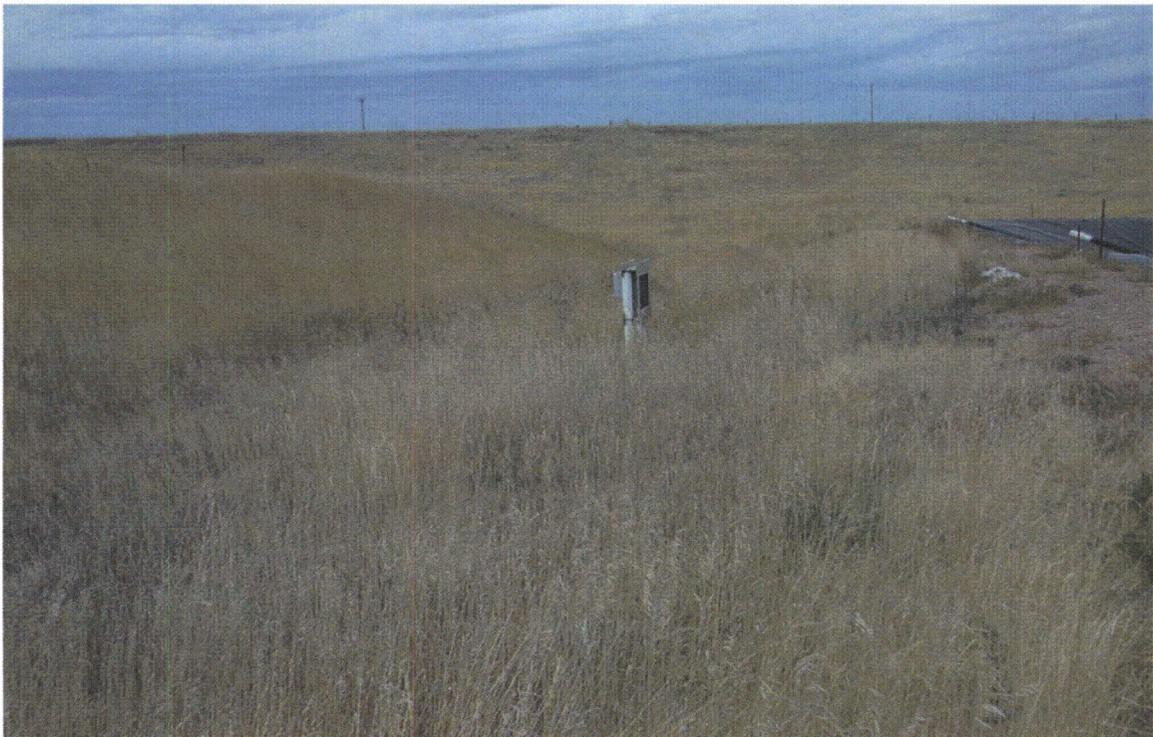
**#6 View of vegetation between Ponds #3 & #4 Date: 10/08/10**

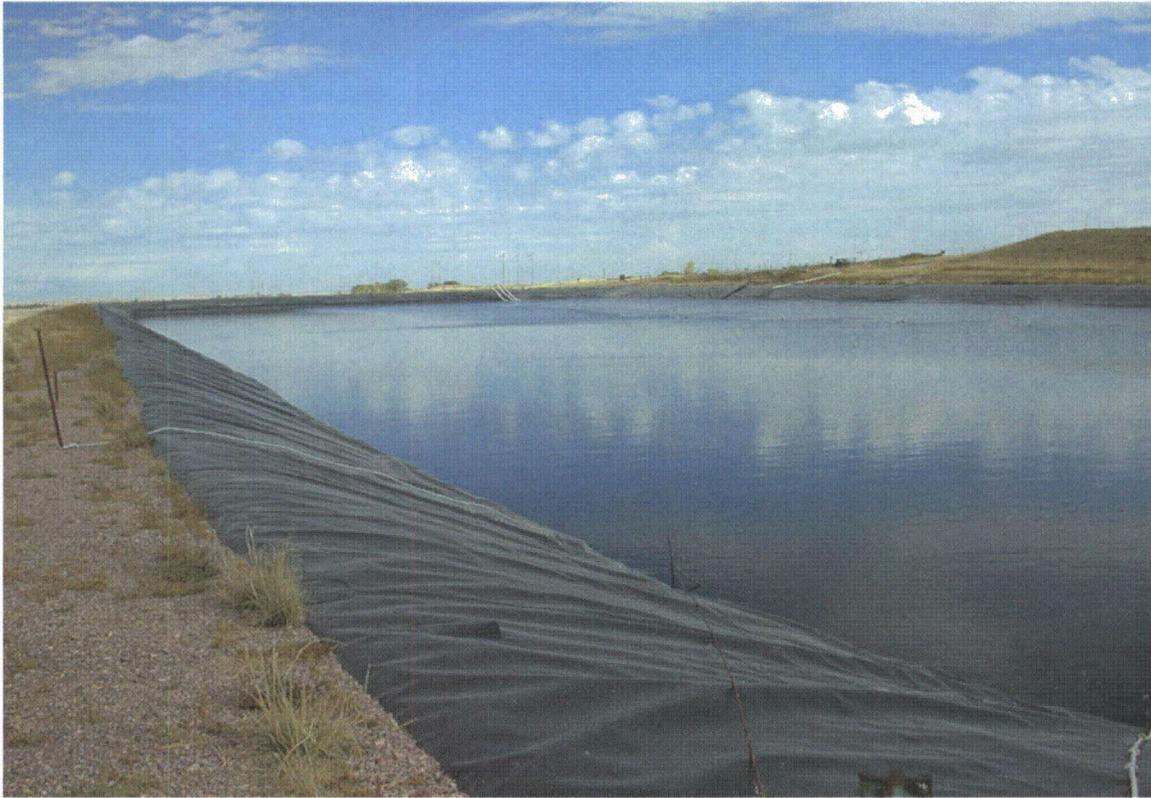
**Northeast view of Pond #3. 10/08/10**

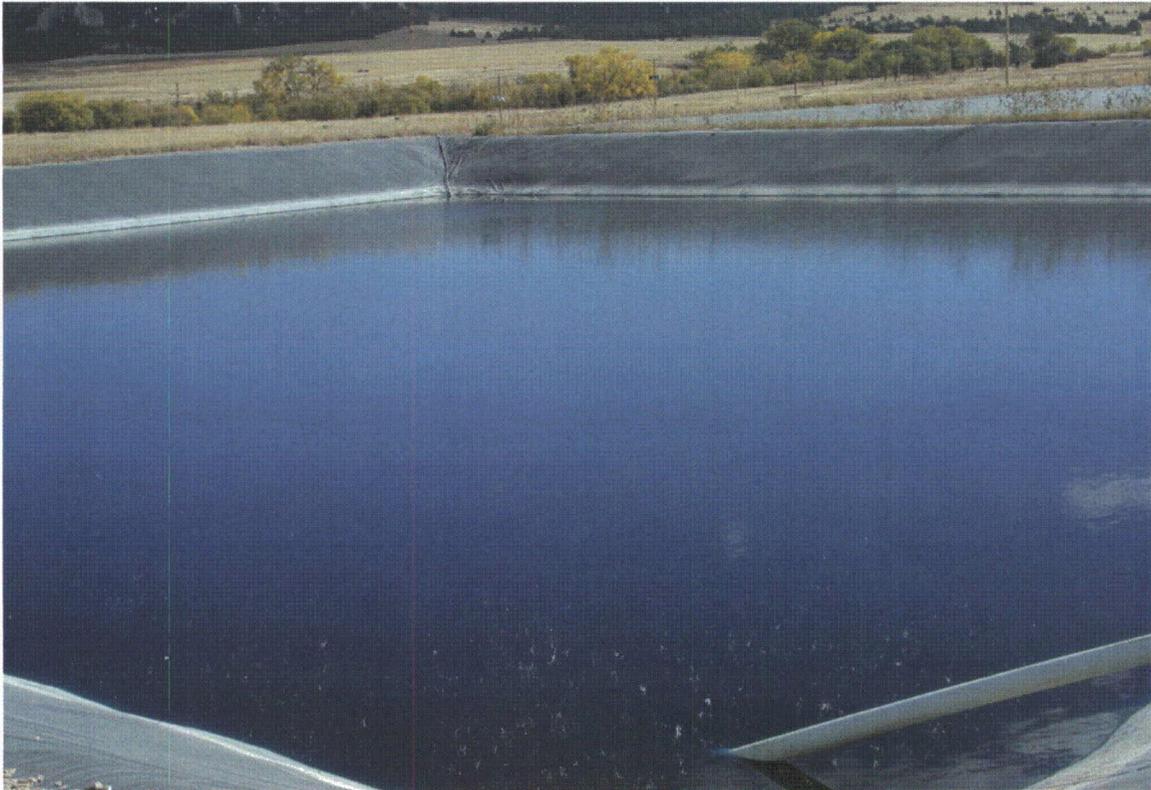
**#8 Northeast views of R&D ponds. Cell #1 (west pond) in foreground.  
Date: 10/08/10**

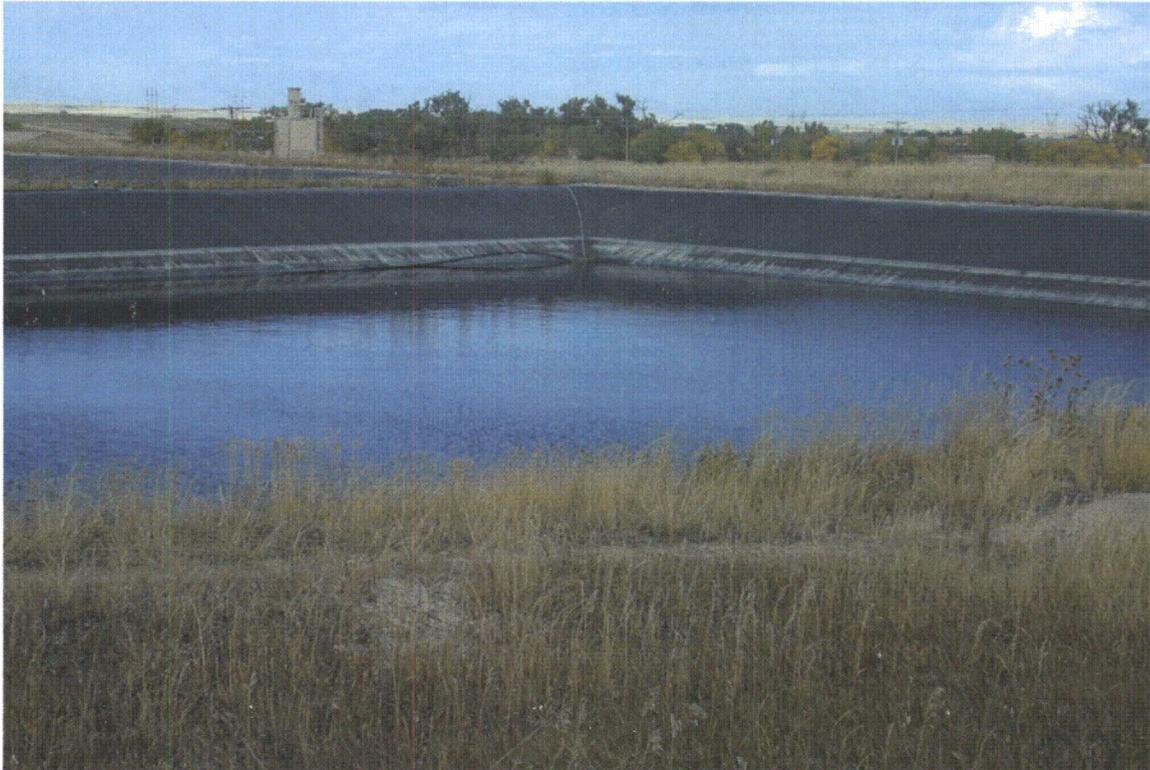
**Northwest view of east R & D pond: Date: 10/08/10**

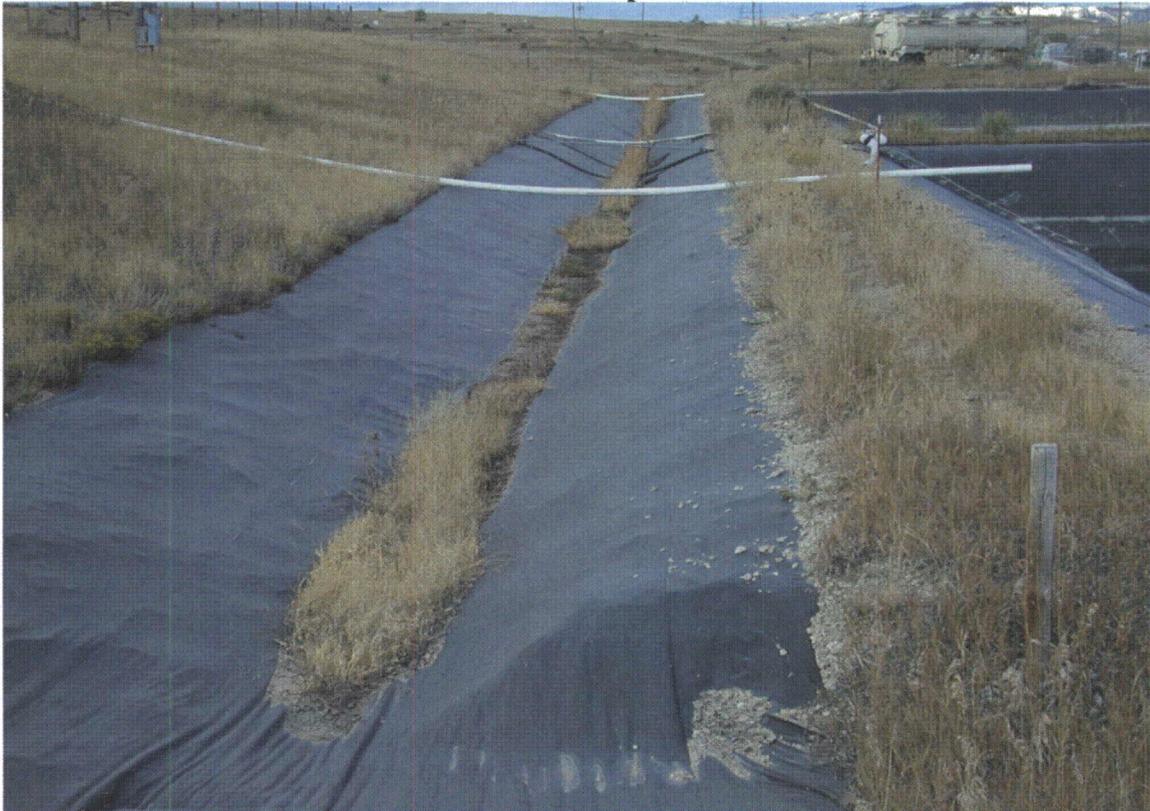
There has been no change in the cutoff dike. The dike still has a good growth of vegetation in the bottom of the channel. There was no standing water in the bottom of the cutoff dike.

**Photo #10 View of diversion ditch on the south side of the R & D ponds  
Photo taken 10/08/10**

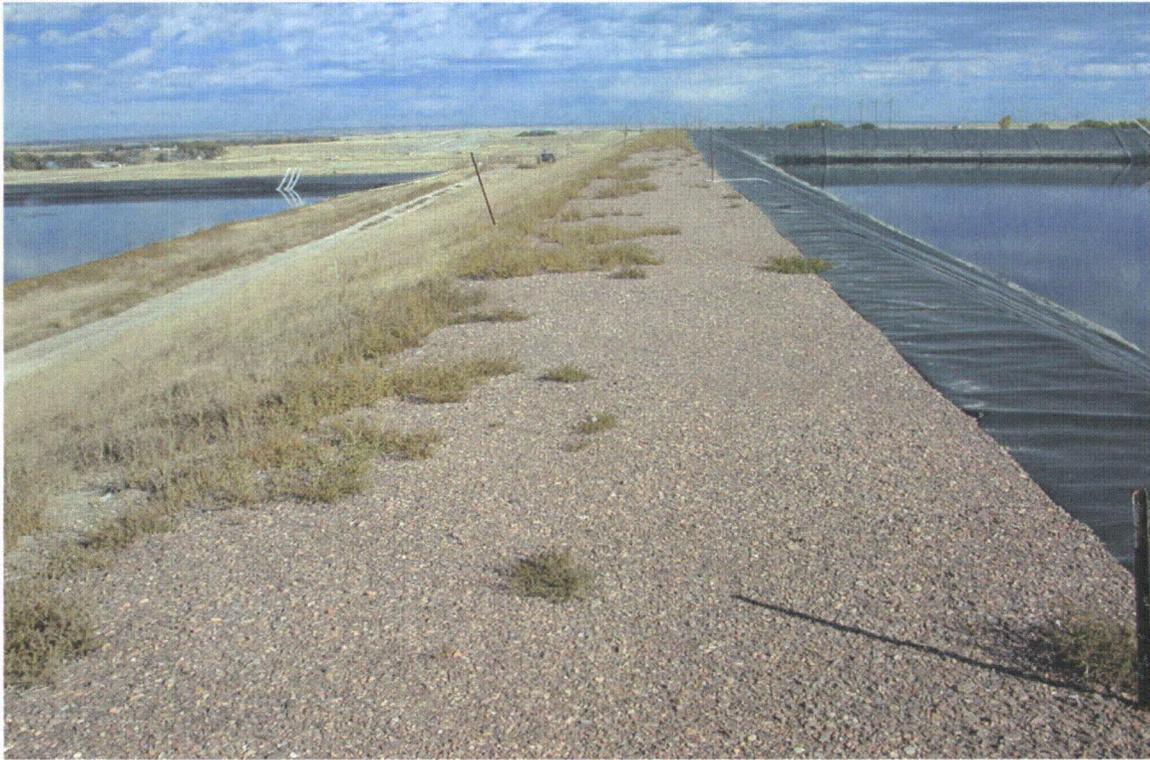
On the west berm of pond #1 there is vegetation mixed with a limestone gravel surface. The vegetation showed a slight improvement over last year and it was well established on the limestone surface. The vegetation mixed in with the gravel surfacing does not have any detrimental effect on the safety of the pond embankment. It would be nice to have all the berm tops of the ponds gravel surfaced with limestone base course material. The gravel surface provides a durable surface which is resistant to surface erosion when compared to a marginal soil with limited vegetative cover. The vegetation along outside slope of the pond is good and well established. I did not see any evidence of a longitudinal cracking along the embankment of pond number 1. The gopher control is currently accomplished by hand with Crow Butte employees. There are no signs of leaks along the toe of the dam embankment.

**North view of west embankment & berm of pond #1, good protection against erosion of berm & protection of area adjacent to pond liner. 10/08/10**

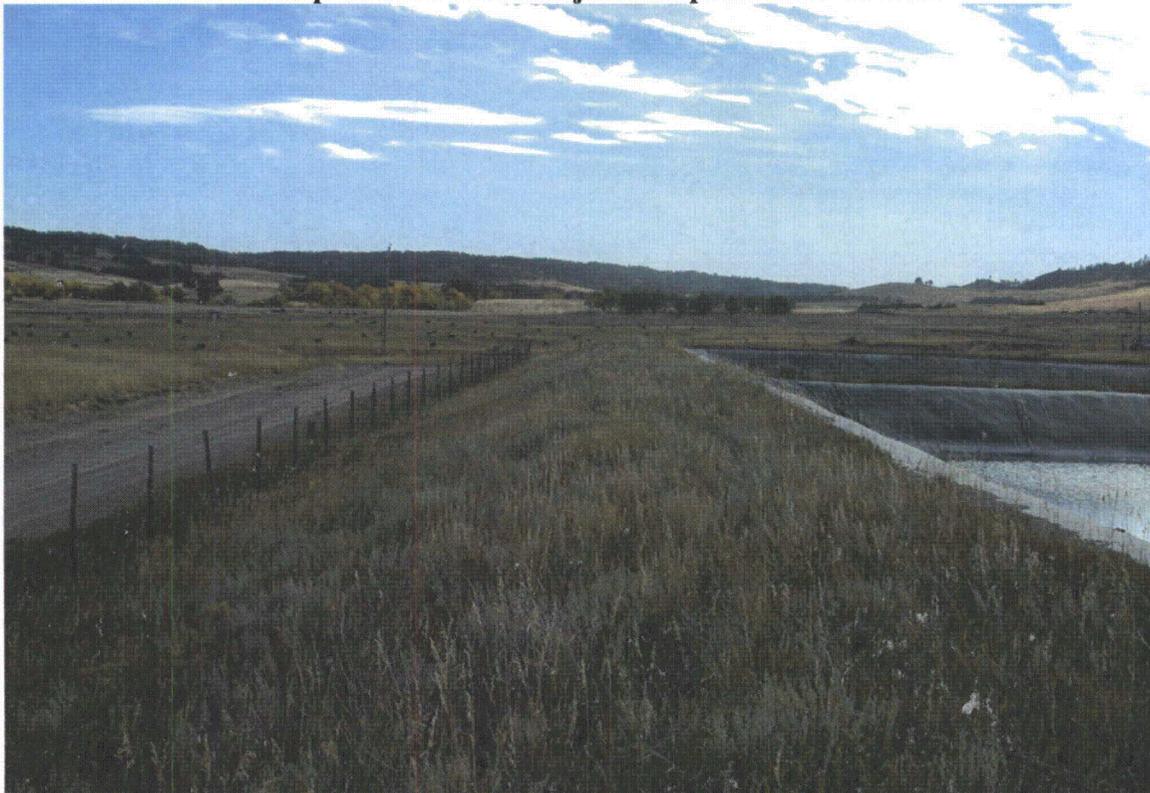
**North embankment slope of R & D ponds; Good vegetation. 10/08/10**
