**babcock & wilcox nuclear operations group**

Subject: Reply to a Notice of Violation in Inspection Report No. 70-27/2010-003

**REPLY TO NOTICE OF VIOLATION****Violation: 70-27/2010-003-02**

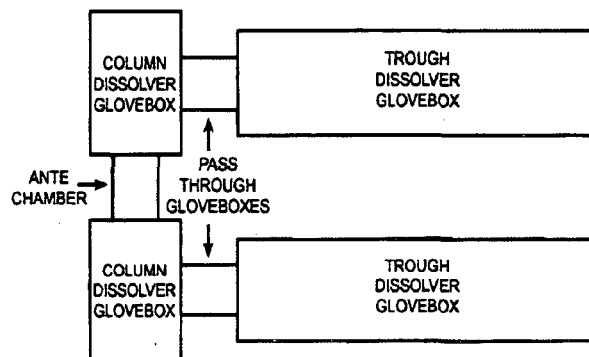
Figure 1 - High-Level Dissolver Enclosure, Top View

Babcock & Wilcox Nuclear Operations Group, Inc. ("B&W NOG"), Lynchburg facility, dissolves high-enriched uranium in two trough dissolvers in the Uranium Recovery ("UR") area. The trough dissolvers are part of a larger enclosure arrangement. The enclosure arrangement consists of two column dissolver gloveboxes, two trough dissolver gloveboxes, two pass-through gloveboxes and an ante-chamber. This enclosure arrangement is connected and arranged as shown in Figure 1 below. The column dissolver and trough dissolver gloveboxes have multiple drains, but the pass-through gloveboxes did not have drains.

Following normal glovebox flushing operations on June 11, 2010, UR area operators observed approximately one-liter of solution at the bottom of one of the pass-through gloveboxes. UR notified Nuclear Criticality Safety ("NCS"). The concentration of the solution was determined to be 26 grams U-235/liter. UR operators cleaned both pass-through gloveboxes to remove any residual material that was in the pass-through gloveboxes. Measurements indicated that a total of 111.65 grams of solid U-235 was removed. B&W NOG determined that presence of fissile solution in the pass-through glovebox represented an unanalyzed condition that failed to meet the performance requirements of 10 CFR 70.61 for nuclear criticality safety. There was no immediate risk or threat to the safety of workers or the public as a result of this event.

After clean-out of the residual material in the pass-through gloveboxes, B&W NOG shut down the system and initiated a Corrective Action (CA 201001322) to investigate the event. The investigation determined that fumes from dissolution of uranium in the trough dissolver entered the pass-through glovebox over time and adhered to the inner walls. Also, aqueous solution entered the pass-through glovebox from the trough dissolver through the hatchway during trough dissolver cleaning operations between dissolution batches when the water hose was directed at the hatchway. This resulted in fissile solution in the bottom of the pass-through glove box where it was difficult to see due to the enclosure configuration and lighting. The investigation did not identify fume penetration into the ventilation system.

3. A test was performed per Radiation Work Permit (#10-0044) which determined that the water entered the pass-through glovebox due to an improper seal on the entrance door gasket.

2. Implement requirements from the NCS evaluation of the trough dissolver pass-through glovebox using NOG-L's Change Management System (e.g. Safety Evaluation Requests, etc.). Requirements include adding independent drains to the pass-through gloveboxes and implementing administrative limits for U-235 mass, container piece count, container volume and spacing.

3. Repair gaskets on trough pass-through glovebox doors to minimize leaks. Install lighting to improve visibility in the trough pass-through glovebox.
