Subject: November 2010 Inspection Report, Cameco Resources, Permits 603 & 633

NOVEMBER 2010 INSPECTION REPORT DISTRICT 1/LAND QUALITY DIVISION

COMPANY: Cameco Resources (CR), Highland Ranch, Permit #603
& Smith Ranch, Permit 633

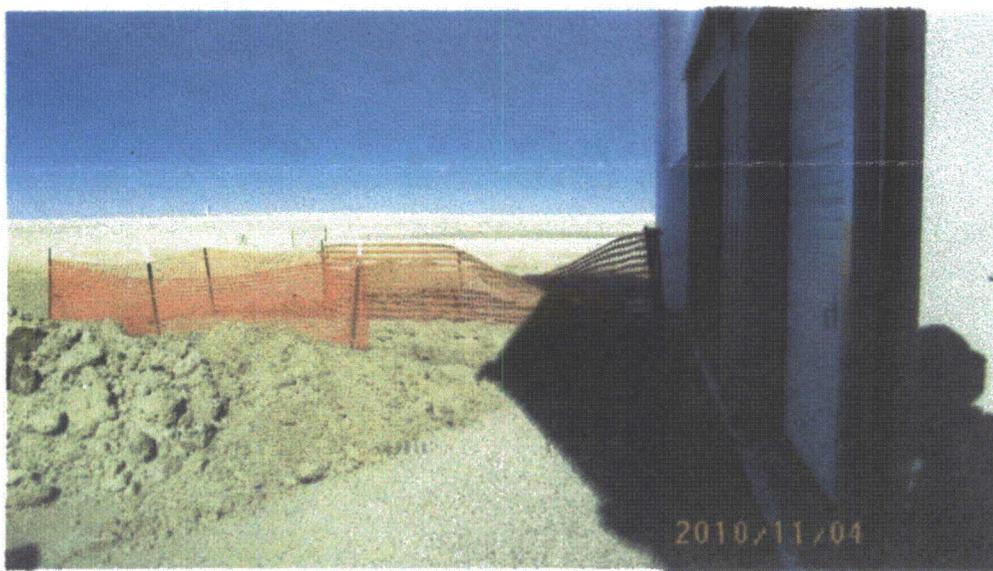
- **Inspection of SHRUP #9** – disturbance was recently seeded and mulched; crimper is not working as well as desired, CR may purchase additional crimping equipment. Work crew was working on general surface and building work to complete backfill following power and pipeline installations (Figure 1). The disposal well will be used in part for disposal of waste water from MUs D and E; waiting on approval from WDEQ/WQD

Figure 1 power line installation at SHRUP #9

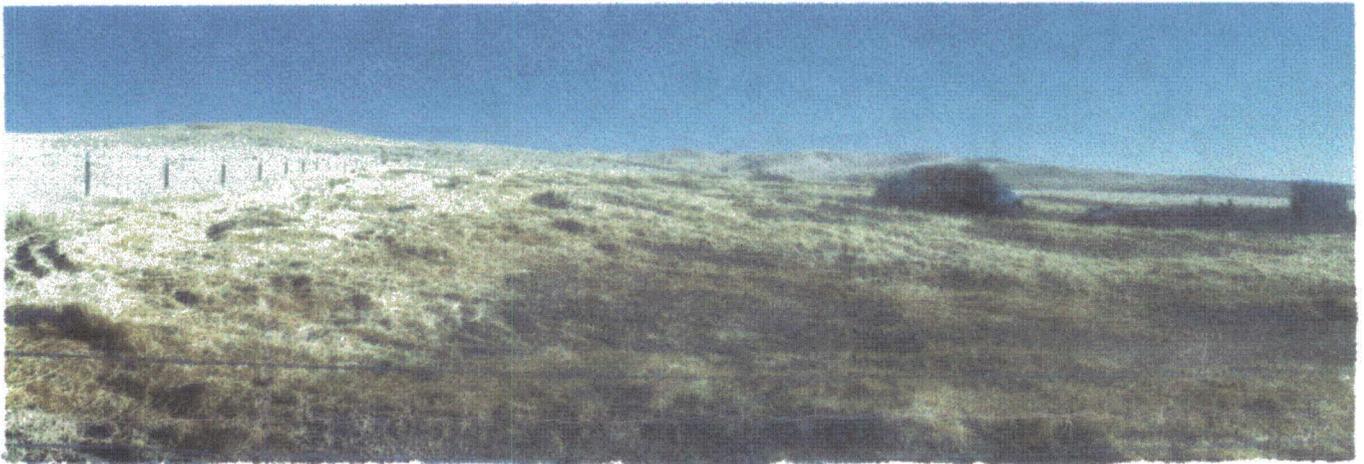
Inspection of SHRUP #10 – waiting on power installation; surface reclamation in progress (Figure 2); also conducting some road work for the landowner. The disposal well will be used in part for the disposal of waste water from MU-4; waiting on approval from WDEQ/WQD. The sediment that was located outside the disturbance noted during the September inspection was removed and the surface reseeded. A topsoil stockpile remains on the location (Figure 3). A connecting road has been improved from the DDW site to Satellite No. 1.

Figure 2 Reclaimed wellpad SRHUP #10

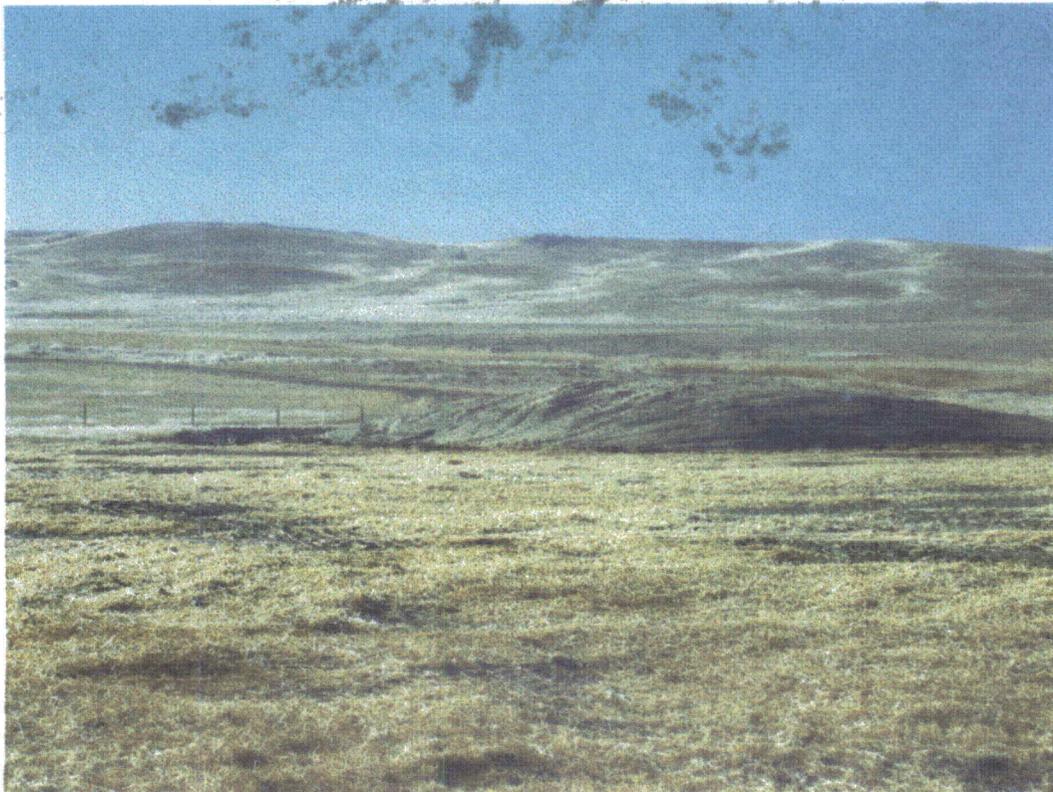
Figure 3 Topsoil stockpile at SRHUP #10

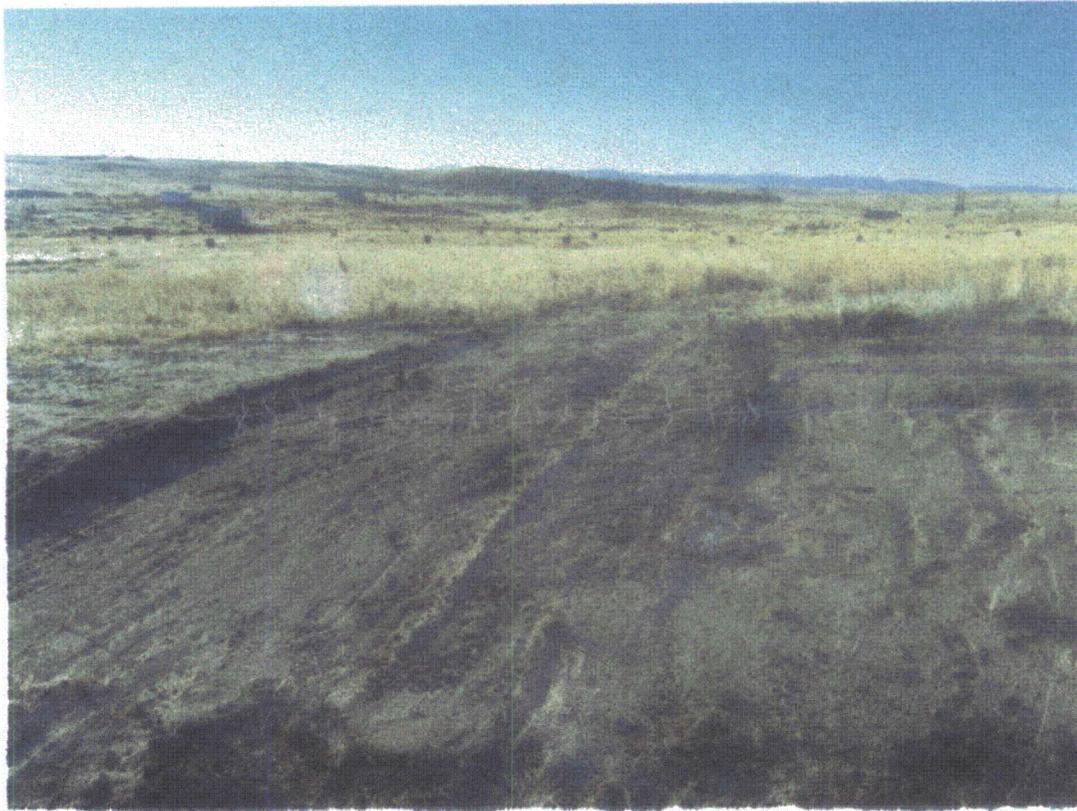
The inspector attempted to inspect some of the abandoned drill holes located in MU-3. A GPS locator was used to find the hole locations, however, the sites had been backfilled, topsoiled and seeded without a stake placed at the hole location making it impossible to be confident of the hole location. The inspector attempted to probe the approximate location but could not be sure that the cap was located. Without a confident means of inspecting the hole plugging, the hole inspections are postponed until other inspection methods can confirm the holes are adequately plugged and abandoned.

The following drill sites were verified as backfilled, topsoiled and seeded (Figure 4):

- 4 Delineation and exploration drill holes are plugged and abandoned without surface stakes/markers for inspection of abandonment. Although the locations can be approximated with GPS, it is not possible to confidently locate a subsurface cap that has been backfilled, topsoiled and seeded without a surface marker. Further, locating a subsurface cap provides assurance that a hole is capped but does not ensure the plug is in place. Therefore, LQD will request excavation and removal of caps for a percentage of drill holes during future inspections to verify the plug is in place and is not settling. LQD does not have the resources to inspect plugging activities during the activity and therefore will need to conduct the inspections after the work is completed. These inspections will be announced to ensure CR has adequate staffing on site to provide the excavation and cap removal.

Figure 4 Graded, toposited and seeded drill site in MU 3
