Study of the Unit 2 Spent Fuel Pit Permeability

**Entergy Nuclear Northeast
Indian Point Unit 2**

*Report No. 1464385-R-004
Revision: Draft B*

**ABS Consulting
118 Portsmouth Avenue
Stratham, NH 03885**

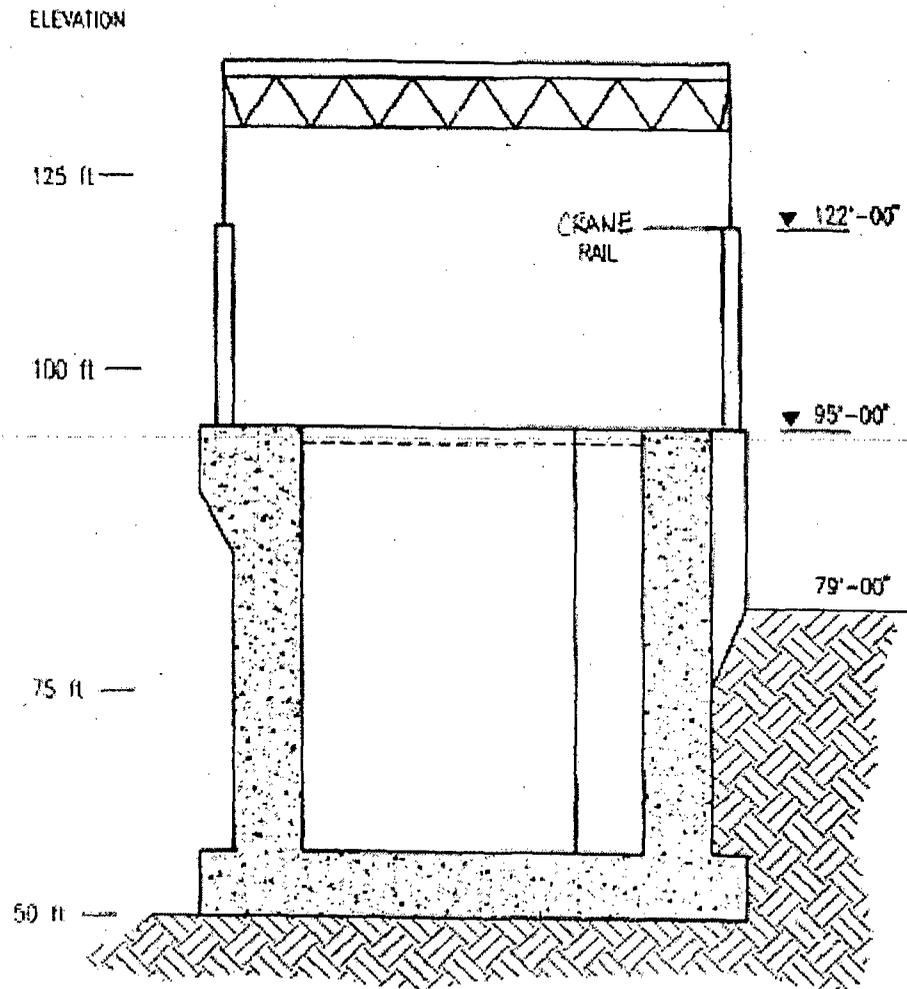
The pit has walls of 4'0" and 6'-3" thick with a 3'-0" thick base mat. The structure is founded on rock at elevation (El.) 50'-0" beneath the spent fuel pit, see Figure 1 and Figure 2.

Figure 1: FHB Looking North

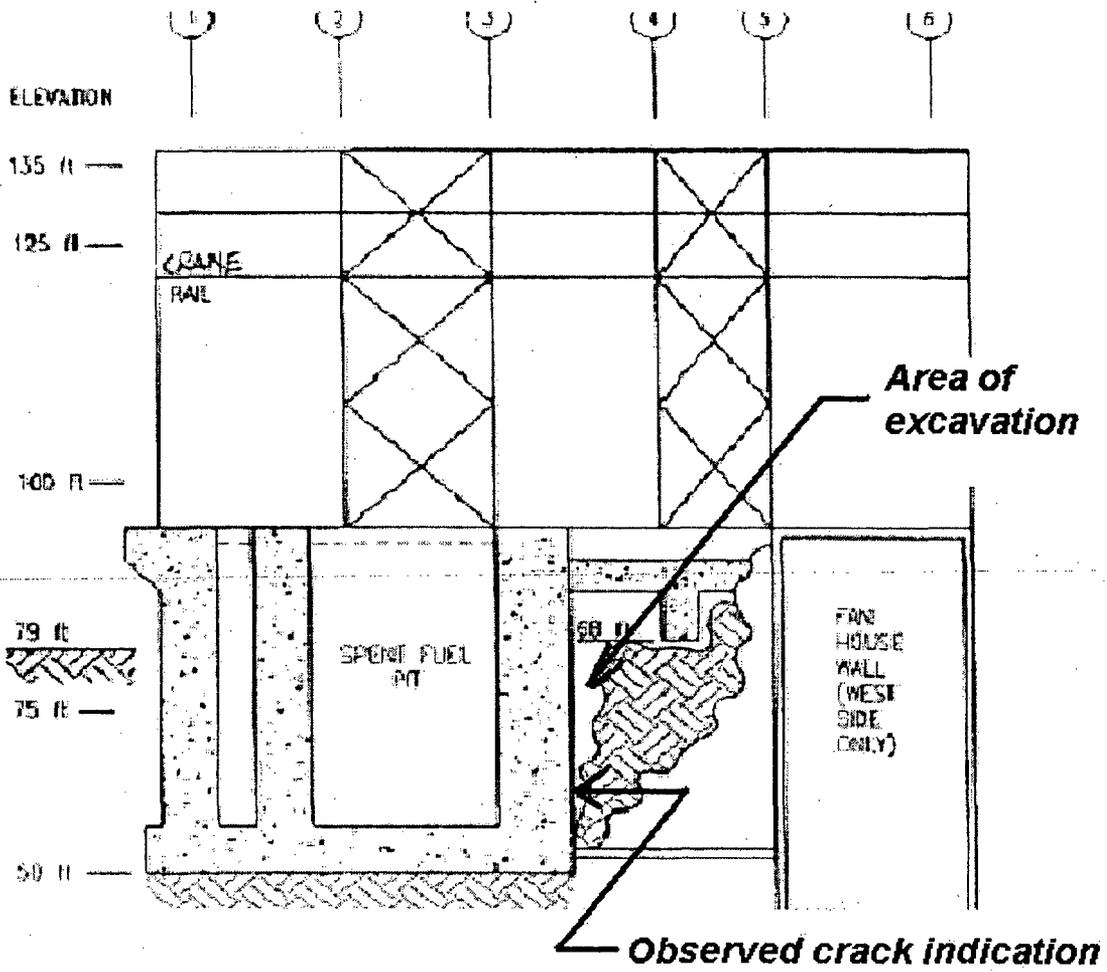
The south wall of the SFP was originally covered by the back-filled soil and rock material in the space between the outside of the wall, and the excavated rock to its south, see Figure 2. The back-filled material (soil) provided an overburden pressure against the wall. During excavation of this soil it was noted that the composition contained large rock with voids being present. With the soil in place, the concrete of the wall and a portion of the soil adjacent to the wall will with time approach the temperature inside the pool, approximately 100 degrees F. With the soil removed adjacent to the wall, the exterior of the wall is exposed to ambient air conditions.

Figure 2: FHB Looking East

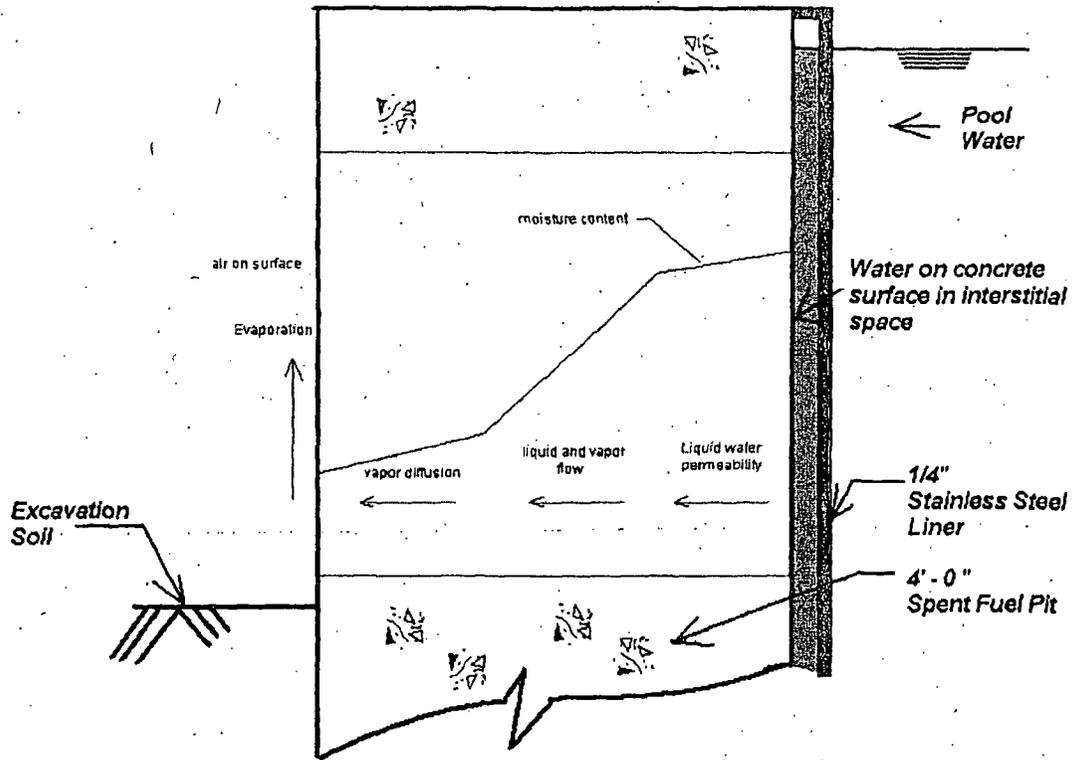
The transfer of water through the concrete wall is a function of the transfer of liquid water, water vapor, and of the removal process at the exterior wall (Ref. 2). A diagram showing the penetration of water into the concrete wall, from right to left, is presented in Figure 4. In this diagram, the liquid is driven to some depth in the wall by the head of water in the interstitial space between the inner exposed concrete surface and the liner. At a mid-wall point, vapor diffusion and liquid flow are combined, and at the final section of the wall, vapor diffusion carries the flow to the outside surface. If liquid water does not continue to the outside wall, the surface appears dry. If liquid does reach the outside wall, the surface appears wet, and evaporation or drainage carries away the surface moisture.

Figure 4: Unsaturated Flow Through SFP Wall
