NC STATE UNIVERSITY

Re: Reportable Event 46484; Radiography Incident
License No. R-120
Docket No. 50-297

Neutron Imaging Facility Personnel Exposure Incident Report

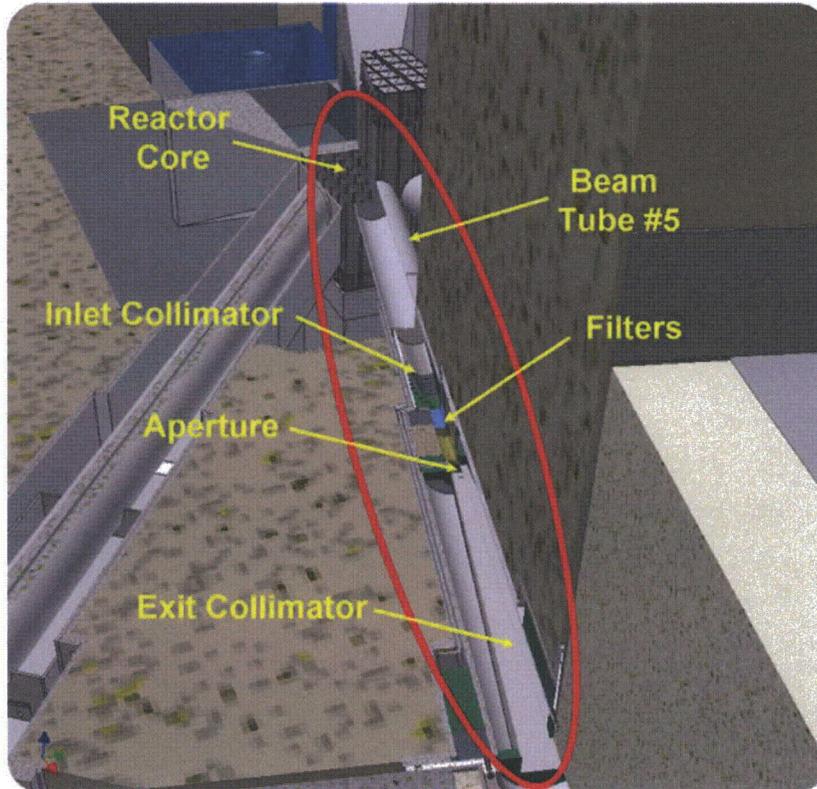
Beam tube #5 – cutaway view of NIF collimator assembly

The Neutron Imaging Facility is installed at beamport #5 of the PULSTAR reactor. The beam is collimated and filtered.

Fluence rate at the imaging plane in its current configuration is reported to be $1.8 \text{ E}6 \text{ n/cm}^2/\text{sec}$.

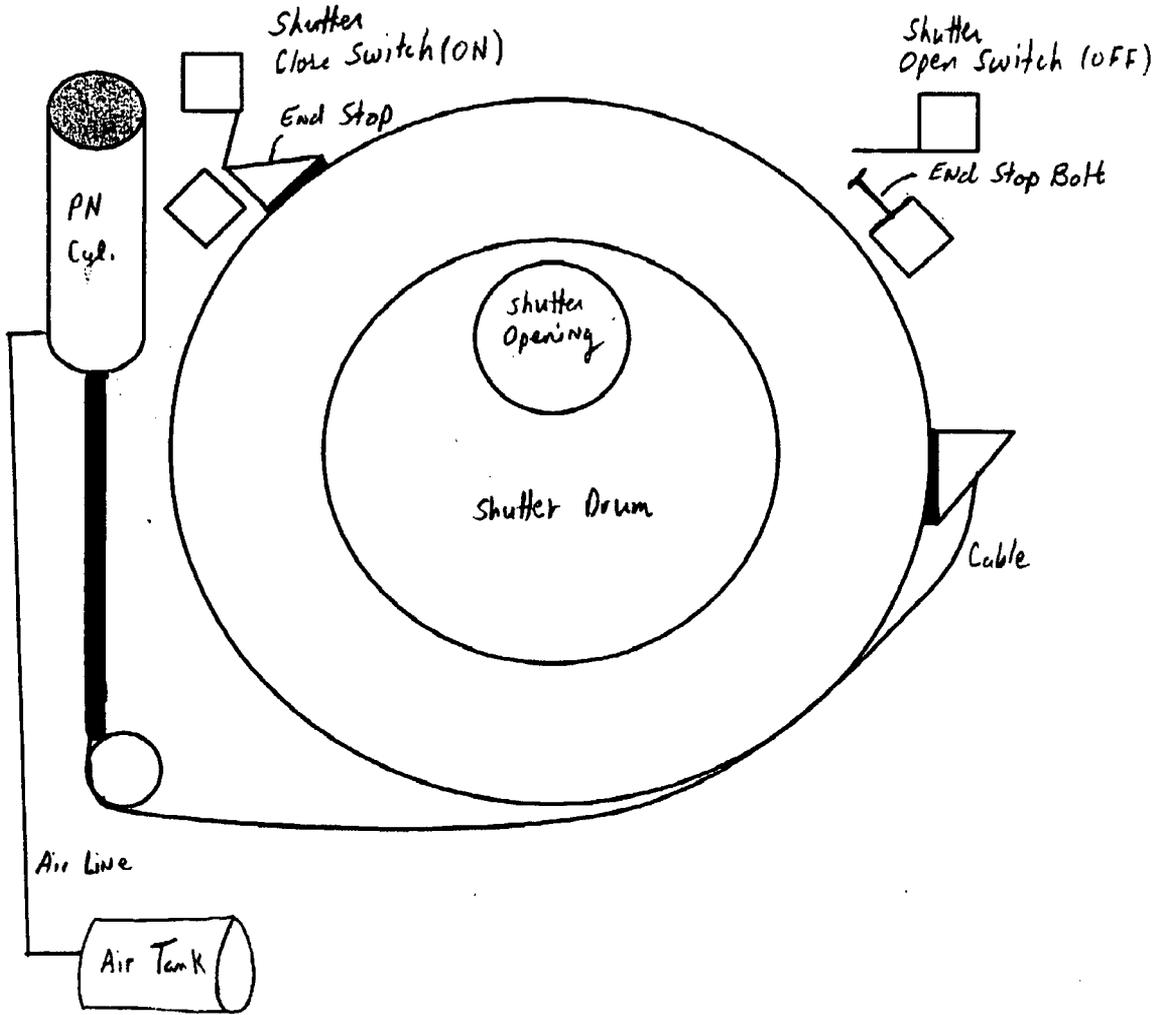
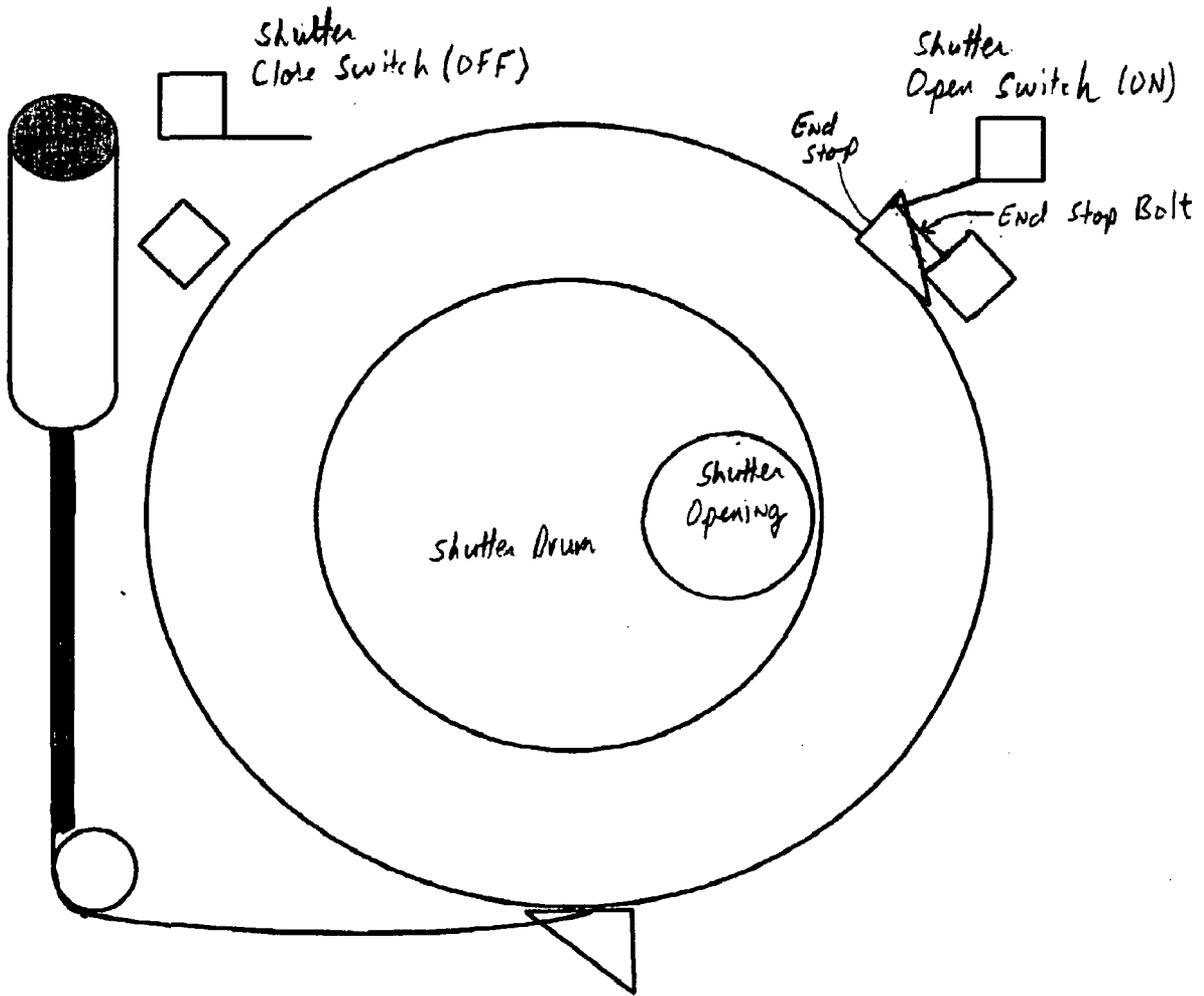
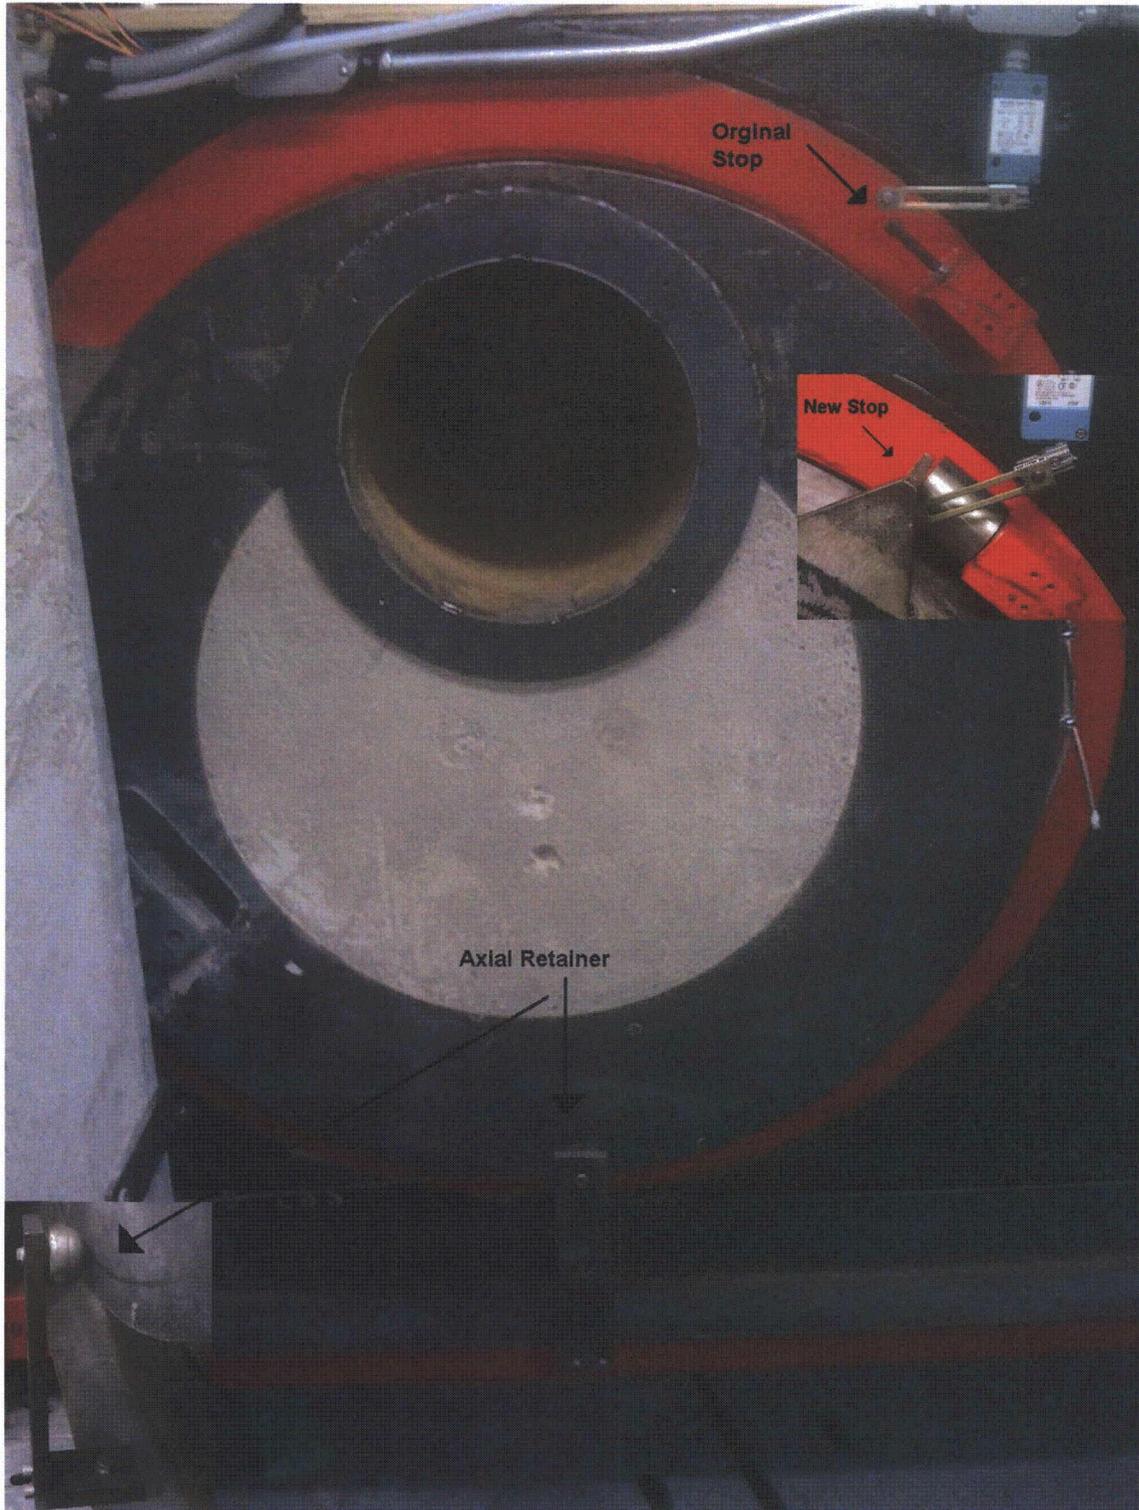
ATTACHMENT 2 NIF SHUTTER in CLOSED POSITION

In this incident when the timer reached zero minutes, the 24 volt circuit de-energized and air was vented from the pneumatic cylinder. Normally this would cause the shutter to close by gravity. In this incident the shutter failed to close because it hung-up on the end-stop bolt. [Refer to Attachment 2]

Due to a design flaw, the shutter got hung-up because the shutter drum had moved outward in the axial direction by approximately 0.5 inches over time from repeated opening and closing. This altered where the shutter end-stop was making contact with the end-stop bolt, and the end-stop became jammed on the end-stop bolt.

2. The end stop bolt that prevented the NIF shutter from closing has been replaced with a cylindrical block that is unlikely to get caught on the shutter end stop.

3. A retaining bar has been installed at the base of the shutter to prevent the shutter rotating drum from moving outward.
4. The shutter closed position switch AND a radiation monitor have been connected to the NIF door interlock. The shutter must now be fully closed AND the radiation monitor reading must be below a radiation set point for the NIF door to open from the outside. For egress reasons, the Exit Permit Pushbutton on the inside of the NIF remains as designed causing the shutter to close and the NIF door to open. Similar arrangements with a radiation monitor interlock are being planned for installation at the Primary Piping Vault door and Positron Facility door.

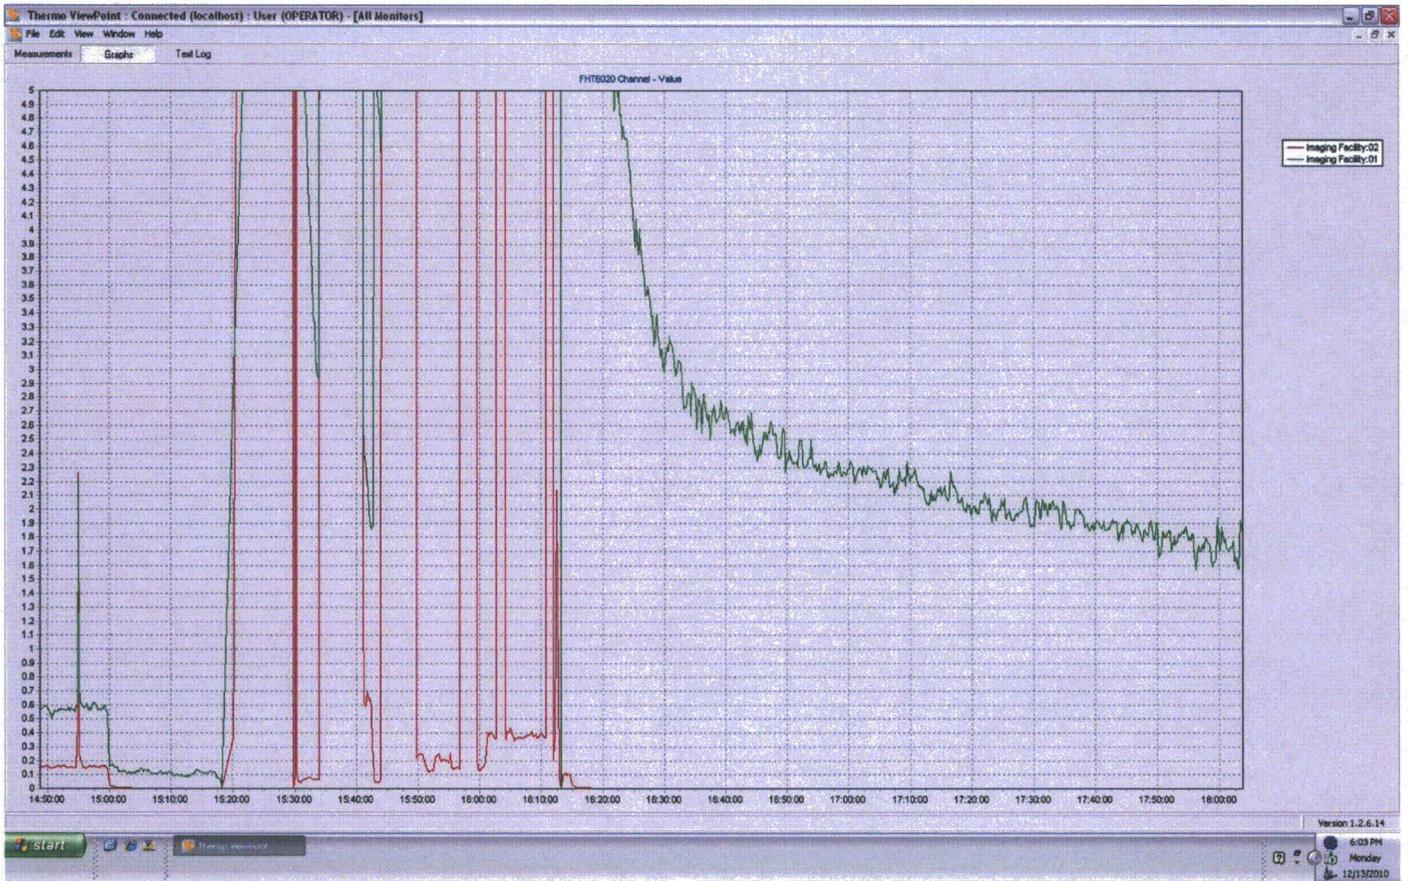
ATTACHMENT 3 NIF Radiation Monitor Display (screenshot) for 13 Dec 2010

The incident alarms (spikes) are shown on the left side of the display. The remaining display is from the dose evaluation with the radiation detectors located inside the NIF.

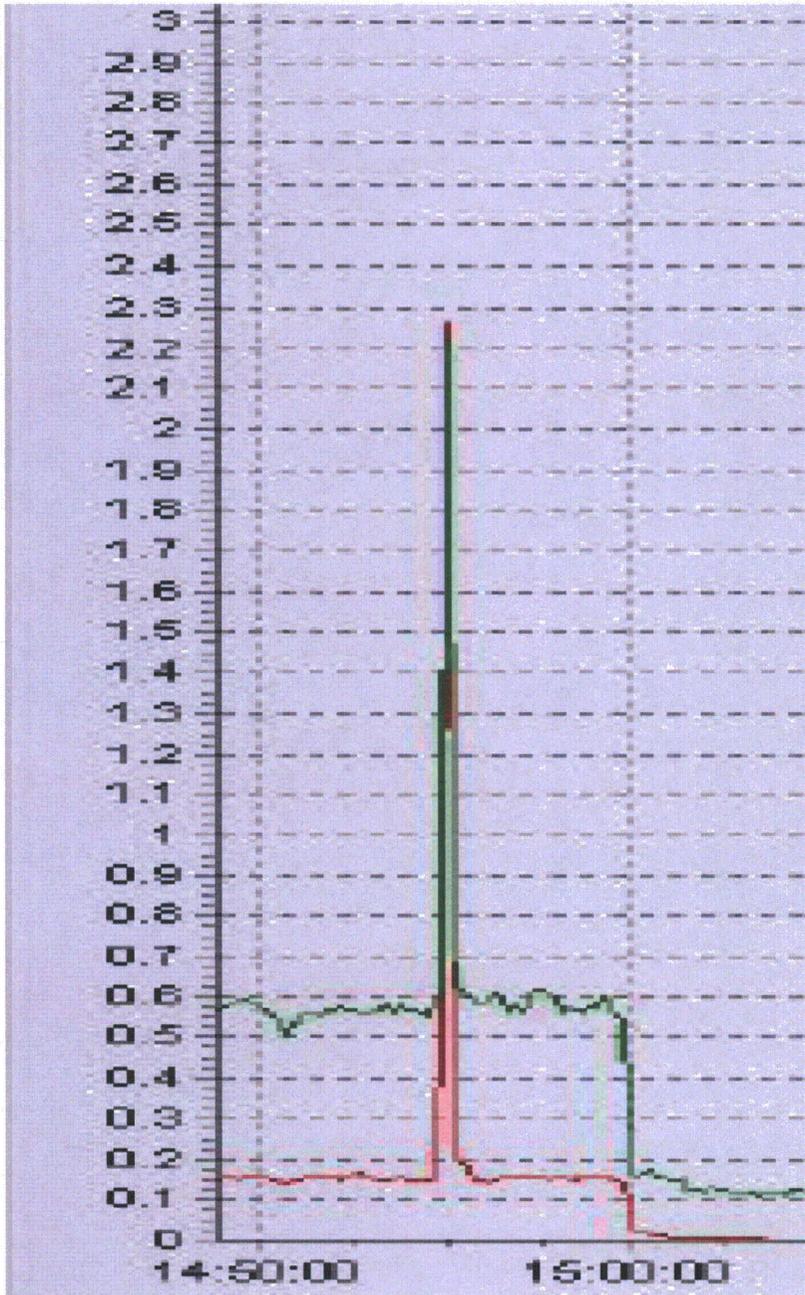
ATTACHMENT 3 NIF Radiation Monitor Display (expanded screenshot)

Alarm setpoints are 2 mrem/h for the gamma (green line) and neutron (red line) detectors. Both detectors went into alarm. The time stamp on the radiation monitor computer is 10 minutes slower than the security video computer. Therefore, the alarm (spike) occurred at approximately 3:05 pm, which matches the NIF entry time by the radiographer.
