SUBJECT: SUMMARY OF CONFERENCE CALL WITH PALISADES NUCLEAR PLANT
REGARDING THE FALL 2010 STEAM GENERATOR INSPECTIONS
(TAC NO. ME4671)

CONFERENCE CALL SUMMARY
PALISADES NUCLEAR PLANT FALL 2010 (1R21) OUTAGE STEAM GENERATOR
INSPECTIONS

STEAM GENERATOR TUBE INSPECTION DISCUSSION DURING PALISADES 2010 (1R21) OUTAGE

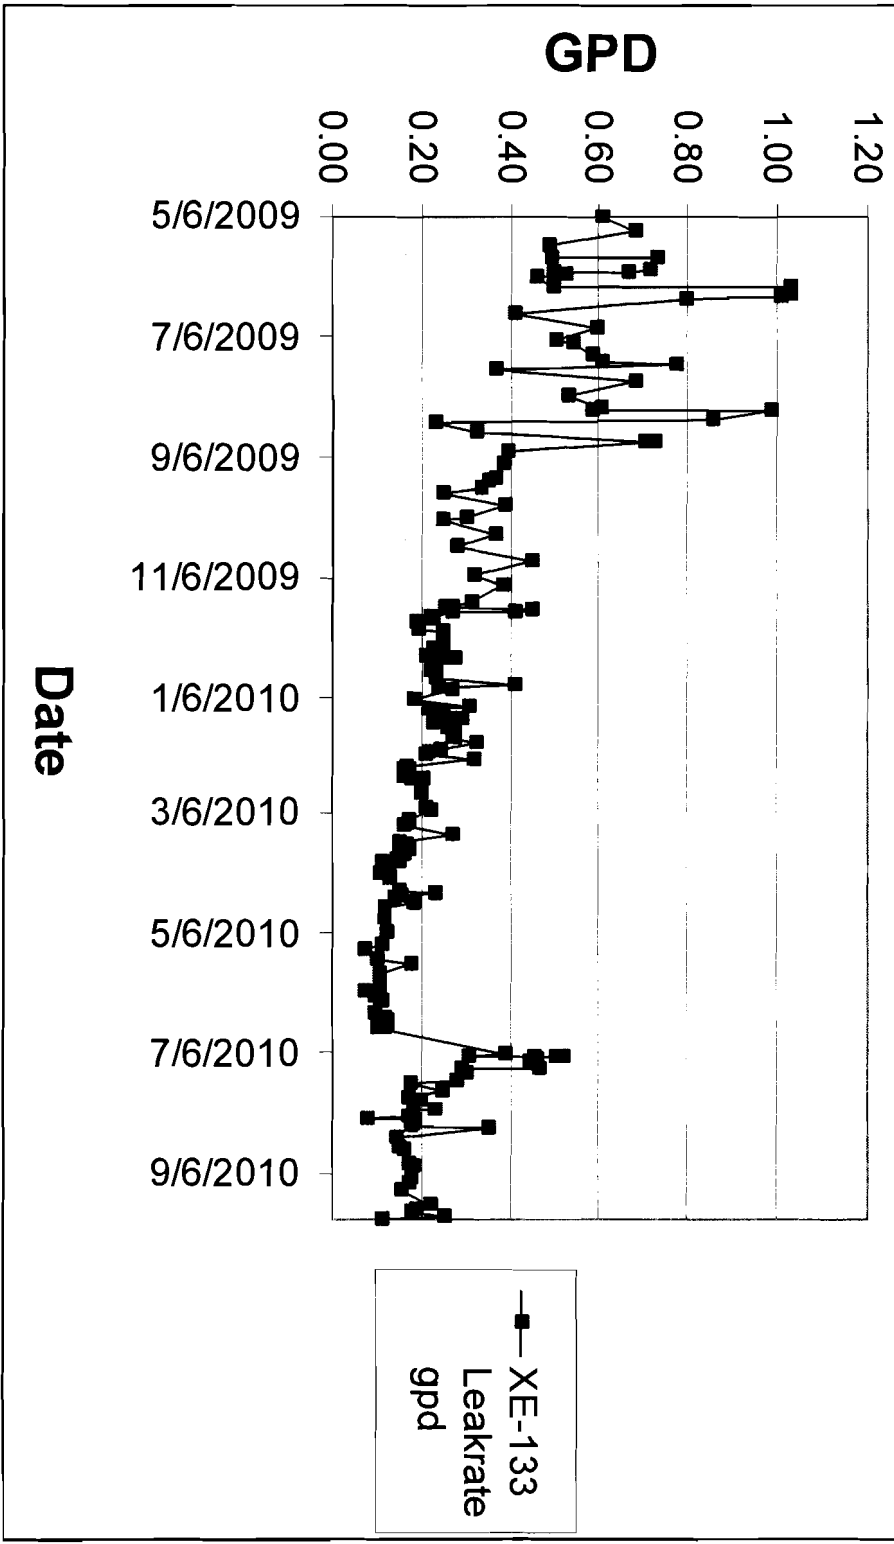
Palisades Cycle 21 Primary to Secondary Leakage

Refer to attached Primary to Secondary Leak Rate for Operational Cycle 21 Primary to Secondary Leak Rate graph. Leakage has been minimal all cycle.
