**From:** Ottenberg, Geoffrey - R2  
**Sent:** Friday, August 21, 2009 8:43 AM  
**To:** Michel, Eric  
**Subject:** FW: Scanned Document  
**Attachments:** Document.pdf

In case you didn't see these- it may give some perspective to what they are planning. They are construction photos of the SSF, so you can see the piping before it was covered with soil. The first picture shows the discharge lines from the outside of the SSF (the now buried portion). The licensee believes the flaw is somewhere near the 90deg elbow (~ 23 ft below grade).

OCONEE NUCLEAR STA  
11 7 80 NO 8453  
SHUT DOWN FAC

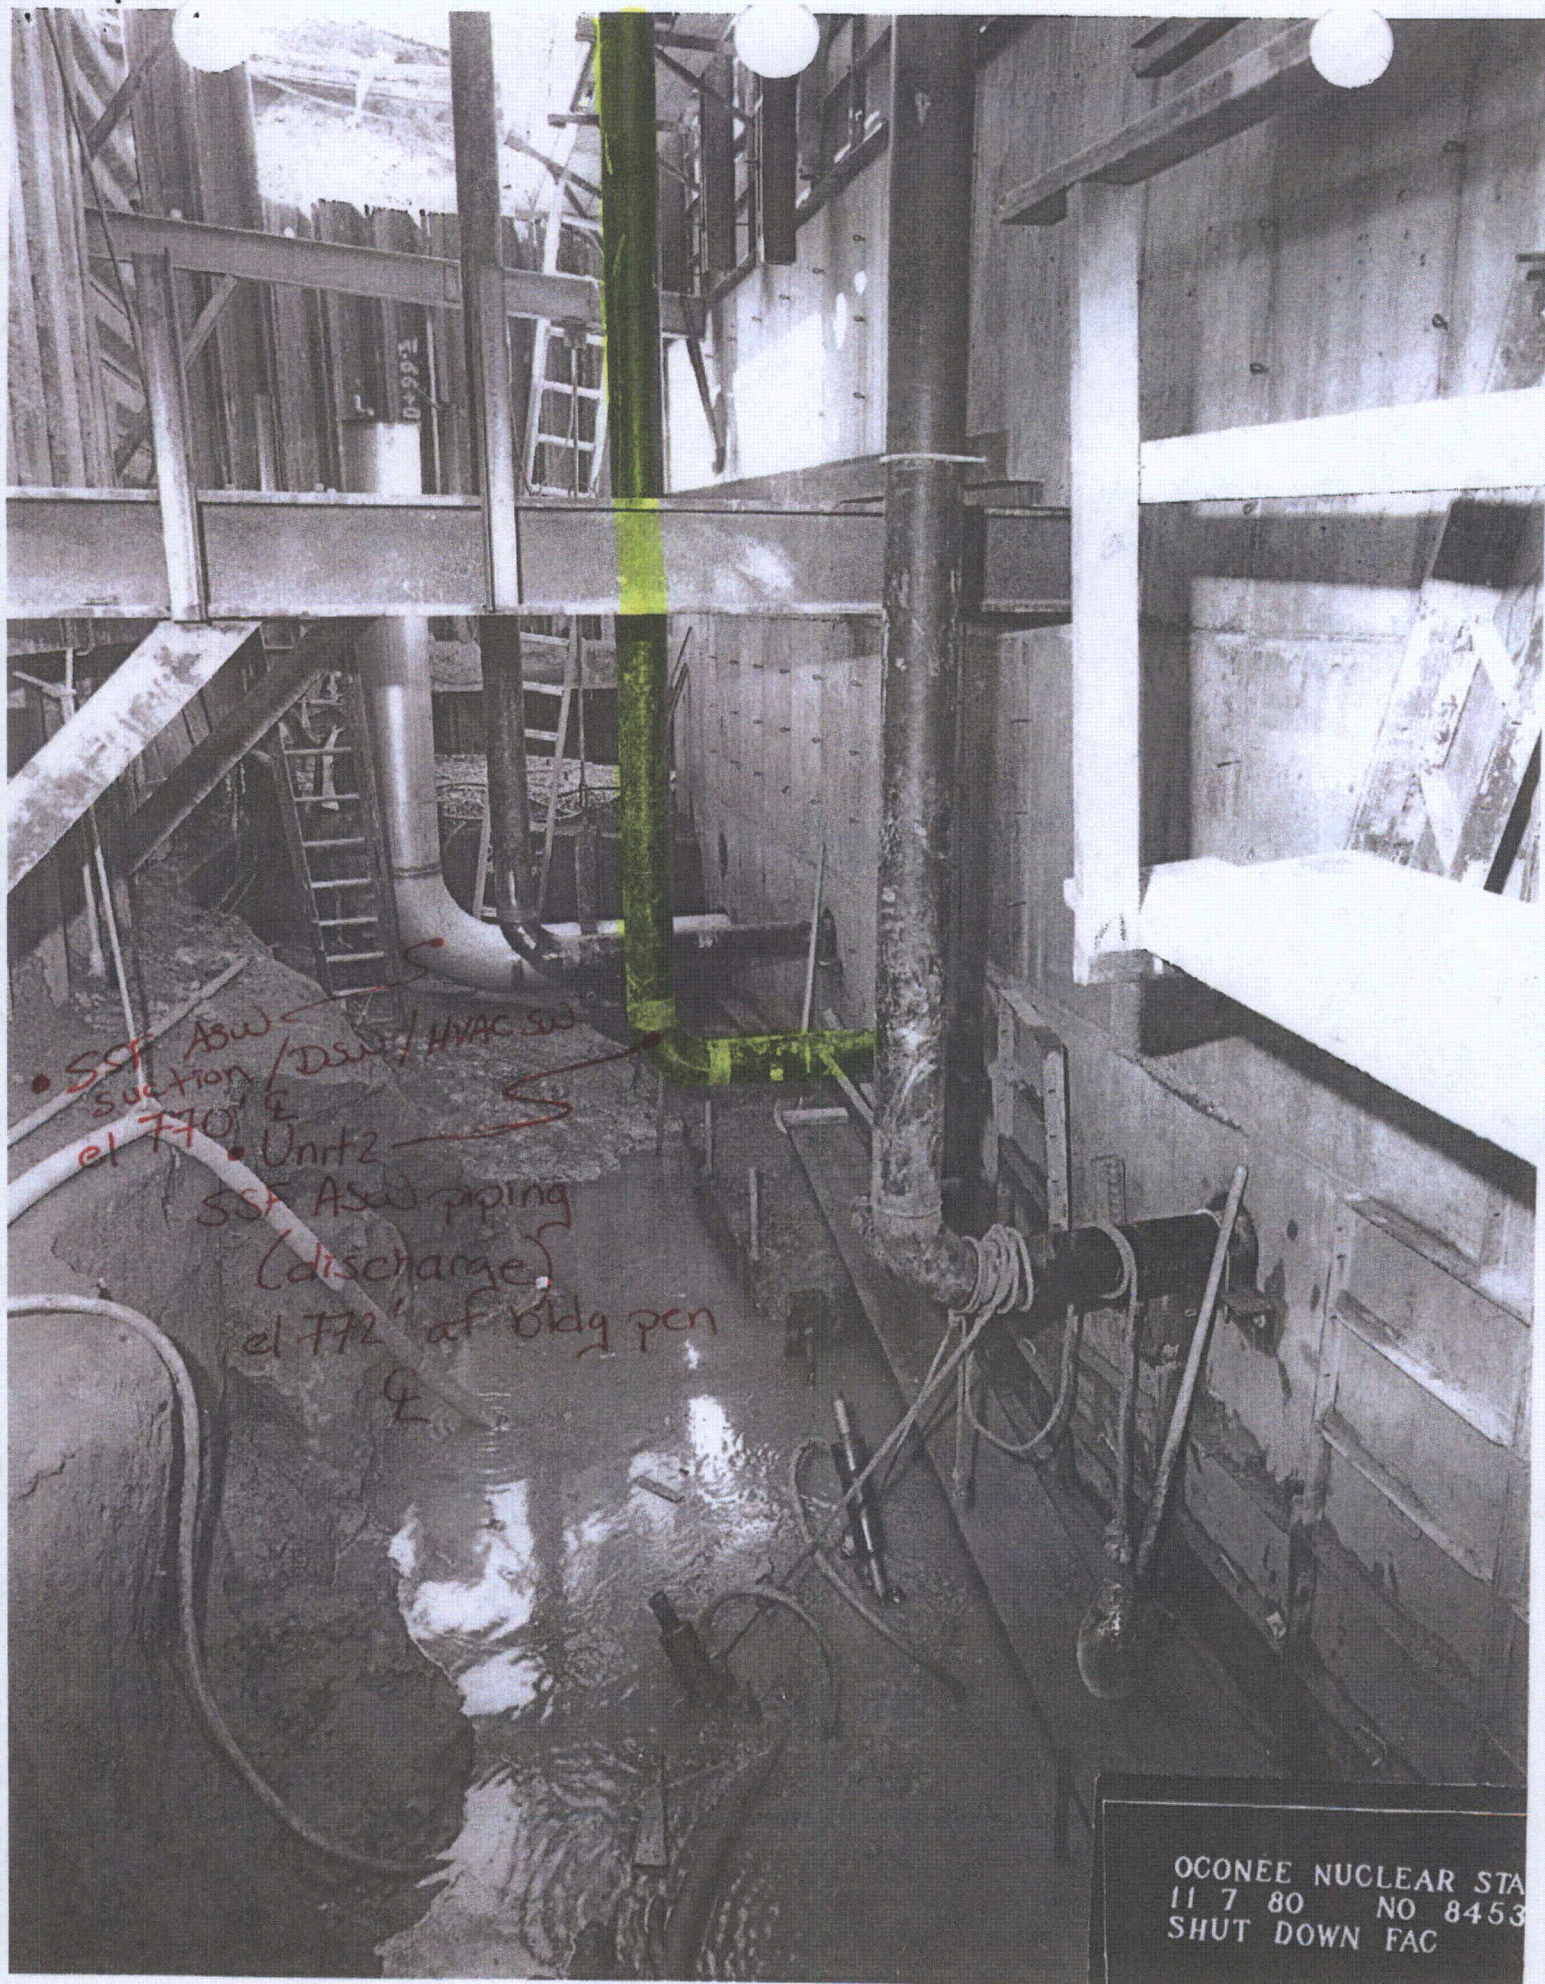
• SSF ASW  
suction / DSW / HVAC SW  
el 770' ±  
• Unit 2  
SSF ASW piping  
(discharge)  
el 772' at bldg pen  
±

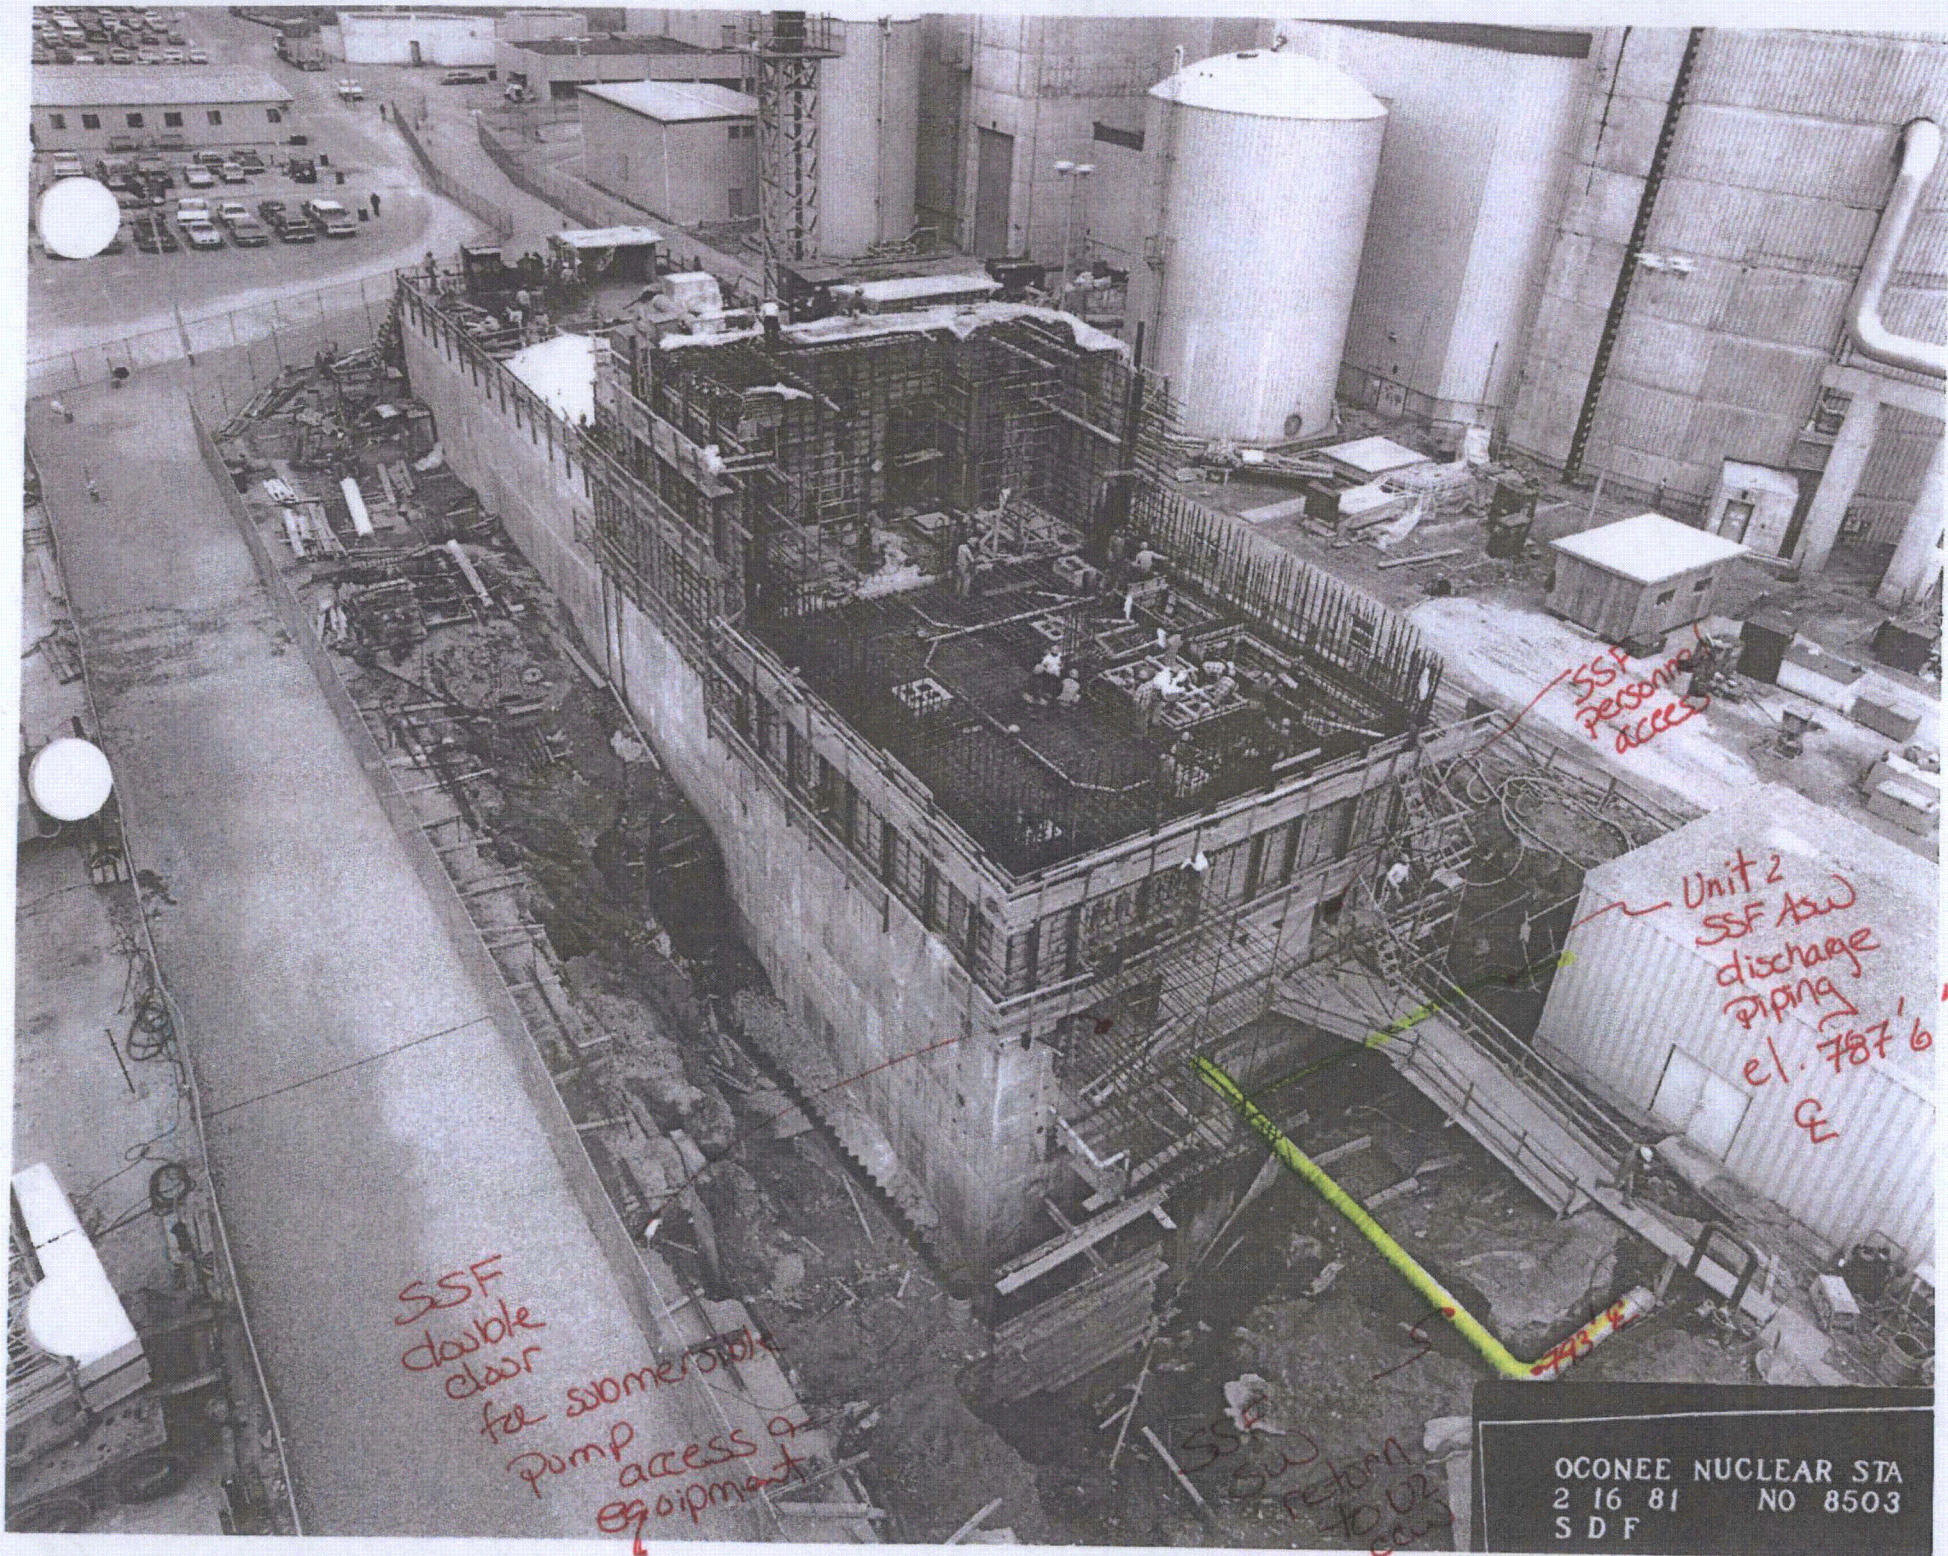
OCONEE NUCLEAR STA  
2 16 81 NO 8503  
S D F

SSF double door  
for submersible  
pump access &  
equipment

SSF  
personnel  
access

Unit 2  
SSF ASW  
discharge  
piping  
el. 787'6"  
±

SSF  
SW return  
to U2  
cond
