ROOT CAUSE REPORT

TITLE: INADEQUATE RESPONSE TO UNPLANNED ENVIRONMENTAL TRITIUM RELEASES FROM BRAIDWOOD STATION DUE TO THE LACK OF INTEGRATED PROCEDURAL GUIDANCE.

Unit(s): Braidwood Units 1 and 2

Event Date: 11/30/2005

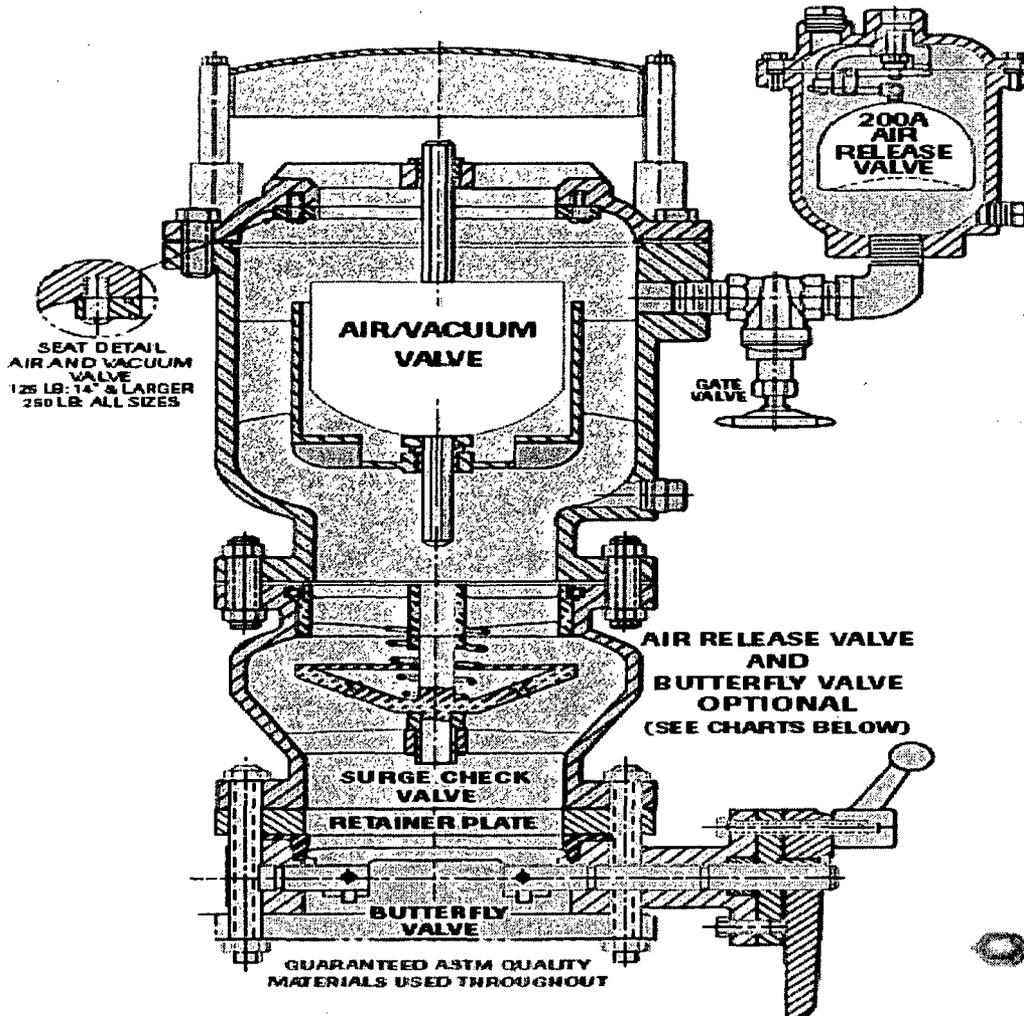
Typical vacuum breaker:

Work history on the Circulating Water Blowdown System vacuum breakers was reviewed. There were no recorded vacuum breaker float assembly failures prior to 2000, however several instances of leaking air release valves were noted from the review. The 0CW060 air release valve was discovered leaking in 12/98. PIF # A1998-04324 was generated to address the flooding of site property and the Smiley Road ditch immediately adjacent to site property. The piping to the air release valve on the 0CW058 failed in 12/96. The complete vacuum breaker assembly including air release valve was replaced with a new assembly in 6/97. It should be noted that the 0CW058 vacuum breaker failed again on 11/20/2000 while this root cause investigation was in progress. The float assembly broke at the bowl to guide bar weld. No other significant work history was identified.

The failure of the 0CW136 float assembly was discussed with the vendor. Based on the failure description, the vendor indicated that it appeared to be consistent with the effects of a pressure surge (i.e.: water hammer). The vendor indicated that surge protection check valves should be considered for a vacuum breaker

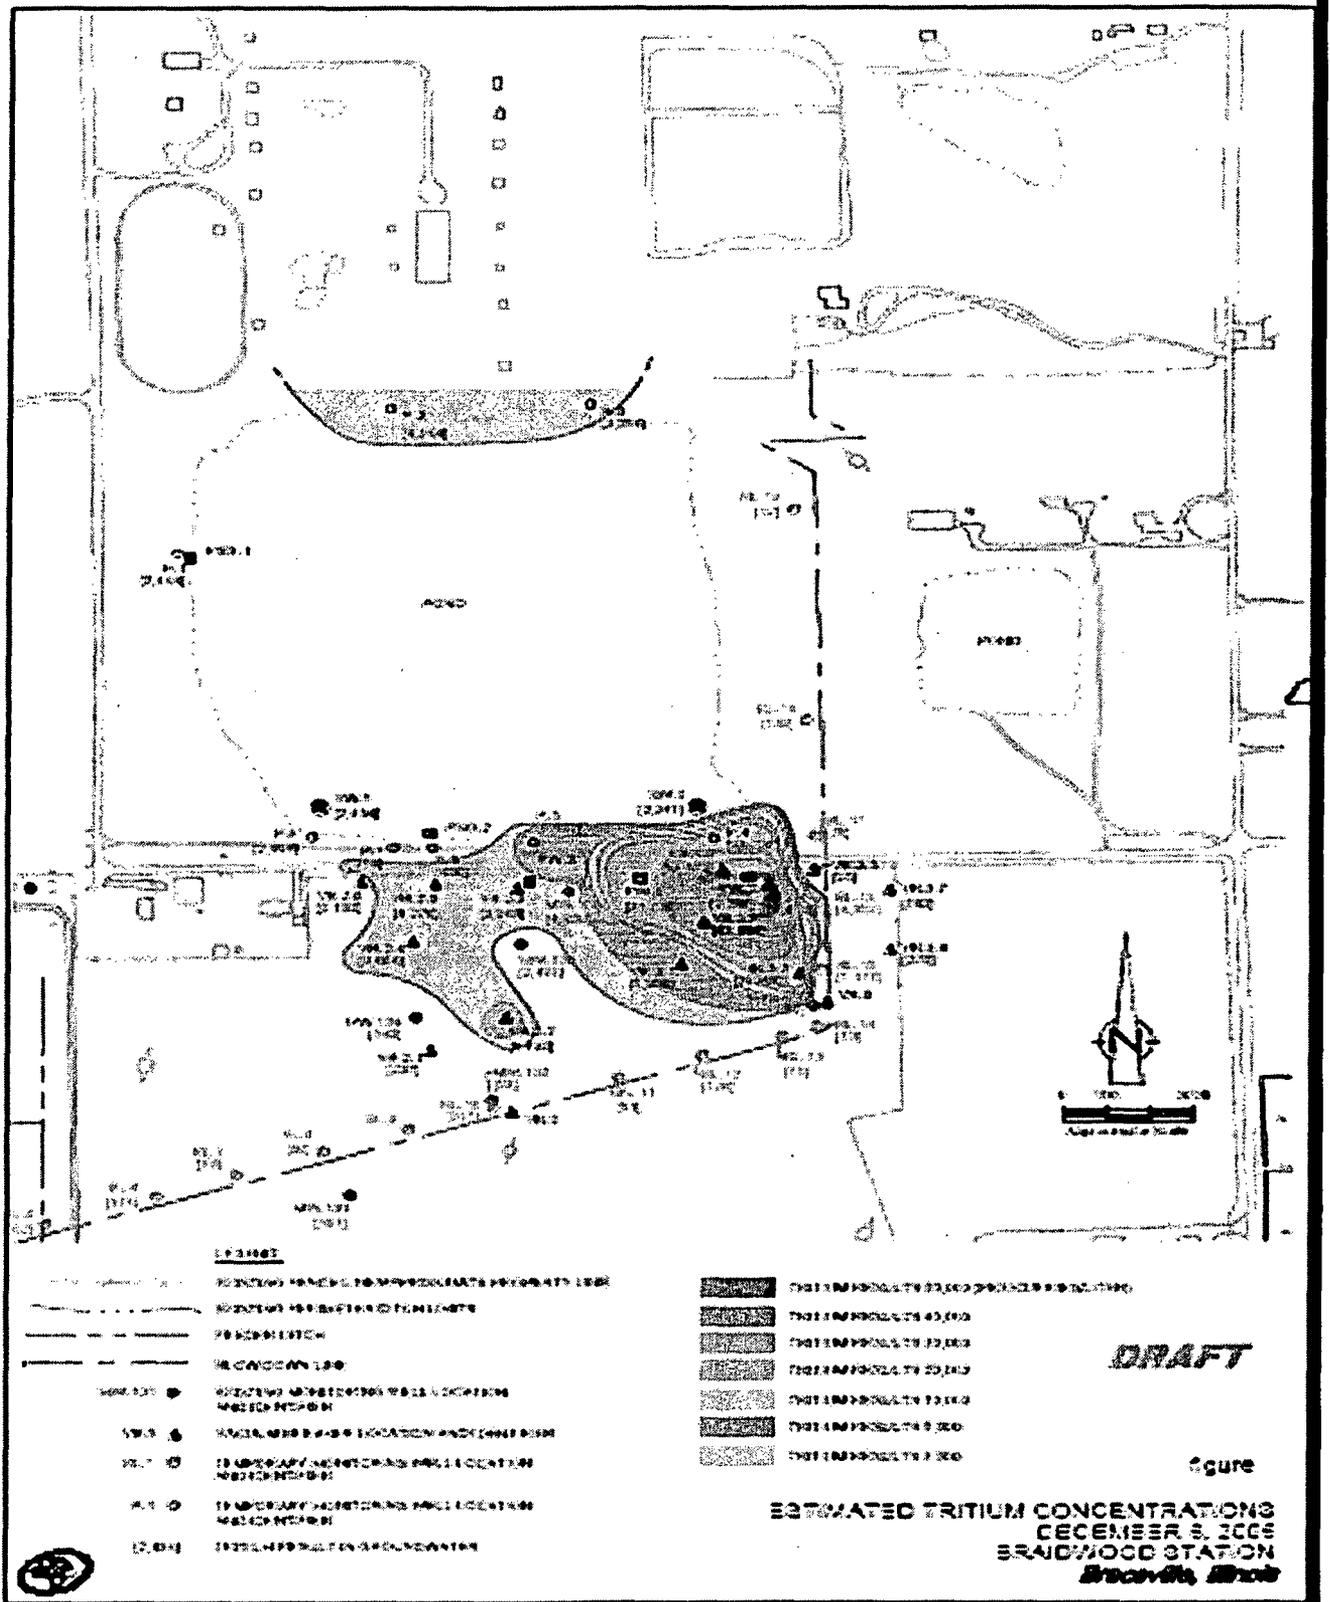
Attachment 5 - Tritium Plume Map

Braidwood Station identified elevated levels of tritium in the groundwater both on and off the plant property. The presence of these elevated levels violates Illinois EPA regulations (Attachment 3). The elevated levels of tritium appear to have originated from historical spills. As of January 6, 2006, acoustic testing of the blow down piping showed no measurable evidence of a leak. The tritium remediation plan will be tracked to completion under IR# 435383. The scope of this investigation was to determine the root cause of the Station's historical response(s). These responses were inadequate in that they did not effectively evaluate, mitigate or remediate these spills, which had the potential to affect the public. A review of a previous Root Cause regarding Circulating Water (CW) Blowdown (B/D) vacuum breaker failures was performed to determine if the corrective actions were effective.

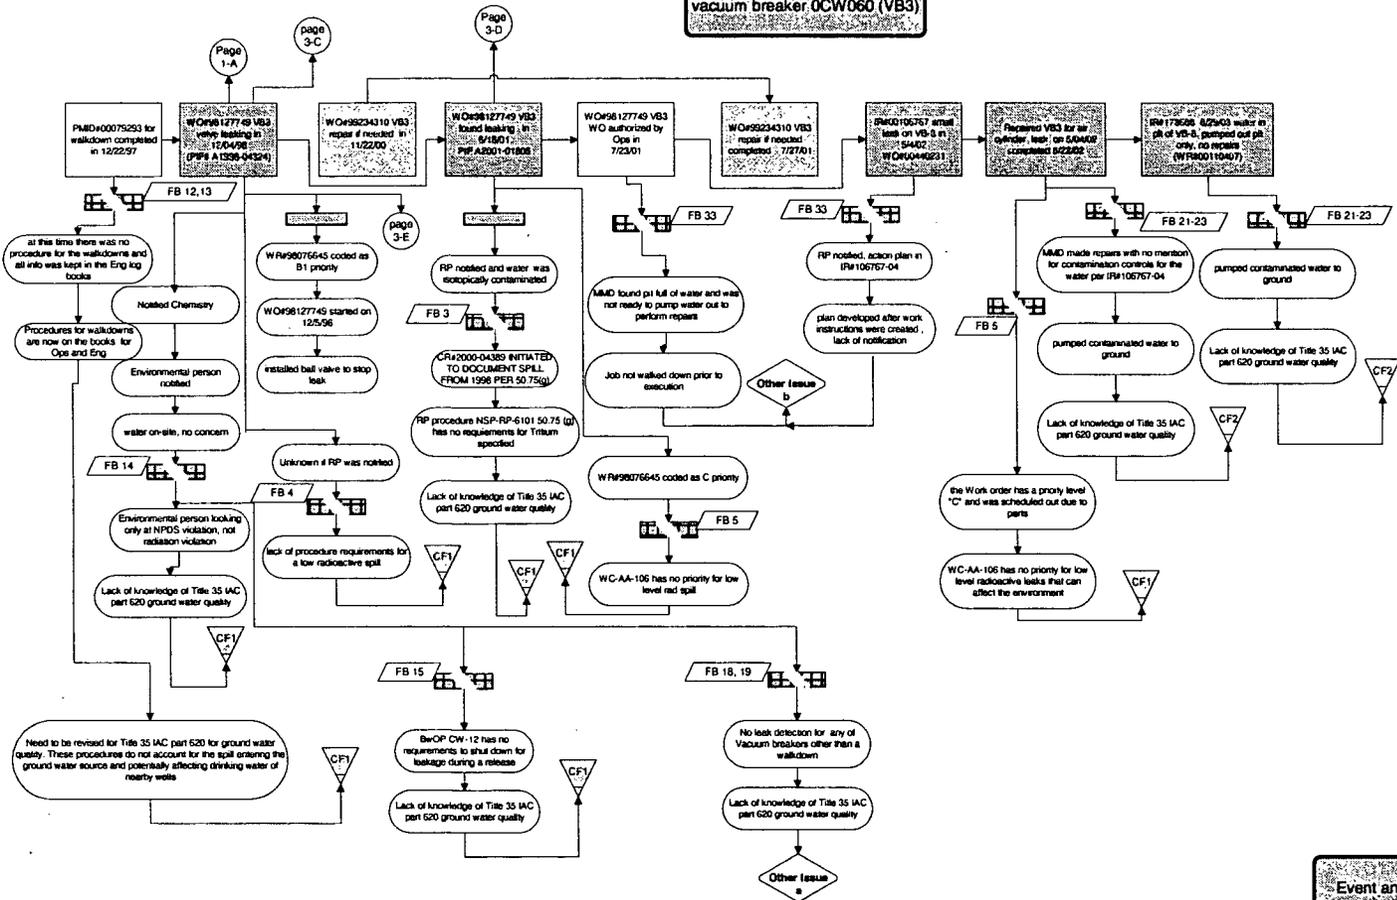
Page 2 for history of blowdown vacuum breaker OCW060 (VB3)

~~In 1998, VB-3 failed and released approximately three million gallons to the ground. Once again, the only response to this event was to repair the valve as soon as possible. During the review of this event, the team could not find any documentation of sample analysis for radioactive materials. The NPDES Coordinator was notified and determined that there were no environmental concerns because the water had not reached a waterway. There was no documentation that there was any spill remediation performed.~~
