Part 21 (PAR)

Event # 46523

PART 21 REPORT FOR POTENTIAL SAFETY HAZARD ON SPEED SWITCH INSTALLED ON EMERGENCY DIESEL GENERATOR (EDG)

**FM Notification Report Serial Number 10-05
Fairbanks Morse Engine
10CFR 21.21 (d)(3)(ii) Notification**

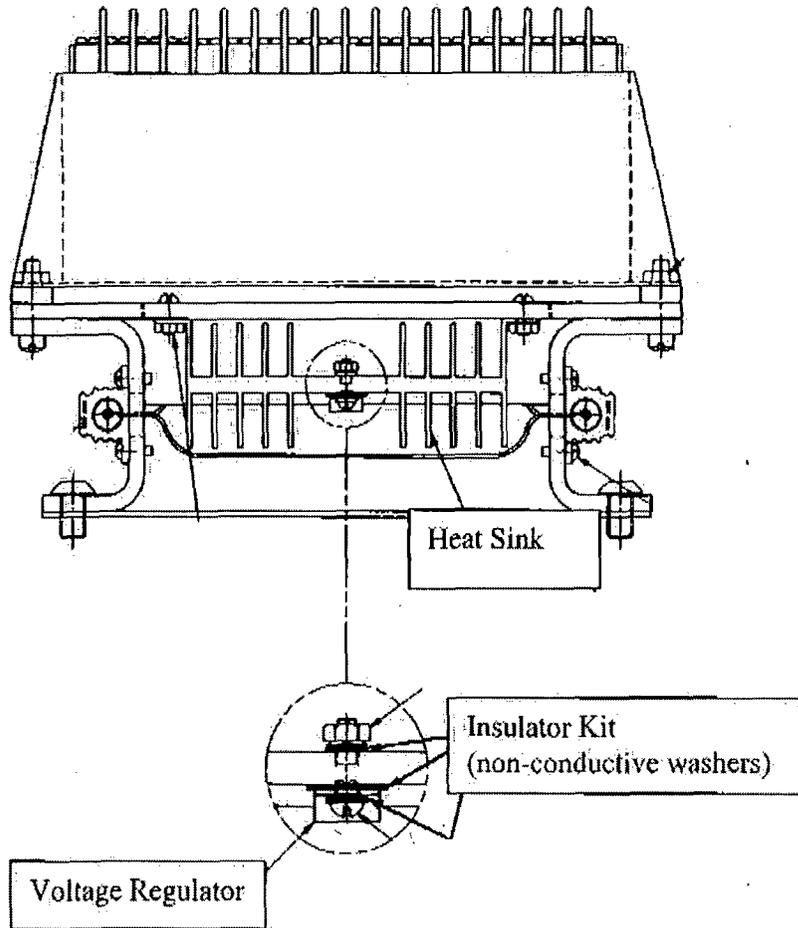
Figure 1

Fairbanks Morse (FM) evaluation has determined that a potential safety hazard existed for the original FM P/N 11916260 created from FM P/N P12620666 rev 0 that was delivered to Hope Creek. Subsequent to shipment to Hope Creek, additional testing found that when the speed switch assembly was mounted on a conductive surface, the voltage regulator grounded out the 24 vdc power through the heat sink preventing the speed switch from operating.

By adding an insulator kit, the speed switch circuit was isolated from ground and verified as functional. The FM initial design of the speed switch did not include the insulator kit (non-conductive washers) that would electrically isolate the voltage regulator from the heat sink and thus the metal mounting surface.

The one affected unit 11916260 created from P12620666 rev 0 was recalled and modified by adding an insulator kit (item 23) between the voltage regulator (item 8) and the heat sink (item 7) as shown in Figure 1. The design records have been updated accordingly. The assembly drawing, P12620666, and engineering bill of material have been updated. In addition the inspection plans for this part have been updated to include a circuit isolation check to confirm that the case of the voltage regulator is electrically isolated from the aluminum brackets. The inspectors have been trained in how to perform these checks.
