RE: License No. SUA-1139, Highland Reclamation Project

Uranium Transport - Conceptual Site Model Summary, with Application to Well 175

Geochemical and Hydrologic Conditions at Well 175

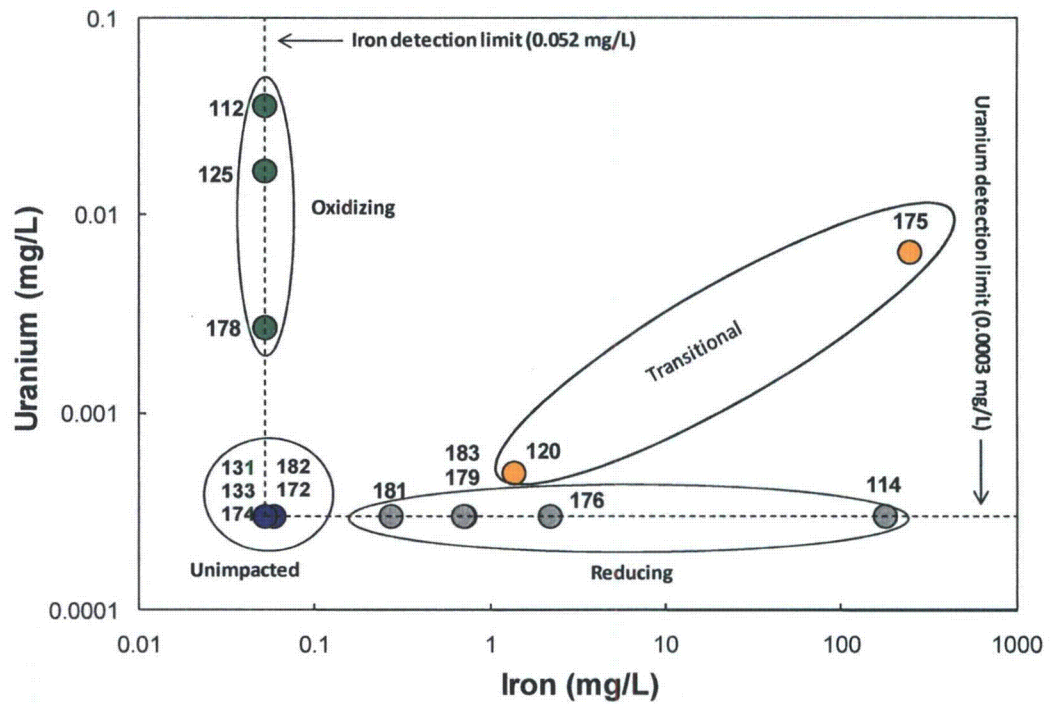
Analysis of TDSS groundwater samples for iron and uranium was conducted during first Quarter 2010 to evaluate the potential for contrasting oxidation-reduction (redox) conditions in the TDSS. The resulting relationship between iron and uranium is consistent with variable redox control of uranium in the TDSS (Figure 1). Oxidizing conditions are signified by groundwater containing non-detectable iron concentrations (<0.052 mg/L) but with measureable uranium. Conversely, reducing conditions are represented by groundwater containing measureable iron but with non-detectable concentrations of uranium (<0.0003 mg/L). Two of the wells located at the margin of tailings impoundment (Wells 120 and 175) produced anomalous chemical results, with detectable concentrations of both iron and uranium (Figure 1). The groundwater in Wells 120 and 175 is characterized as transitional and may indicate the presence of a redox boundary in the vicinity of the wells.

The increasing trend in uranium at Well 175 has been interpreted previously as oxidation of precipitated U(IV) minerals, such as uraninite, solely promoted by a shift toward oxidizing conditions caused by desaturation of the TDSS. However, the occurrence of elevated iron in conjunction with detectable uranium is inconsistent with a shift toward oxidizing conditions. For this reason, groundwater at Well 175 is now classified as transitional (Figure 1) because it contains chemical characteristics of both oxidizing and reducing groundwater.

Figure 1. Iron and uranium concentrations in selected TDSS monitoring wells.

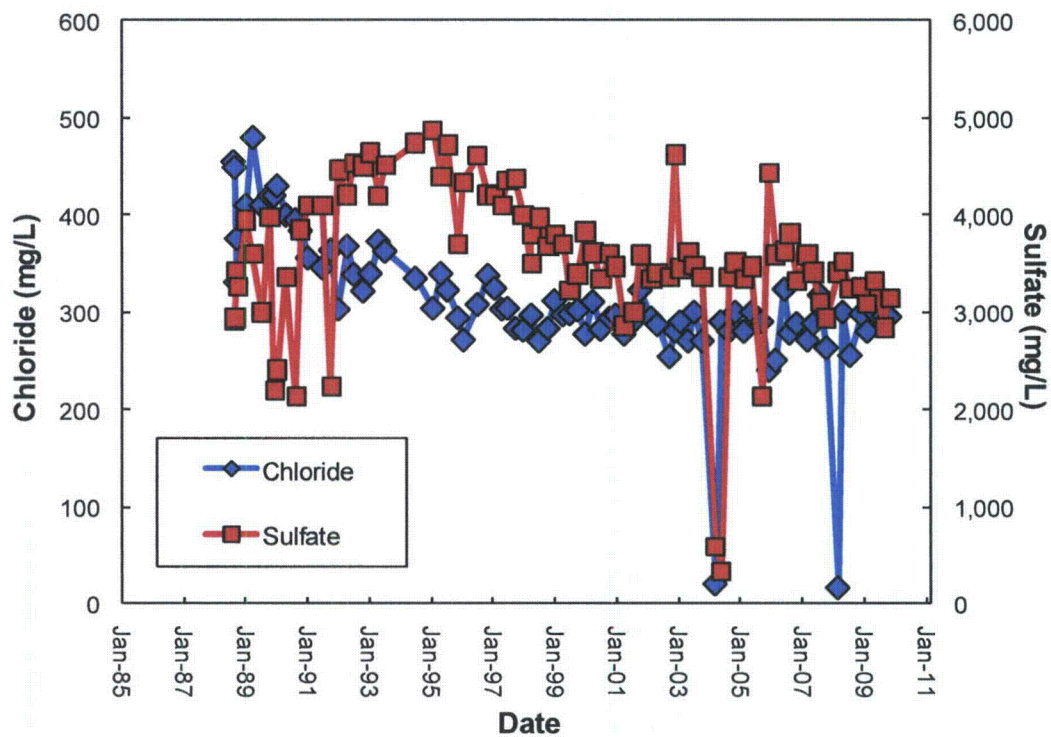
Well 175 is located on the western edge of the tailings impoundment. It has demonstrated historic tailings seepage impacts based on the elevated chloride and sulfate concentrations, both of which have been slowly decreasing since the mid-1990s (Figure 2). Moreover, uranium concentrations were consistently low to non-detectable in Well 175 from the time of installation in 1988 until about 2002 (Figure 3). The low uranium concentrations during this period suggest the presence of locally-reducing groundwater as described above and in the CSM. Recently, iron data have become available to better understand groundwater redox conditions. Since 2003, uranium has been increasing in Well 175, and the August 2010 concentration (0.0325 mg/L) exceeds the MCL of 0.03 mg/L.

Figure 2. Chloride and sulfate concentrations trends in Well 175.

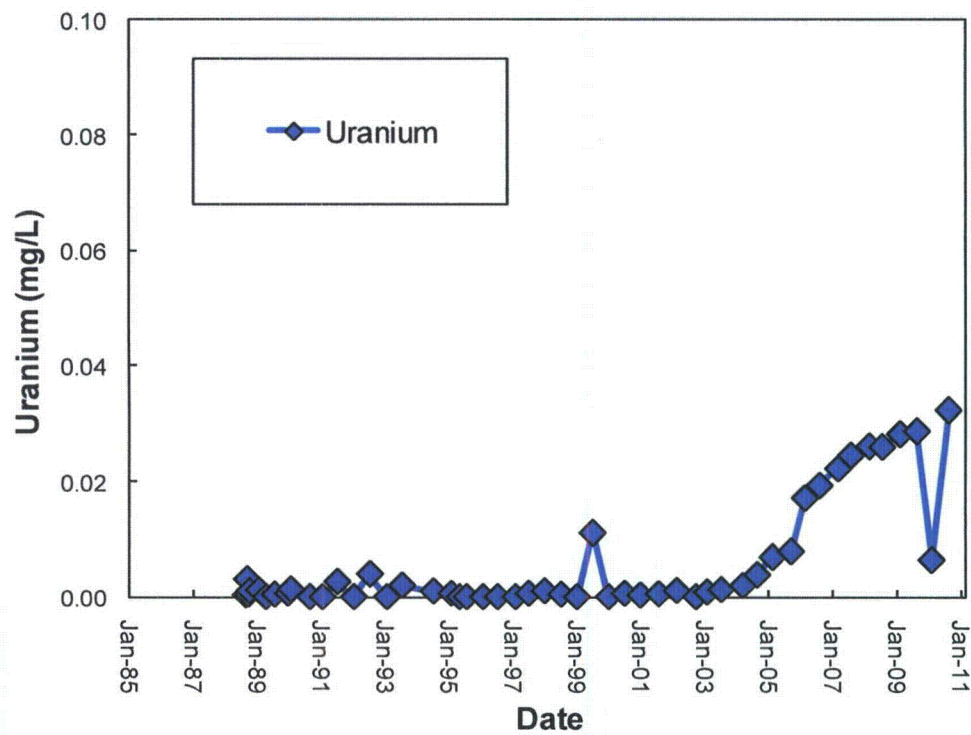
Prior to 2003, the redox state of groundwater at Well 175 was predominantly reducing, based on the low uranium concentrations. The elevated concentrations of chloride and sulfate indicated that the groundwater in Well 175 was impacted by seepage from the tailings impoundment. However, continued desaturation of the TDSS has resulted in transient flow conditions in the vicinity of Well 175 which appear to be bringing groundwater from different zones within the aquifer, resulting in the mixing of oxidizing and reducing waters. The trend in increasing uranium concentration indicates that the relative proportion of oxidized water to reduced water being intercepted at Well 175 has been increasing since 2003. Accordingly, the ACL Application will further address tailings seepage at Well 175 in order to provide a complete resolution of site groundwater control issues with respect to long-term surveillance and monitoring and, ultimately, license termination. Please let me know if you have any further questions.

Figure 3. Uranium concentrations in Well 175.
