# 2010 Review and Evaluation of the Shiprock Remediation Strategy

January 2011

U.S. DEPARTMENT OF  
**ENERGY**

Legacy  
Management

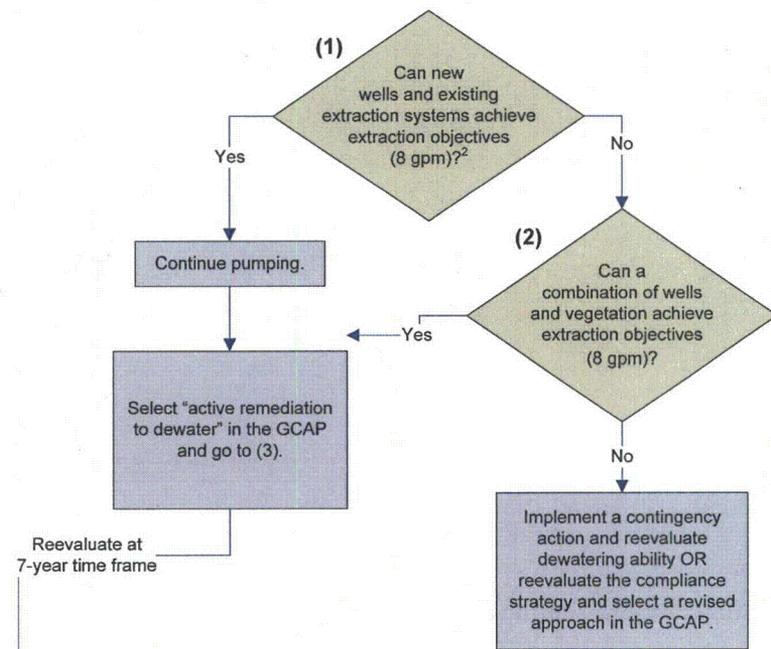
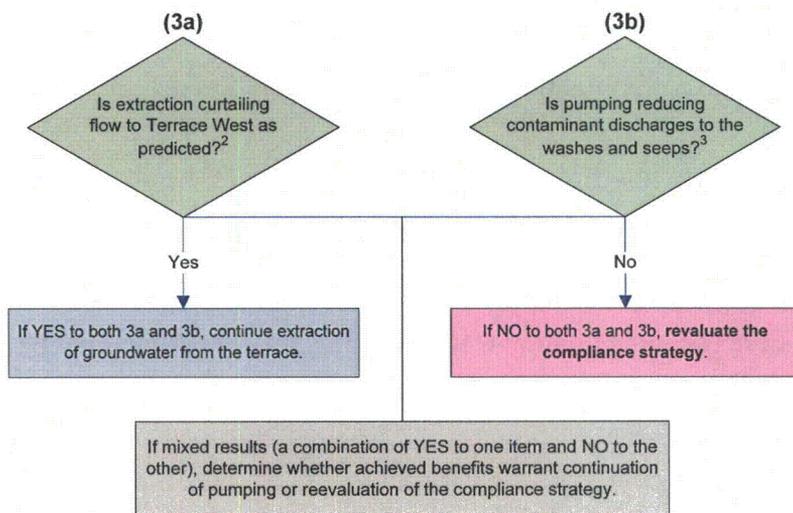
**Terrace Decision Process**  
 Source: DOE 2005 (Addendum 1, Exhibit 1)

- As of October 2010, despite expansion of the extraction system, the 8 gpm objective has not been achieved. For the last 2 years, total combined terrace extraction rates have been about 2 gpm, well short of the 8 gpm goal.
- Although the 8 gpm extraction objective has not been attained, progress has been made in terms of the overall dewatering objective (see below). The extent to which this is due to pumping or other influences (e.g., cessation of irrigation on the west terrace and/or drought conditions) is not clear.

- Although it is premature to evaluate the long-term decision endpoints at this time, some interim observations can be made:
- As shown in Figure 5, water levels have declined, particularly in the western portion of the terrace. However, the extent to which flow to the west terrace has been "curtailed" is not clear.

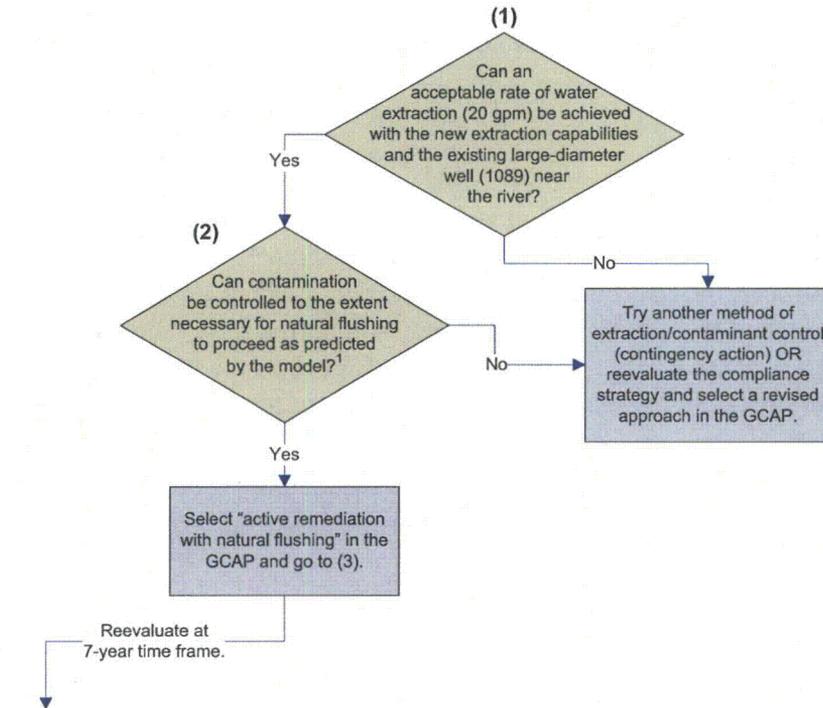
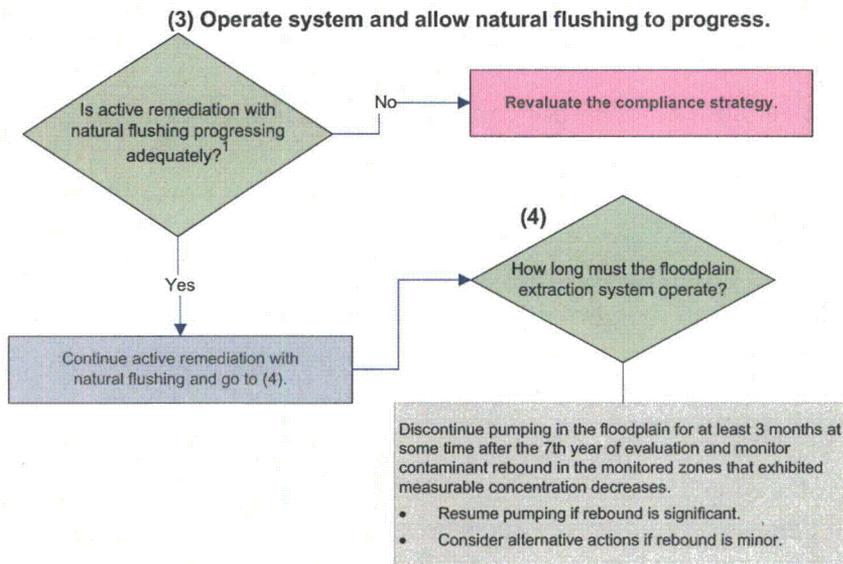
**Floodplain Decision Process**  
 Source: DOE 2005 (Addendum 1, Exhibit 2)

- At the time this decision matrix was developed, it was recognized that wells 1089 and 1104 were not meeting objectives. In 2006, DOE installed two trenches at the base of the escarpment to improve extraction rates. The 20-gpm rate is now being achieved.
- Decreases in contaminant concentrations (uranium, sulfate, nitrate) are apparent in a number of floodplain wells (DOE 2009a).
- In large part, because of the two trenches, progress has been made in terms of extraction rates and contamination control.

- Although it is premature to evaluate the long-term decision endpoints at this time, some interim observations can be made:
- Significant declines in contaminant concentrations are evident in trench area wells.
  - Contaminant concentrations in well 1089 area are variable, and no clear conclusions can be drawn at this time.
  - Although studies are ongoing, the trenches appear to be effective in extracting contaminated water from the floodplain and reducing contaminant concentrations in nearby groundwater (DOE 2009c).

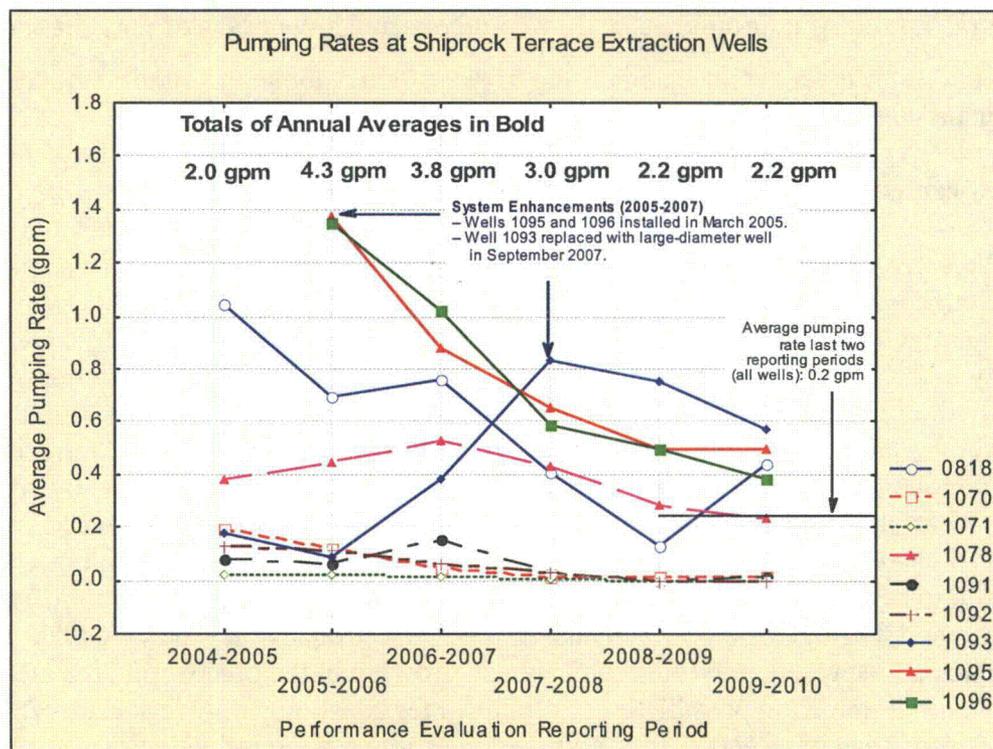
Figure 4. Pumping Rate Summary for Terrace Extraction Wells

As recommended in the Conceptual Model Report, DOE expanded the terrace extraction well network between 2005 and 2007. Two new wells (1095 and 1096) were installed near the evaporation pond in March 2005, and in September 2007, DOE installed a new large-diameter well (1093R) to increase the probability of collecting a larger volume of water (see Attachment 1). As of September 2010, despite expansion and enhancement of the terrace extraction system, the 8 gpm objective has not been achieved. The combined pumping rate from terrace extraction wells has ranged between 2 and 4 gpm since remediation started (2 gpm in the last 2 years), well short of the 8 gpm objective (Figure 4).

Since 2005, DOE has also redeveloped several wells on the terrace to improve well yields. These and other well restoration methods proved ineffective. During pumping tests performed in 2008, the wells evaluated in the immediate vicinity of the current system did not produce enough water to justify adding any additional infrastructure.

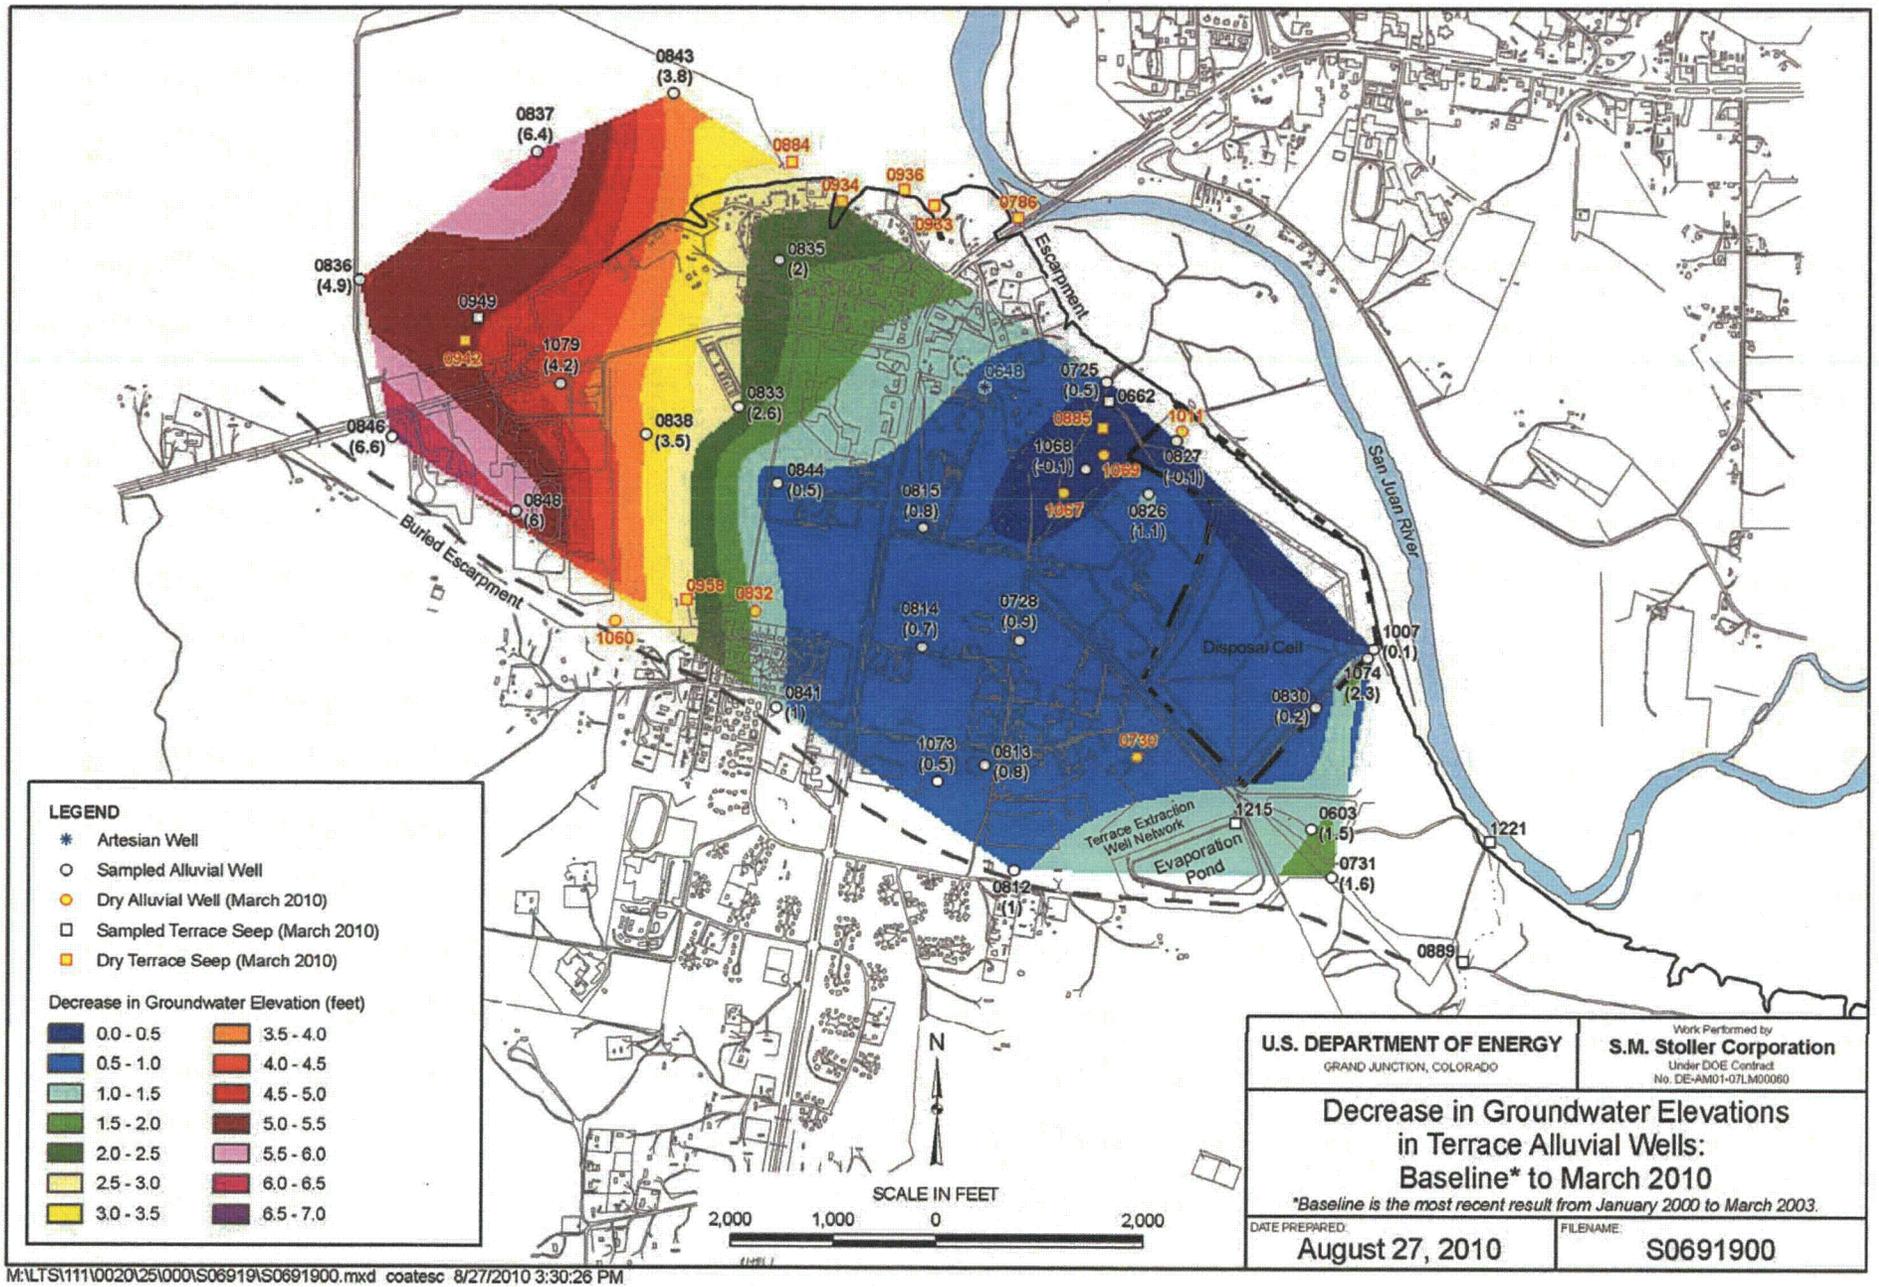
Figure 5. Decrease in Groundwater Elevations in Terrace Alluvial Wells (March 2003—March 2010)

- As shown in Figure 5, water levels on the terrace declined, particularly in the western portion of the terrace. Groundwater elevations measured in 26 groundwater wells in March 2010 have decreased relative to the baseline period of January 2000 to March 2003. A corresponding decrease in flow from seeps along the floodplain and in areas of the western portion of the terrace has also been observed. However, the extent to which flow to the west terrace has been curtailed is not clear.
