2010 Annual Site Inspection and Monitoring Report for Uranium Mill Tailings Radiation Control Act Title I Disposal Sites

January 2011

LMS/S06929

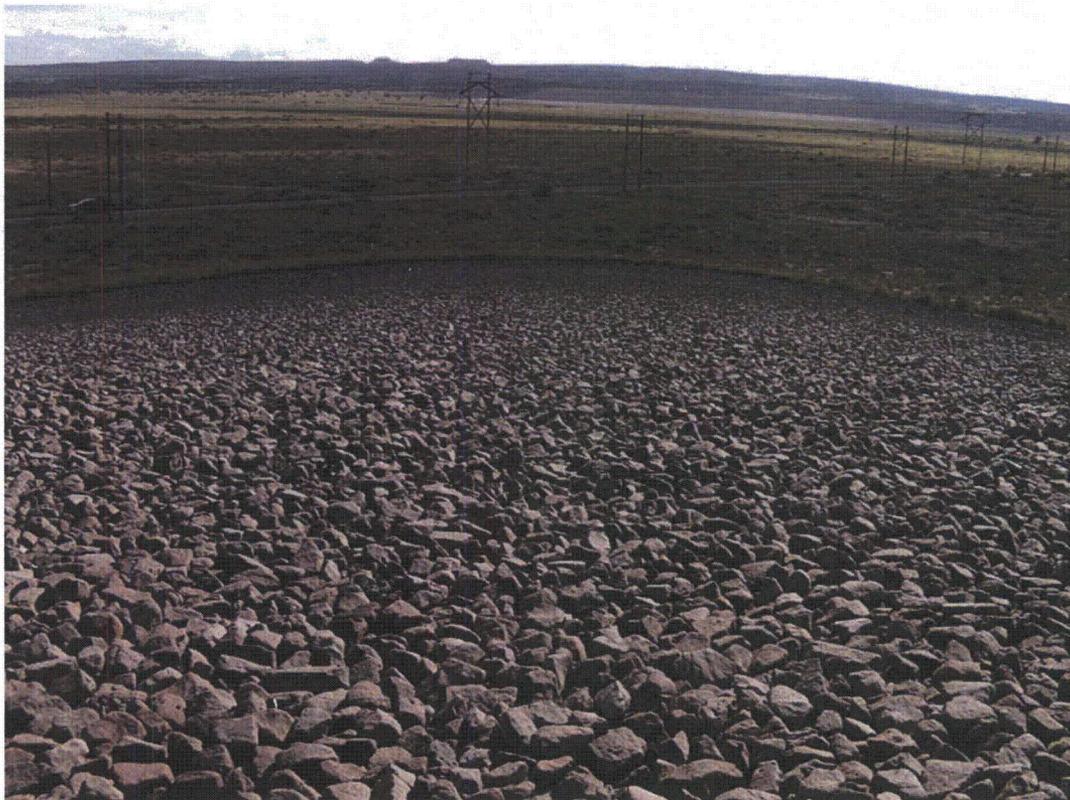
Top of Disposal Cell—The 91-acre disposal cell was completed in 1994. The basalt riprap-covered top of the disposal cell was in excellent condition. There was no evidence of cracking, slumping, or erosion (PL-4). No deep-rooted shrubs were present at the time of the inspection.

AMB 8/2010. PL-4. Southeast view of the disposal cell cover.

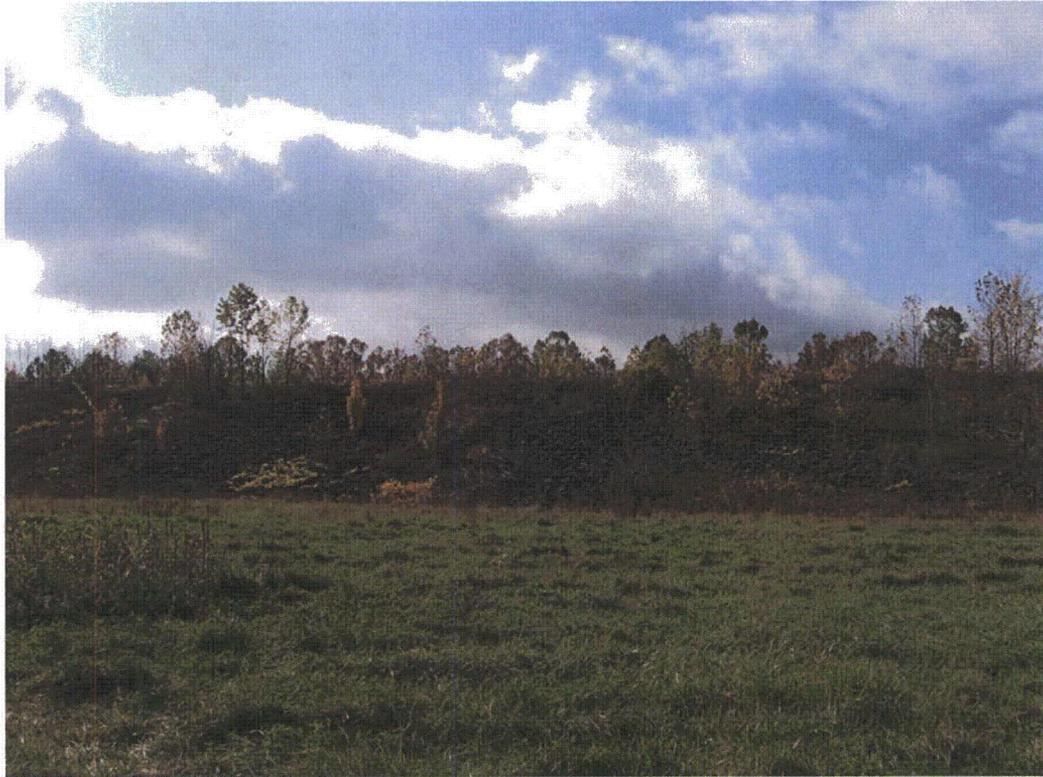
Disposal Cell—The riprap-covered disposal cell was in excellent condition (PL-3). There were no indications of cell instability, such as slumping, bulging, or differential settlement. Rock quality was excellent; degradation of the limestone riprap was not evident.

BUR 10/2010. PL-3. North side of the disposal cell.

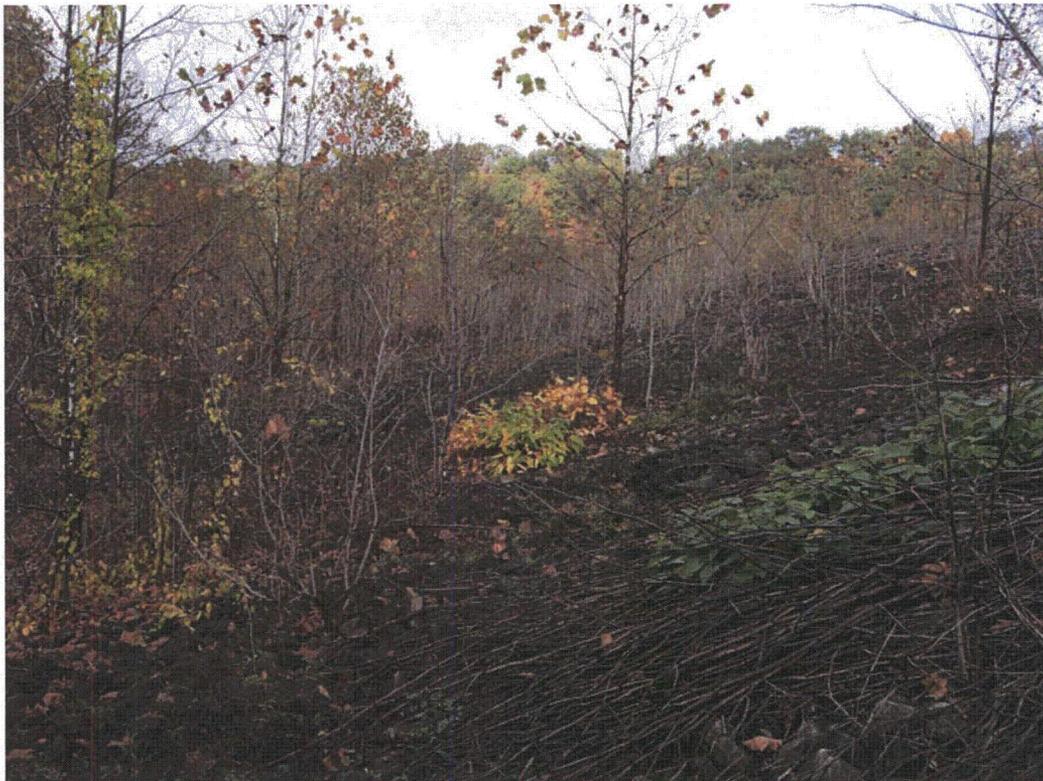
BUR 10/2010. PL-4. Japanese knotweed control on south side of the disposal cell.

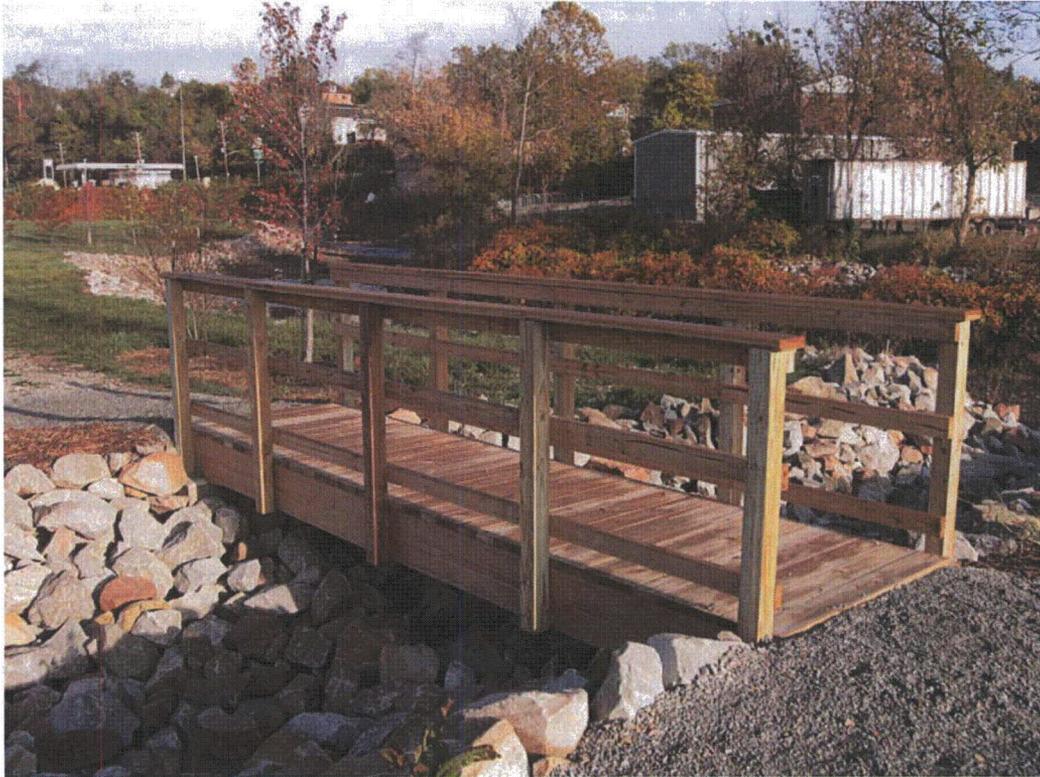
CAN 10/2010. PL-1. Newly installed footbridge across a riprap armored diversion ditch.

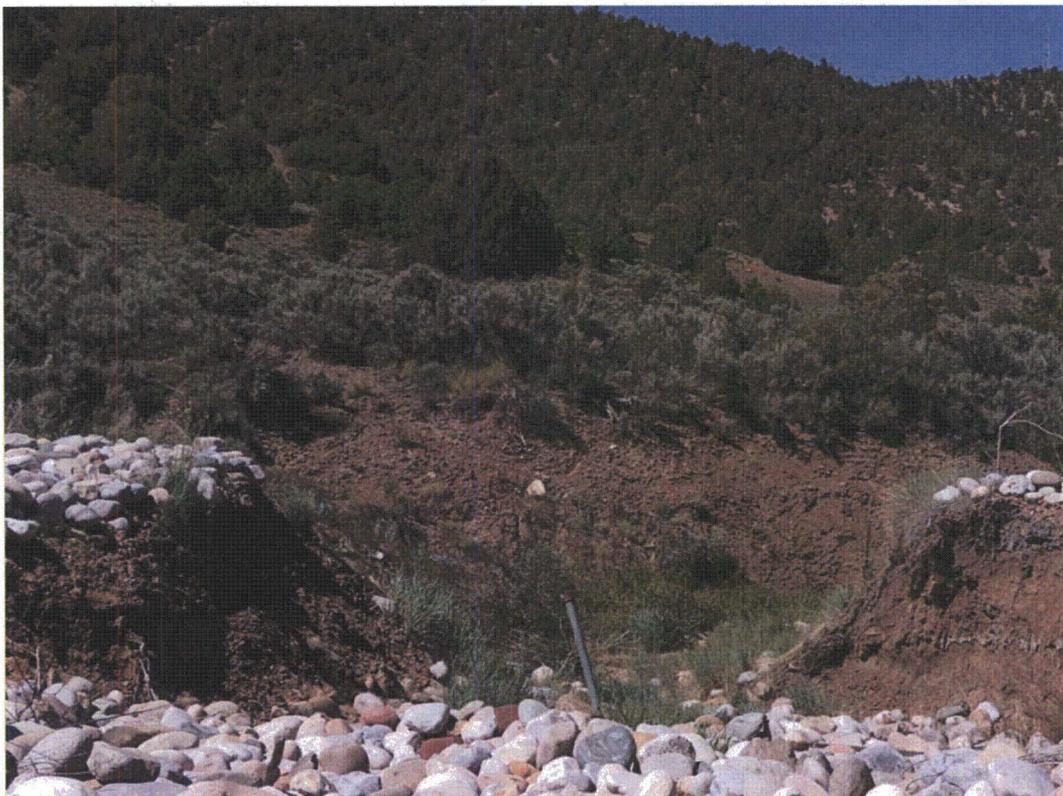
DUR 6/2010. PL-2. Northeast outflow; no new erosion

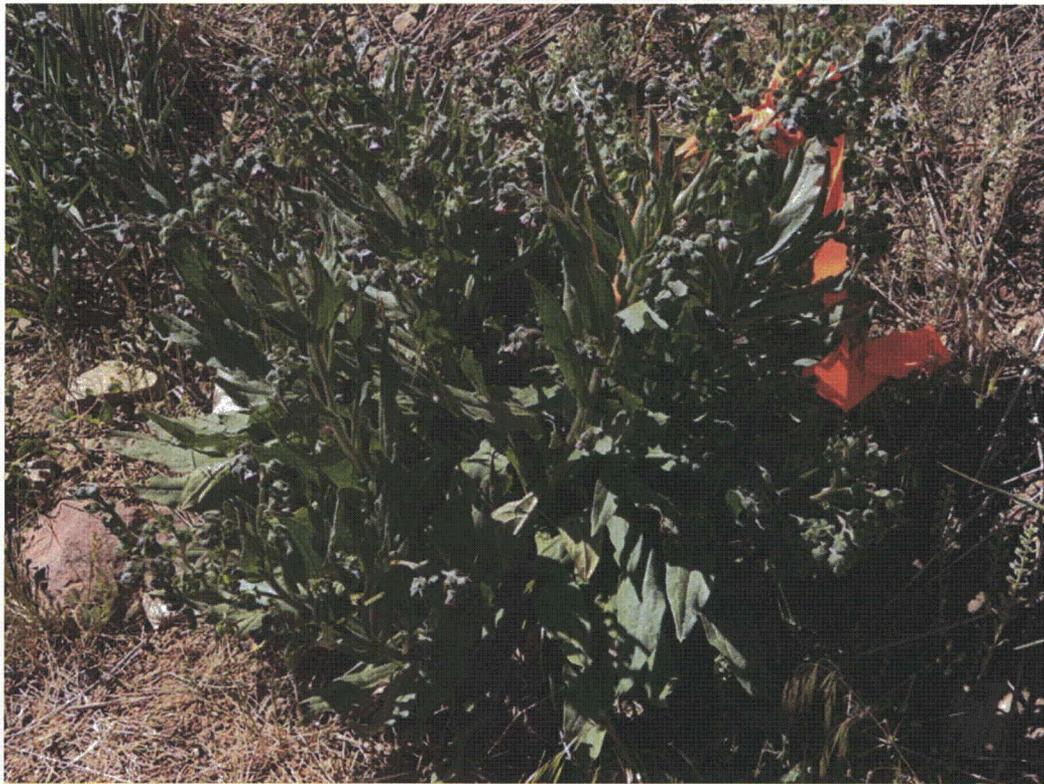
DUR 6/2010. PL-4. Houndstongue, a noxious weed.

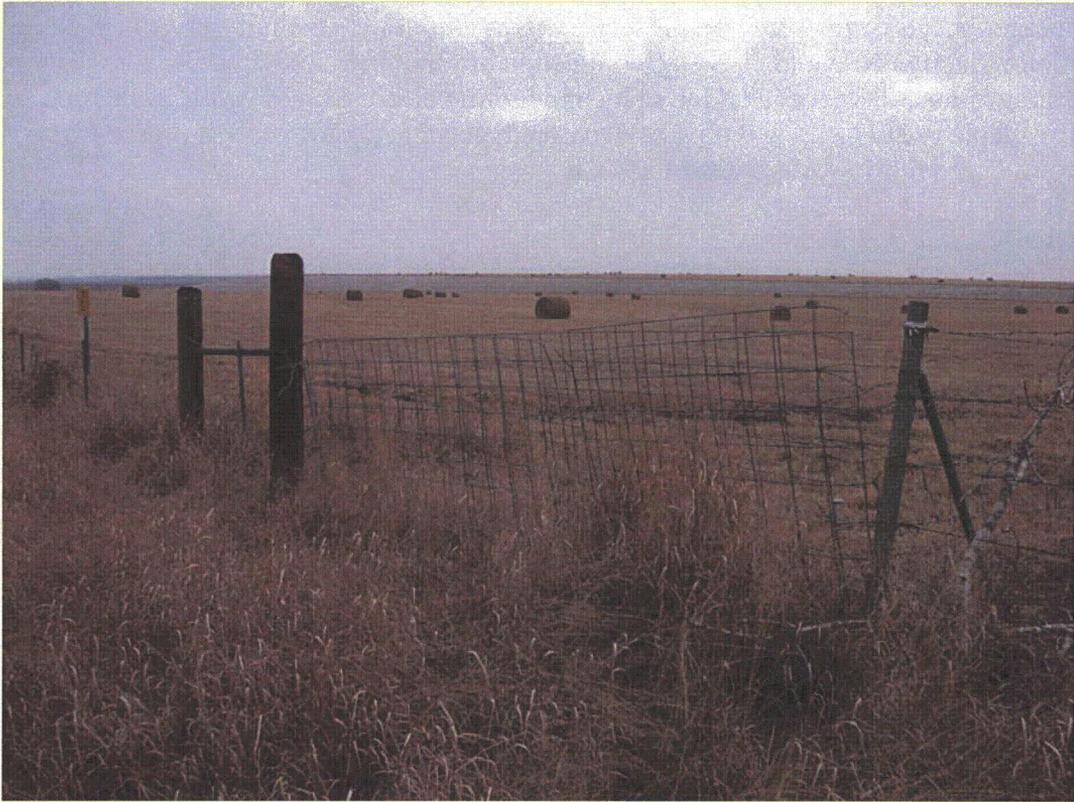
FCT 1/2010. PL-1. Fence panel in west corner of perimeter fence.

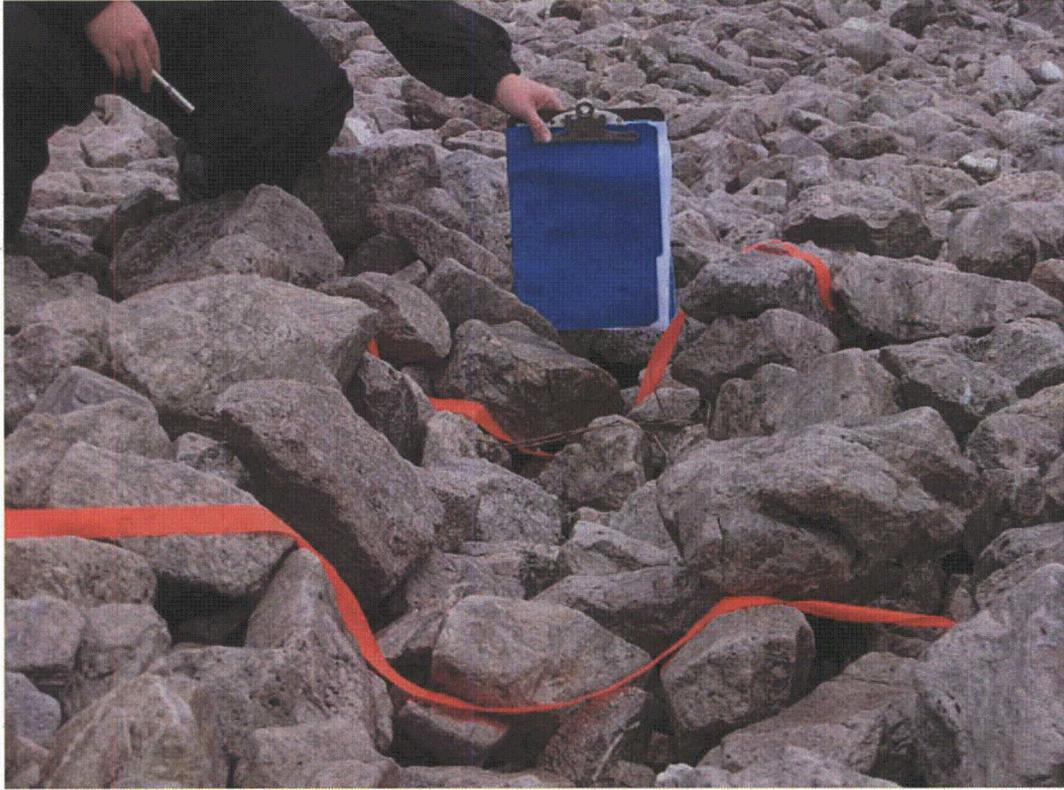
FCT 1/2010. PL-3. Red ribbon delineates riprap disturbance on the northwest side slope.

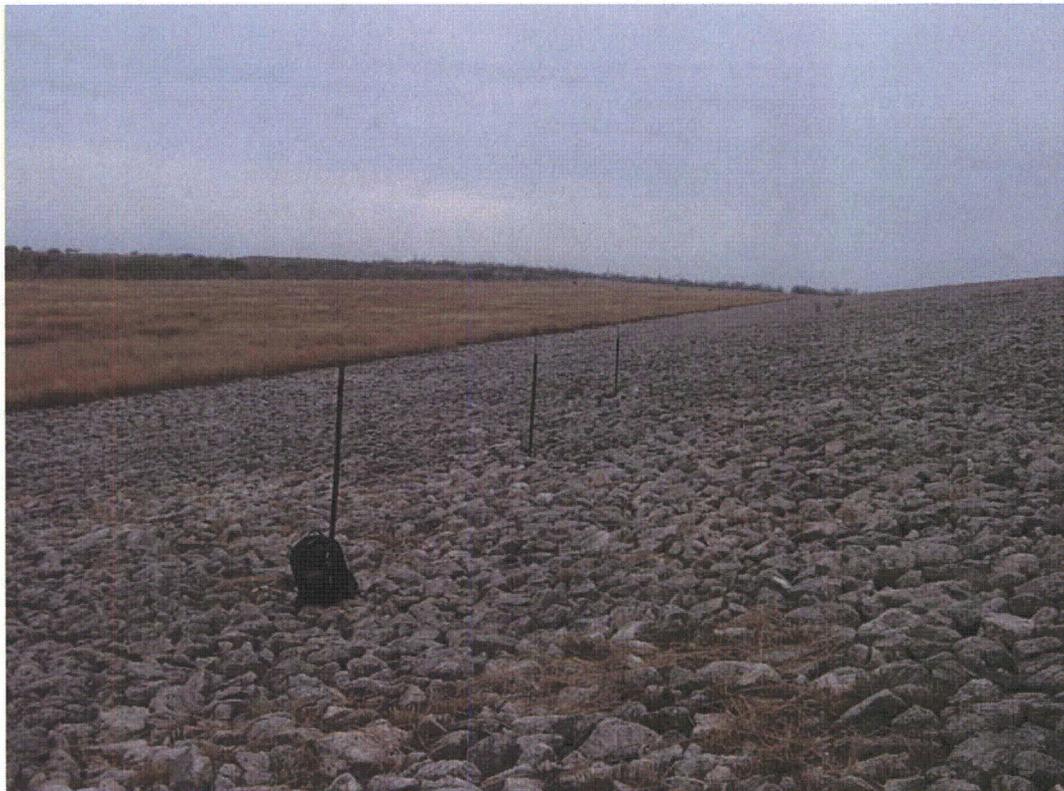
FCT 1/2010. PL-4. Three posts installed in possible subsided area on south corner of the riprap side slope of the disposal cell.

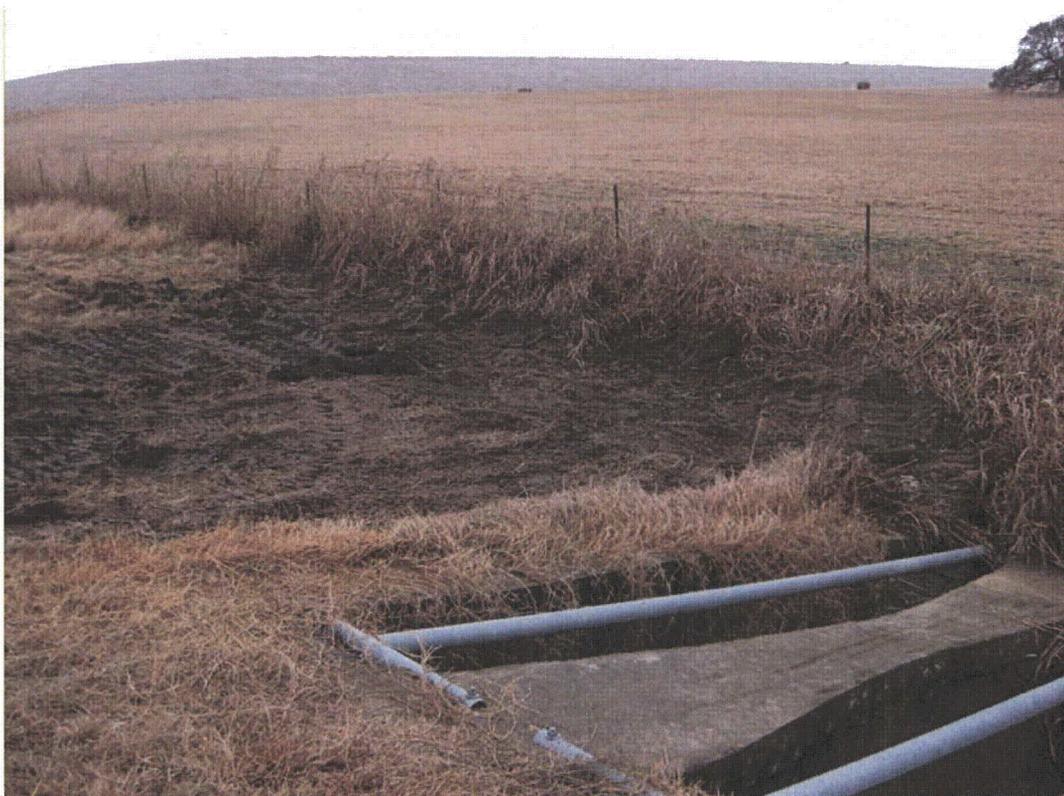
FCT 1/2010. PL-6. Off-property culvert along FM 1344, near perimeter sign P49.

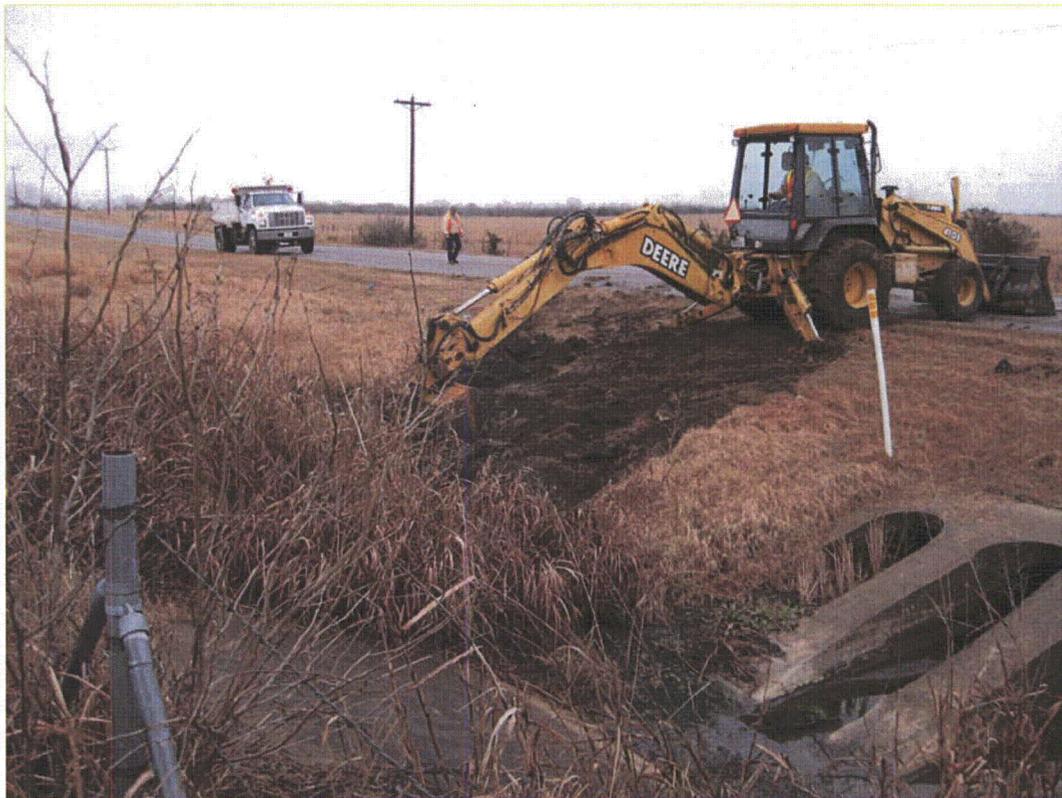
FCT 1/2010. PL-7. Repairs being made to off-property culvert near perimeter sign P58 by Texas Department of Transportation to address erosion and drainage in culvert next to FM 1344.

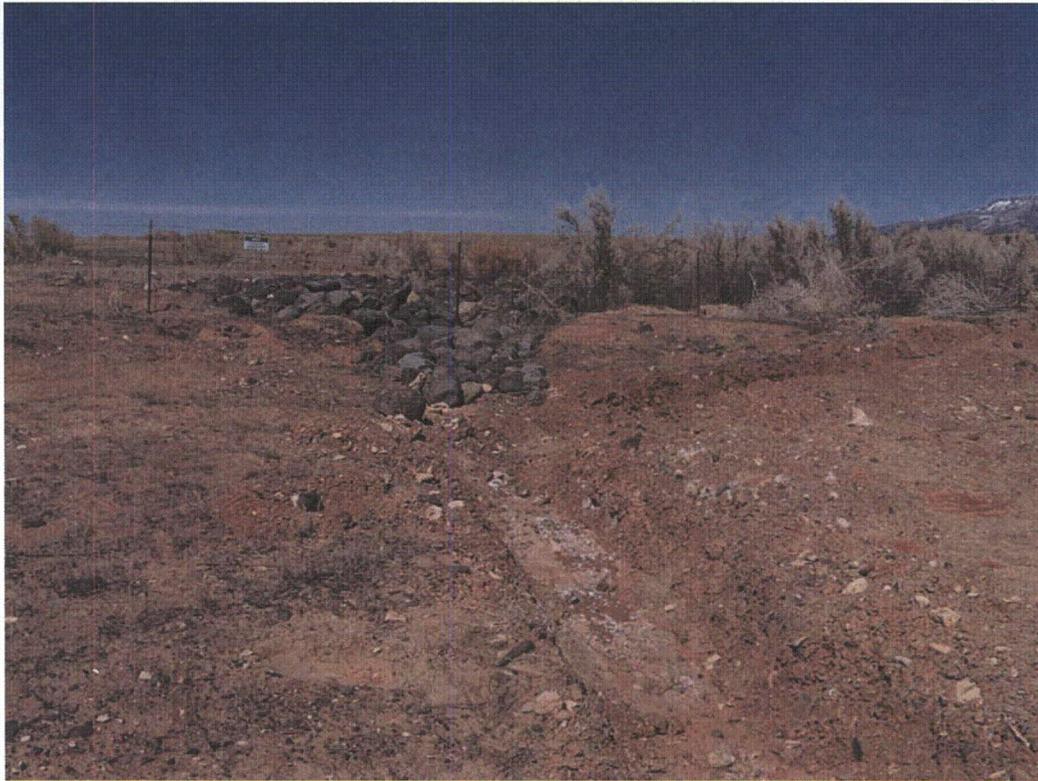
GRJ 3/2010. PL-4. Repaired erosion area in the southeast corner of the site.

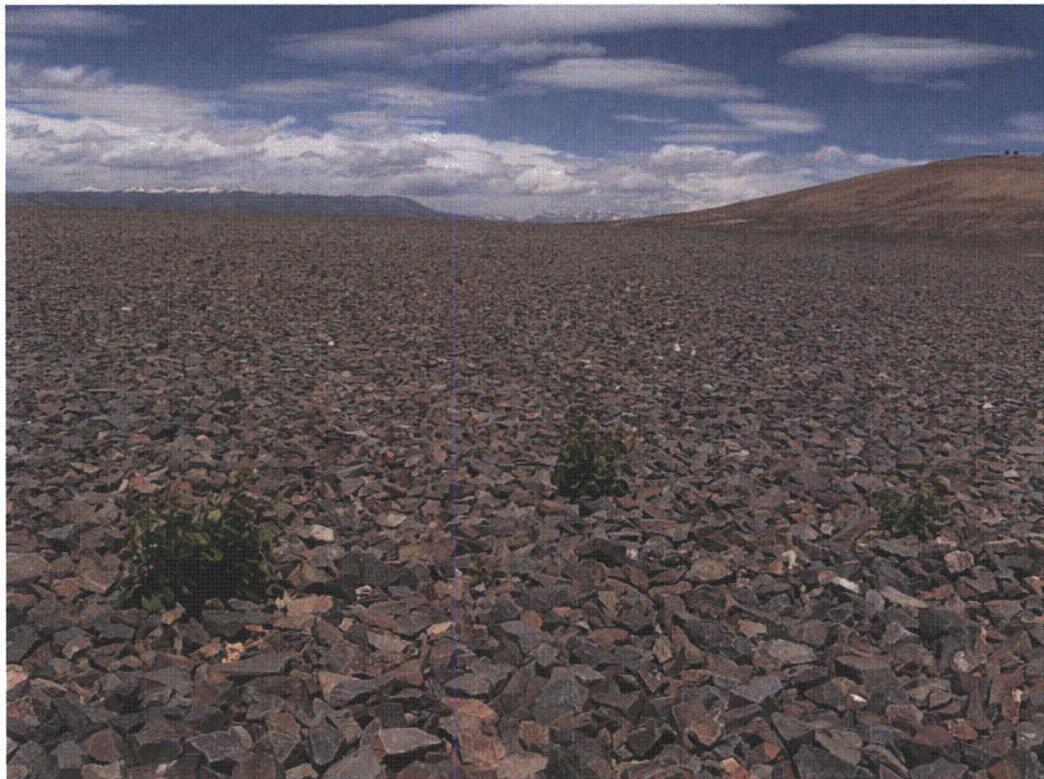
GUN 6/2010. PL-2. Cottonwood tree saplings prior to removal.

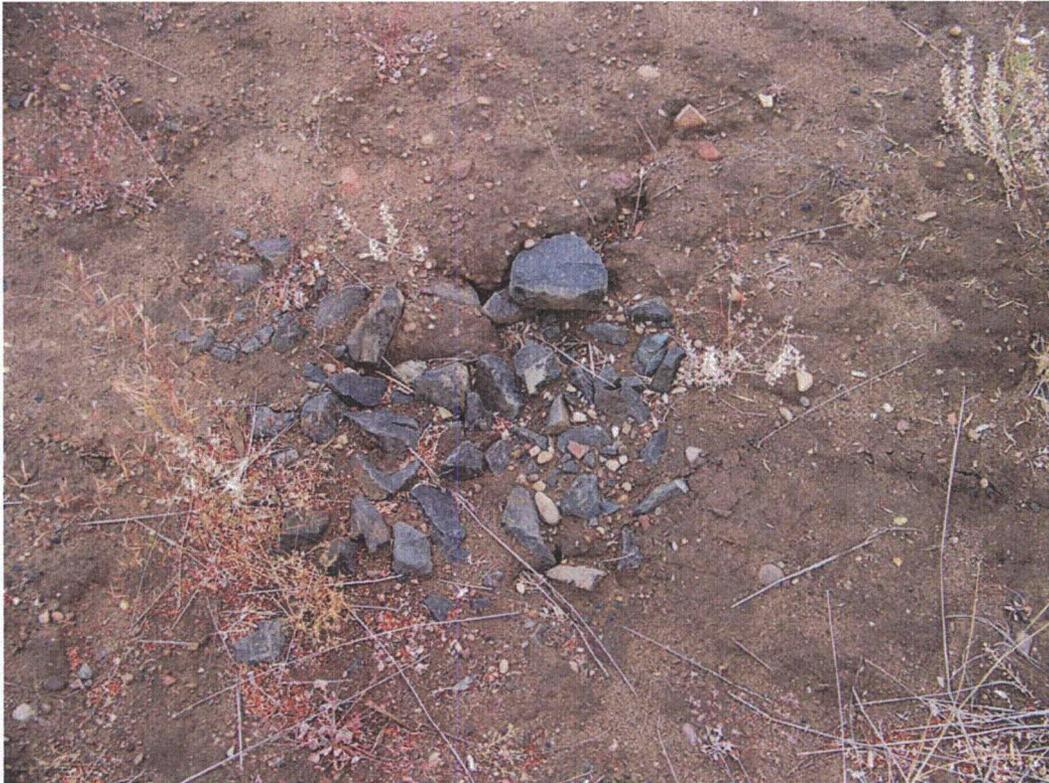
LKV 8/2010. PL-1. Disposal cell top cover with some riprap showing through the soil.
