FM Notification Report Serial Number 10-05

10CFR 21.21 (d)(3)(ii) Notification

Electronic Speed Switch (FM P/N 11916260)

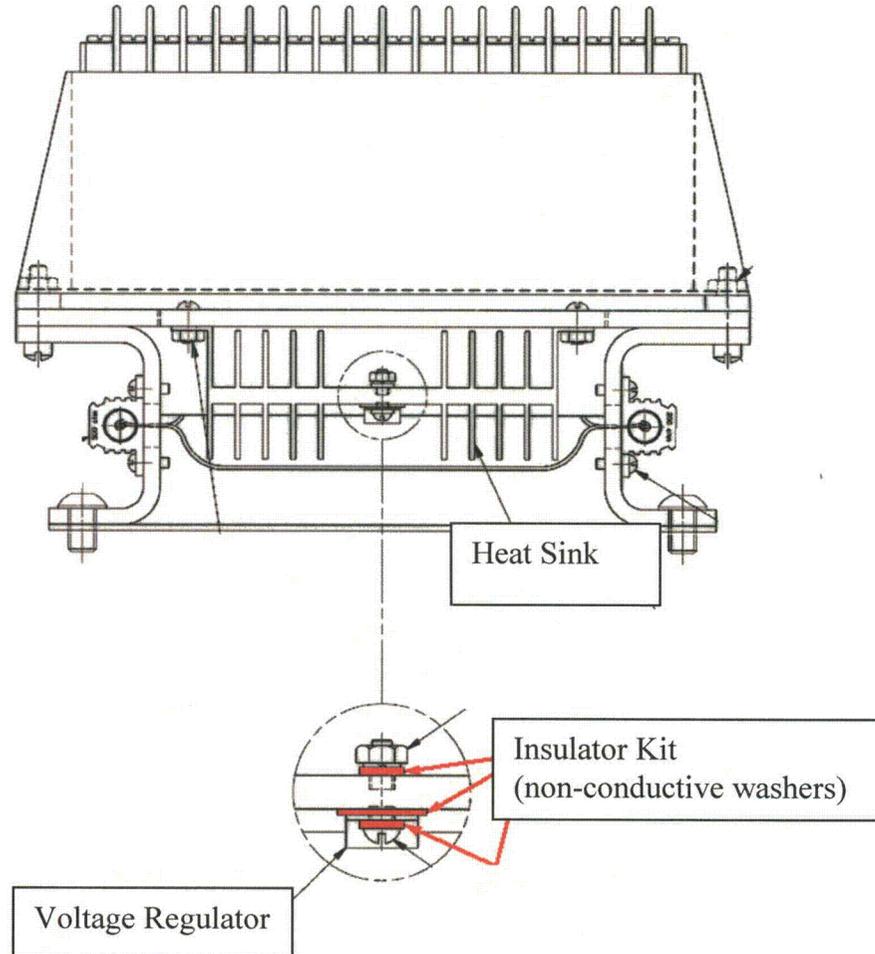
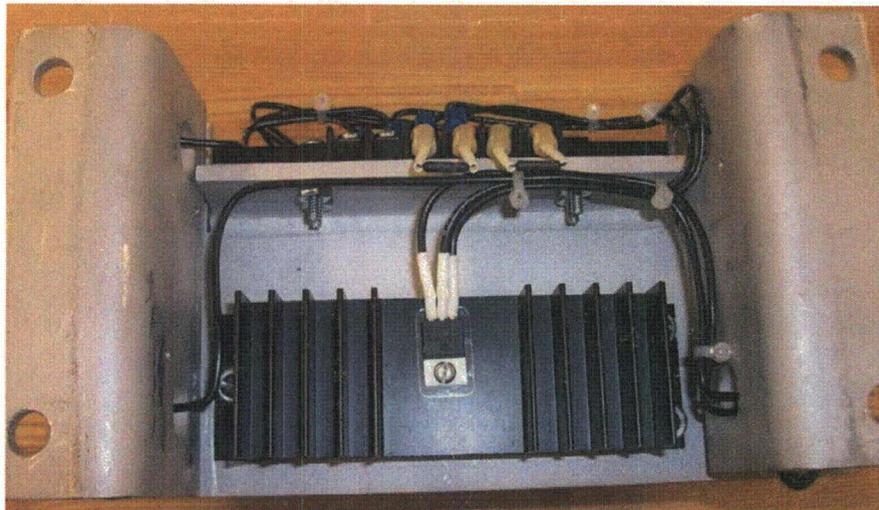
Figure 1

Fairbanks Morse (FM) evaluation has determined that a potential safety hazard existed for the original FM P/N 11916260 created from FM P/N P12620666 rev 0 that was delivered to Hope Creek. Subsequent to shipment to Hope Creek, additional testing found that when the speed switch assembly was mounted on a conductive surface, the voltage regulator grounded out the 24 vdc power through the heat sink preventing the speed switch from operating.

By adding an insulator kit, the speed switch circuit was isolated from ground and verified as functional. The FM initial design of the speed switch did not include the insulator kit (non-conductive washers) that would electrically isolate the voltage regulator from the heat sink and thus the metal mounting surface.

The one affected unit 11916260 created from P12620666 rev 0 was recalled and modified by adding an insulator kit (item 23) between the voltage regulator (item 8) and the heat sink (item 7) as shown in Figure 1. The design records have been updated accordingly. The assembly drawing, P12620666, and engineering bill of material have been updated. In addition the inspection plans for this part have been updated to include a circuit isolation check to confirm that the case of the voltage regulator is electrically isolated from the aluminum brackets. The inspectors have been trained in how to perform these checks.
