FM Notification Report Serial Number 10-05

Fairbanks Morse Engine

10CFR 21.21 (d)(3)(ii) Notification

Electronic Speed Switch (FM P/N 11916260)

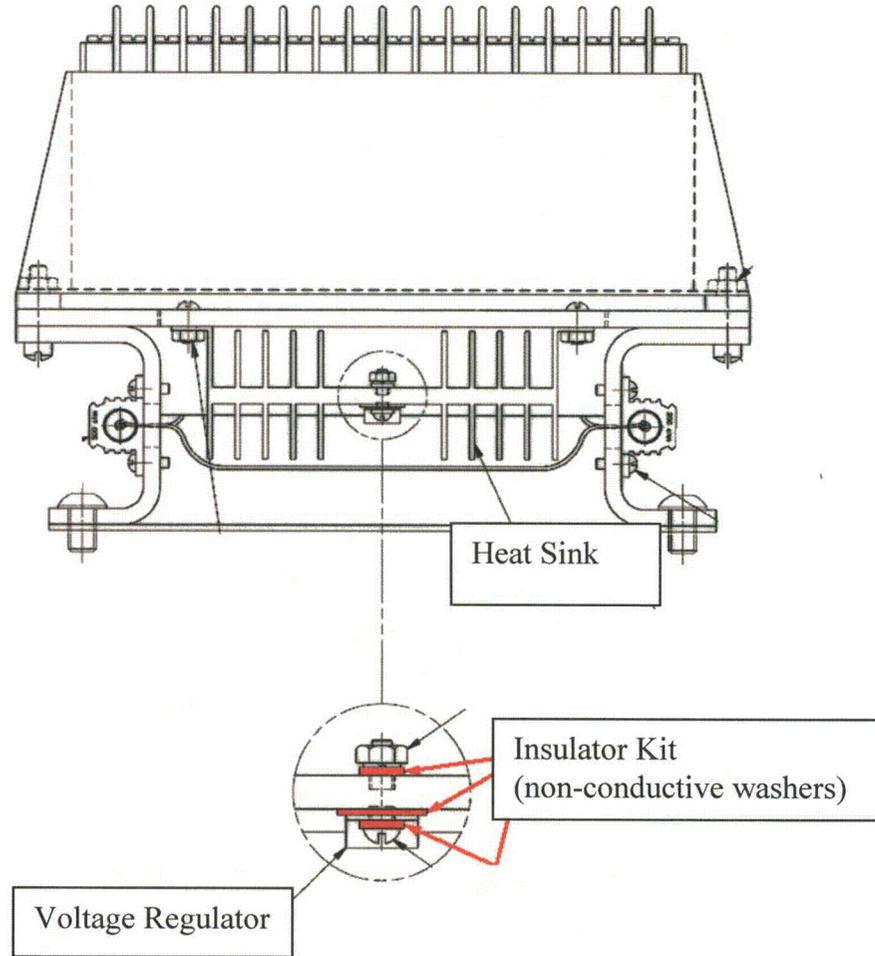
Figure 1

Fairbanks Morse (FM) evaluation has determined that a potential safety hazard existed for the original FM P/N 11916260 created from FM P/N P12620666 rev 0 that was delivered to Hope Creek. Subsequent to shipment to Hope Creek, additional testing found that when the speed switch assembly was mounted on a conductive surface, the voltage regulator grounded out the 24 vdc power through the heat sink preventing the speed switch from operating.

By adding an insulator kit, the speed switch circuit was isolated from ground and verified as functional. The FM initial design of the speed switch did not include the insulator kit (non-conductive washers) that would electrically isolate the voltage regulator from the heat sink and thus the metal mounting surface.

The one affected unit 11916260 created from P12620666 rev 0 was recalled and modified by adding an insulator kit (item 23) between the voltage regulator (item 8) and the heat sink (item 7) as shown in Figure 1. The design records have been updated accordingly. The assembly drawing, P12620666, and engineering bill of material have been updated. In addition the inspection plans for this part have been updated to include a circuit isolation check to confirm that the case of the voltage regulator is electrically isolated from the aluminum brackets. The inspectors have been trained in how to perform these checks.
