Failure Mechanism of 21 Main Transformer and Extent of Condition
CR: IP2-2010-6801 CA: 15

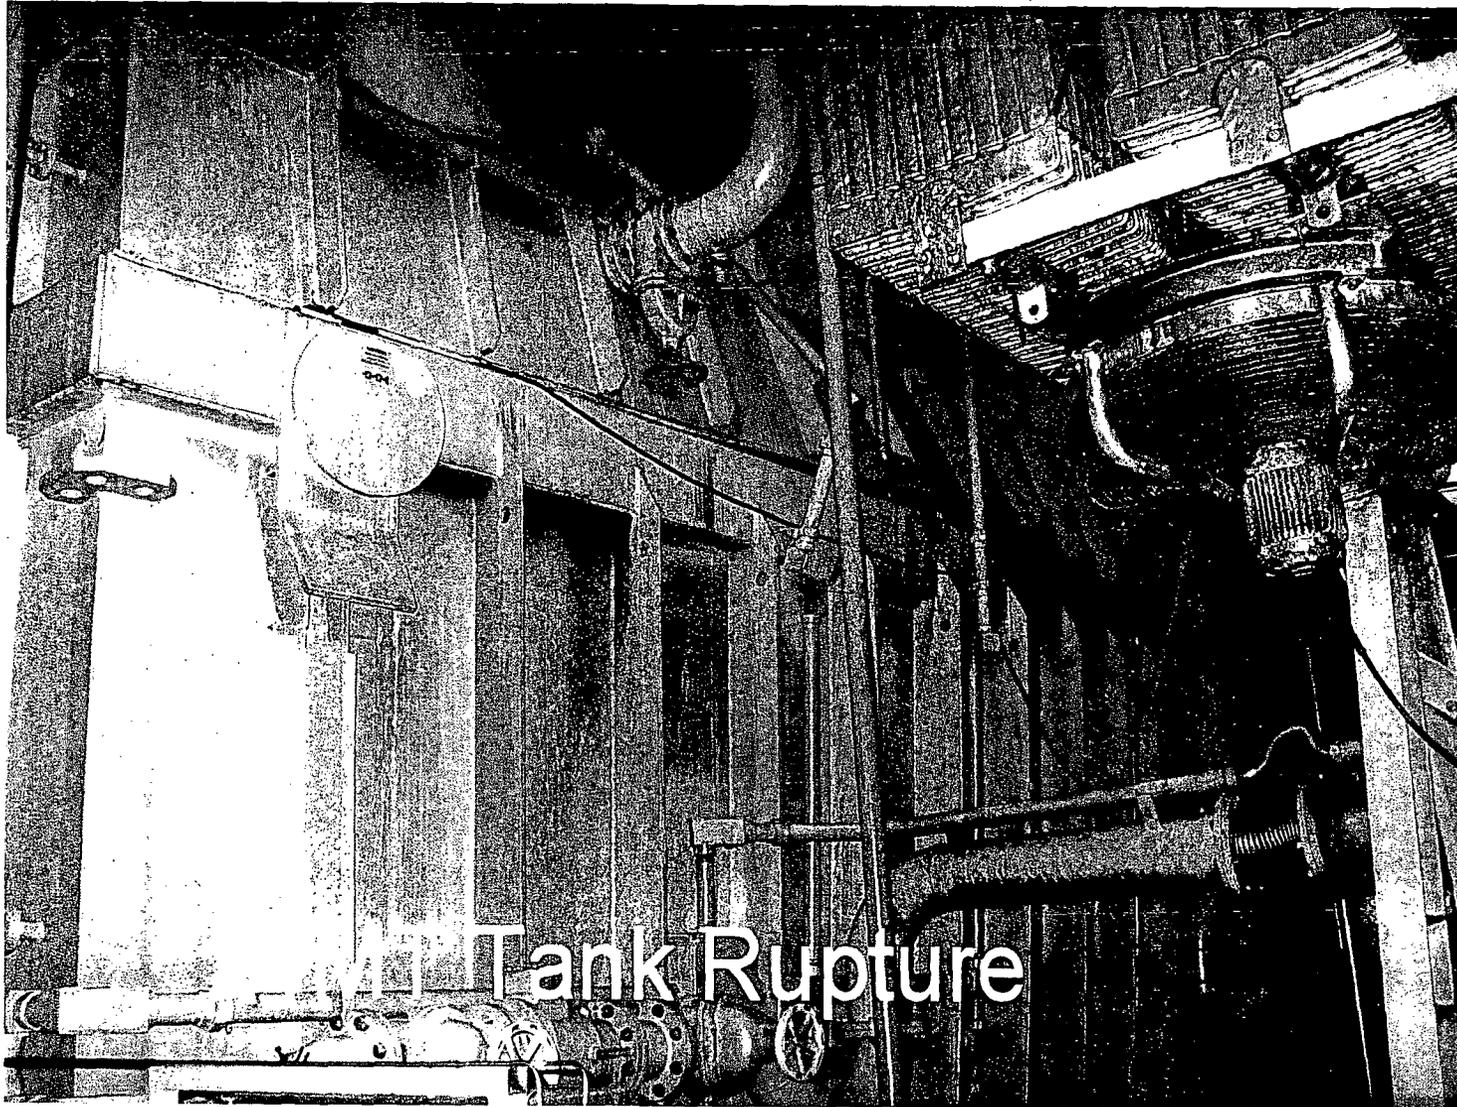
The transformer experienced a rapid increase in pressure due to the failure of the 'B' phase high voltage bushing. This sudden increase caused the tank to fail. Combustible gases, from arcing, built up in the transformer as the insulating oil leaked from the tank breach. After several more minutes, enough oxygen combined with the hot gases causing a secondary explosion. See Attachment 3 for photos of damage to bushings and ruptured transformer tank.
