## Impacts of a Severe Road Tunnel Fire on Transportation of Spent Nuclear Fuel - 11583

E. Easton,<sup>1</sup> C. Bajwa,<sup>1</sup> T. Mintz,<sup>2</sup> J. Huczek,<sup>3</sup> K. Das,<sup>2</sup> K. Axler<sup>2</sup>

In October 2007 just north of Los Angeles, California, a chain-reaction accident involving numerous tractor trailers in the I-5 "Newhall Pass" truck bypass tunnel occurred. This accident also involved an intense fire that damaged the concrete walls of the tunnel and required the tunnel to be closed for repairs. The objective of the work described in this paper was to determine the maximum exposure temperature in the tunnel and evaluate the conditions likely to be found in this fire. The study included analyses of material recovered from the incinerated vehicles. A simulation of the Newhall Pass tunnel fire, using the Fire Dynamics Simulator code developed by the National Institute of Standards and Technology, is also being completed. A discussion of the results of this study as well as the potential implications of this accident for the transportation of spent nuclear fuel by truck is provided.

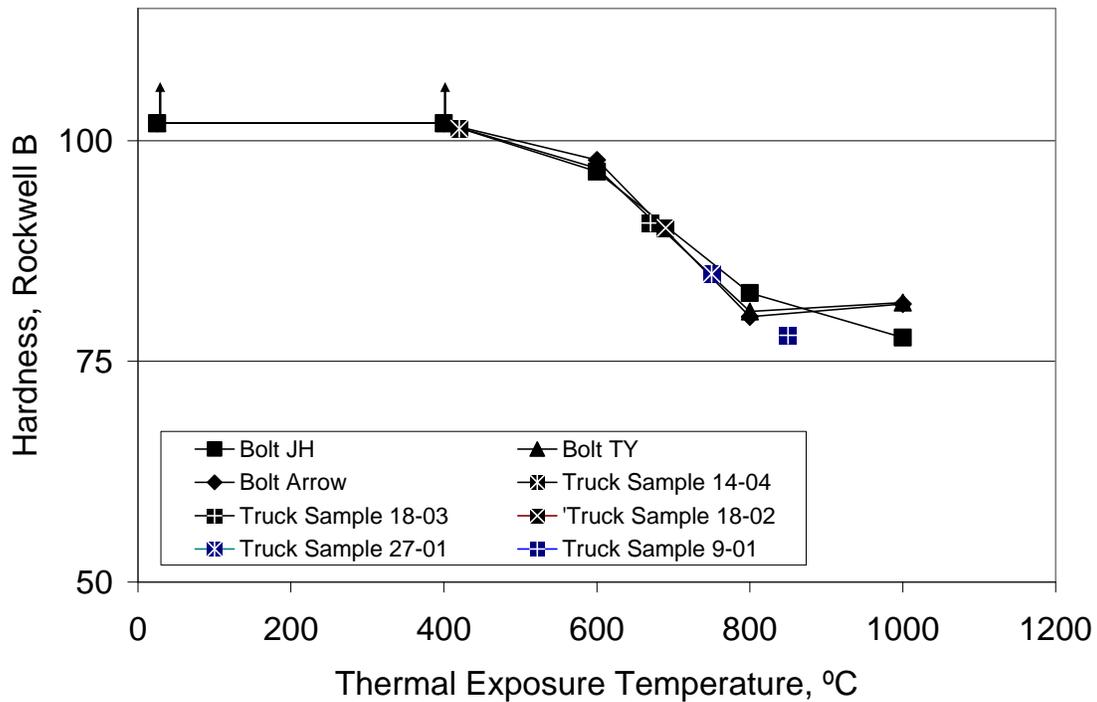
**Fig. 2. Effect of exposure temperature on the hardness of truck samples and commercially available Grade 5 bolts**

SAE Grade 5,<sup>10</sup> which specifies a minimum of 92,000 psi (630 MPa) yield stress; 120,000 psi (830 MPa) minimum tensile stress; and a core Rockwell hardness of C25 to C34.<sup>10</sup> The bolts were sectioned, and the hardness was measured using a Tukon 2100B hardness tester. The as-collected samples had a core hardness that varied from Rockwell B78 to B101 (approximately Rockwell hardness C0 to C24), as shown in Table III. The hardness for these bolt samples collected from the incinerated vehicles is well below specifications, indicating they had likely been heated well above the minimum tempering temperature, thereby reducing strength and hardness.

The measured hardness values for the heat-treated reference samples are shown in Table IV and presented in Fig. 2. The effect of temperature on hardness is shown as a decreasing slope in this figure. Although there were some slight differences in the chemical composition of the three reference samples, the hardness curves as a function of temperature are very similar. The results suggest that an exposure to a temperature between 800 and 1,000 °C (1,472 and 1,832 °F) for 2 hours would result in a reduction of hardness similar to that observed for the as-collected condition of Truck Sample 9-01. The results also suggest that an exposure to temperatures of roughly 420, 670, 690, and 750 °C (788, 1,238, 1,274, and 1,382 °F) would similarly reduce hardness that was observed for the as-collected condition of Truck Samples 14-04, 18-03, 18-02, and 27-01, respectively.
